**SNOWY MONARO**  
REGIONAL COUNCIL

**16.1 Integrated Property, WHS, Public Liability Risk Assessment & BCA/DDA  
Compliance Report for Council Offices, Council Depots and Hostels &  
Community Buildings.**

Integrated Property, WHS, Public Liability & BCA/DDA Report  
Snowy Monaro Council Offices

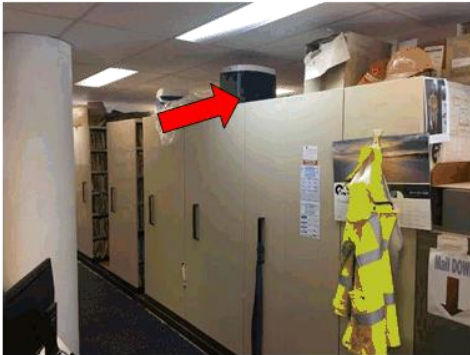
- RCD safety switches are not provided and the number of electrical hazards were observed during our inspection.
- The exterior wall concrete deterioration with concrete spalling may represent a public liability risk in the future.

<p>Concrete exterior wall deterioration facing Bombala Street</p>	<p>Unsafe storage on top of compactus</p>

- Rectify electrical deficiencies noted above as a high priority.
- Upgrade the exterior wall facing Bombala Street with concrete cracking to prevent concrete spalling and possible injury to persons below.

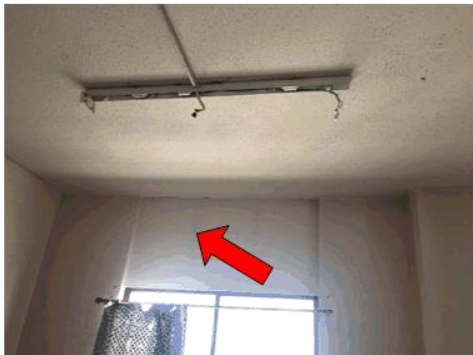
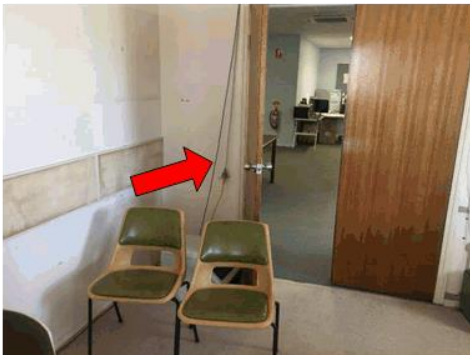
<p>Exposed light fitting cables</p>	<p>Unsafe extension leads run over doorway</p>

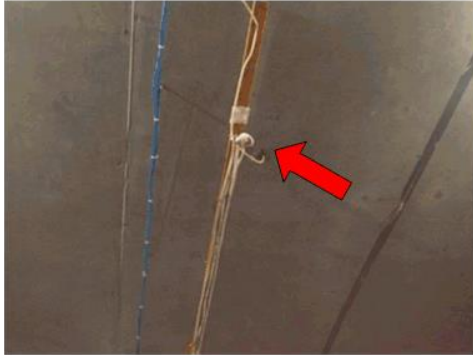
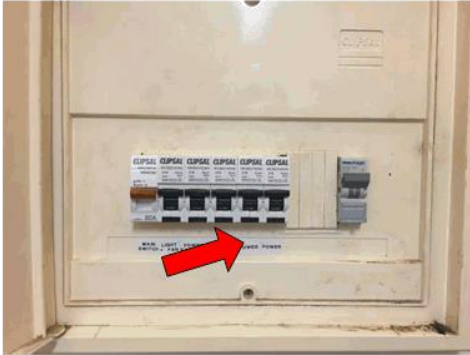
<p>Exposed cables - Junction box cover left off in basement</p>	<p>RCDs (safety switches) not provided</p>

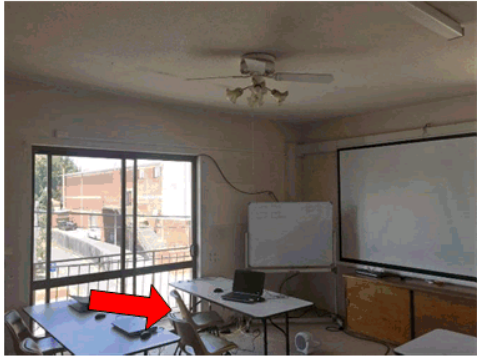
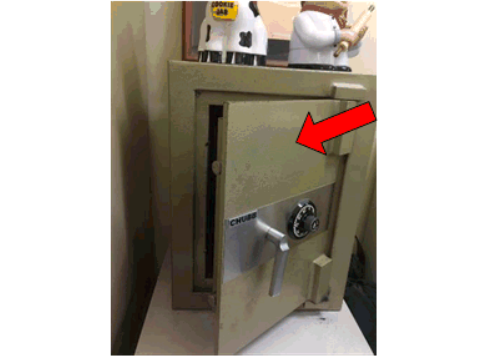
<p>Training Room with excessive leads blow heater (trip hazard and electrical risk)</p>	<p>Safe left open and not secured to the floor.</p>

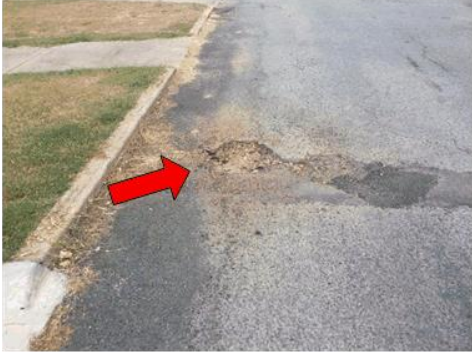
Trip hazard in car park driveway	Unsafe storage on top of compactus

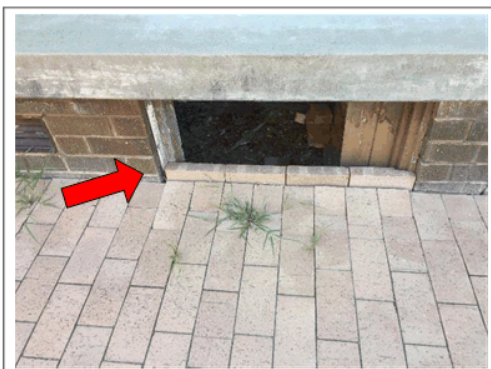
- Trip and fall hazards with uneven surfaces and a lack of handrails and barriers were noted.
- Residual current devices, RCDs (safety switches) are not provided and the old main switchboard is likely to contain asbestos.
- Unsafe storage was noted on top of a compactus which can result in an impact injury.
- A considerable amount of cash may be kept on site which poses a security risk.
- Access beneath the building should be secured.

Access beneath building not secured

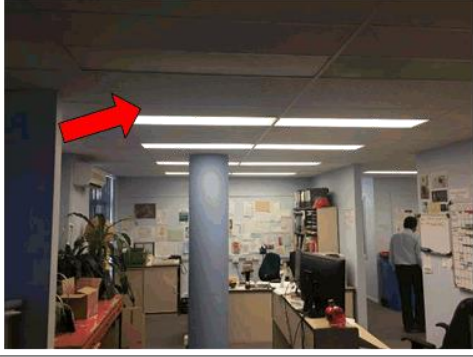
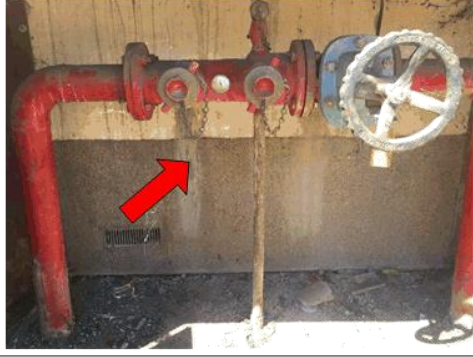
<p>Inadequate Smoke Detection or Emergency Lighting or illuminated Exit Signs.</p>	<p>Hydrant Booster without check valve</p>

- Fire protection should be upgraded with a smoke detection alarm system as per AS 1670 and BCA E2.2 Table 2.2a including connection to a main fire indicator panel and an automatic sound alarm system.

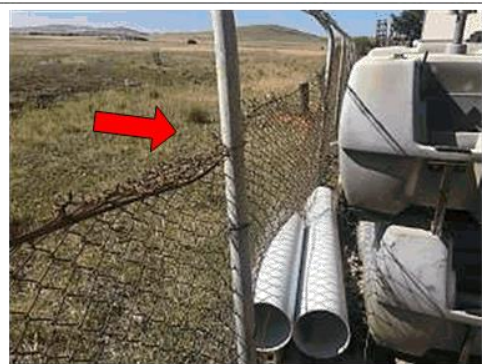
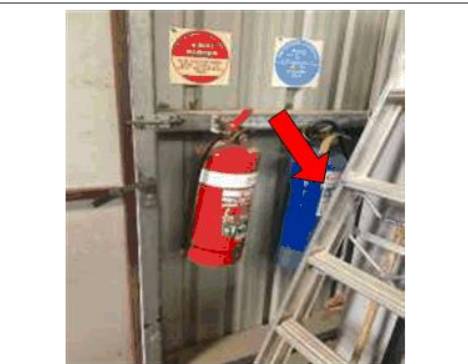
<p>Security fence needs upgrading and storage moved away</p>	<p>Electrically safe fibreglass ladders are recommended.</p>

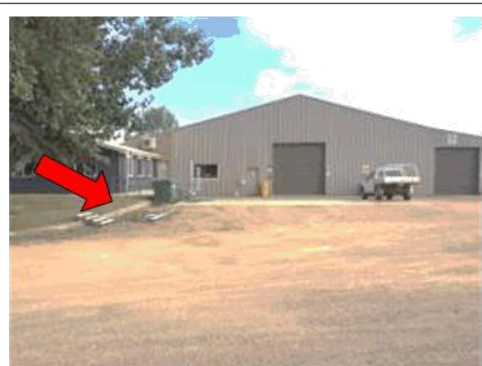
<p>Trip Hazards outside Stores/Office</p>

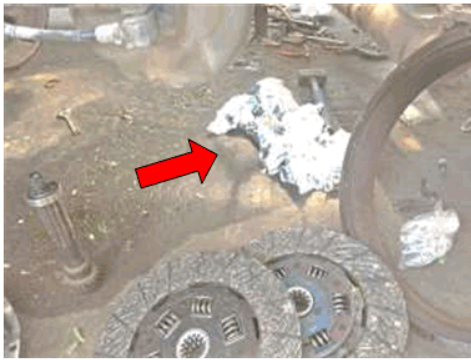
Broken roller door – Workshop Building	Old rags not safely disposed of

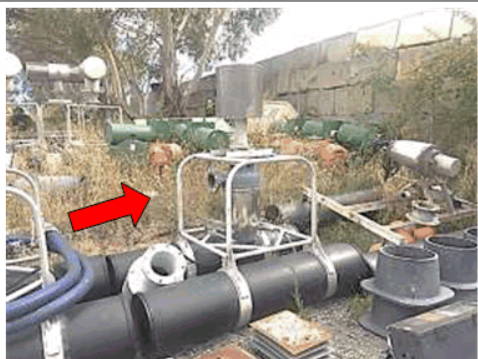
Overgrowth provides a fire hazard to external storage	Small switchboard with unsafe storage. RCDs should be confirmed.

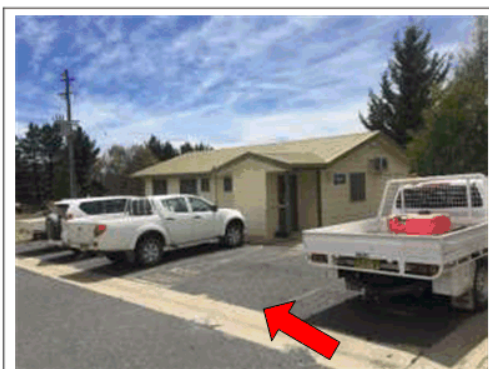
No Disabled Car park space is provided.

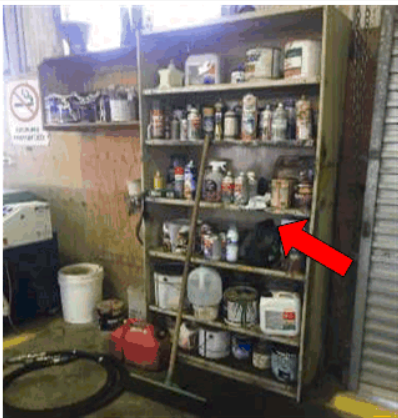
<p>Approved flammable liquid cabinets should be provided for small quantities of dangerous goods.</p>	<p>The emergency information diagram located at the main entrance has faded and needs replacement.</p>

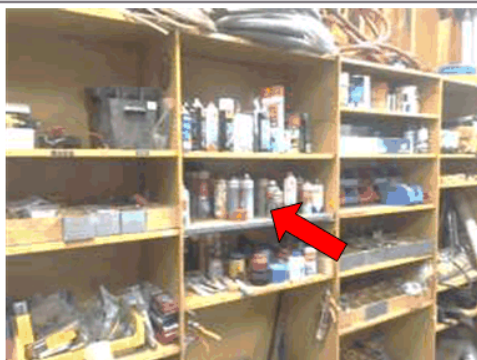
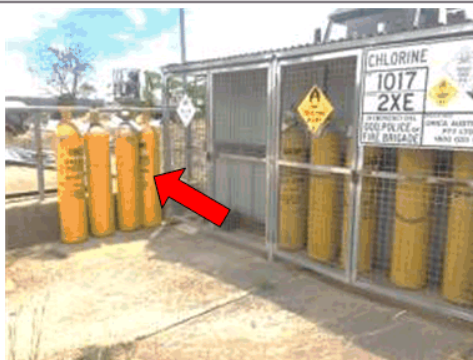
Approved flammable liquid cabinets should be provided for small quantities of dangerous goods.	Chlorine cylinders not adequately stored within caged area.

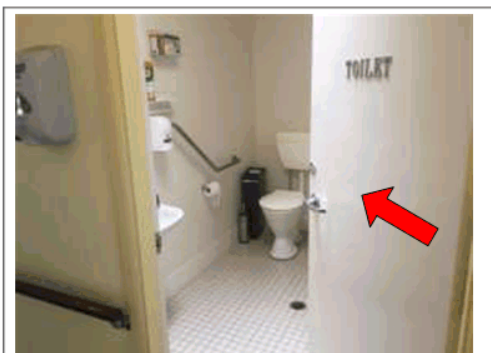
Signage for the disabled toilet is non-compliant

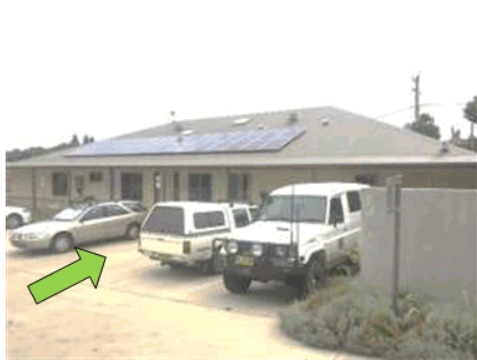
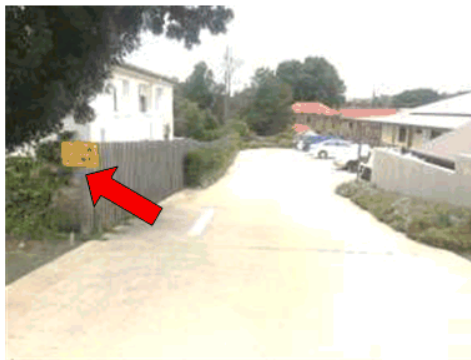
Car park spaces well marked	A speed limit sign is not provided.
