SNOWY MONARO
REGIONAL COUNCIL

**ATTACHMENTS TO REPORTS
FOR
ORDINARY COUNCIL MEETING
THURSDAY 14 DECEMBER 2017**

Bombala Main Street Overview

Prepared by Pip Giovanelli for Snowy-Monaro Regional Council
December 2016

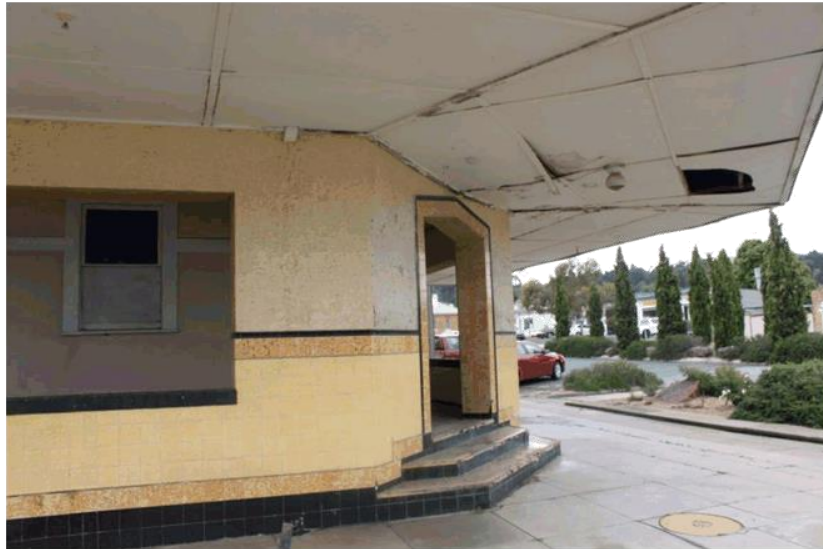
Historic tiles. Note poor condition of awning

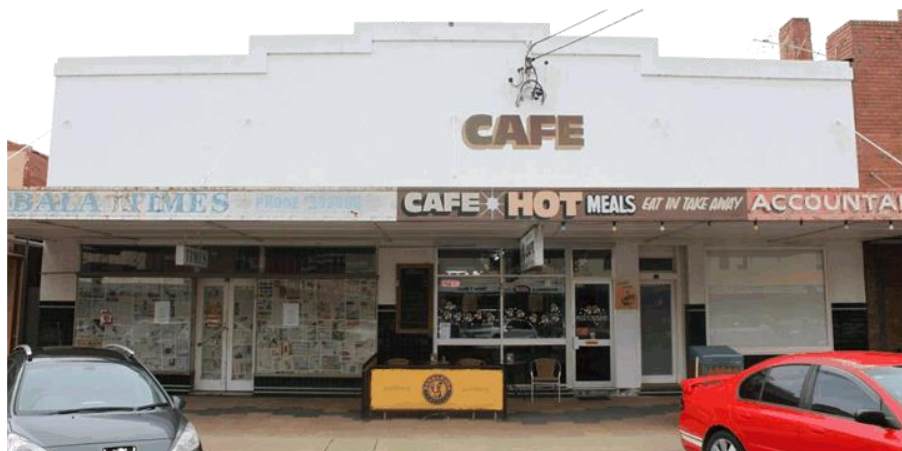
Condition appears to be OK. Integrity of the Bombala Times section is very high and should be retained and conserved. Installation of the shopfront in the café section resulted in loss of original detailing. The window to the former accountant's office is not consistent with Art Deco detailing and may indicate the building façade was modified long ago. The Art Deco crest at the centre of the parapet ridge has been removed or painted over.

Central crest has been removed or painted over

Unify consistency of detailing across front eg café blackboard to go above or below top edge of tiles (but not across), column between cafe and accountants to be tiled to match elsewhere, tiles below café shopfront to be repaired.

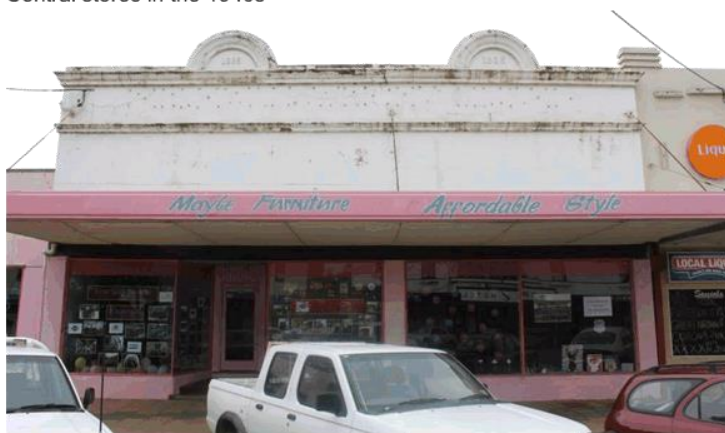
This potentially attractive front elevation needs work. The renderings are in poor condition and need cement patch repair, the underside of the awning is sagging and the window surrounds need restorations

Repair rendering

Repair renderings on parapet, repair upper and lower sides of the awning, strip paint off decorative tiles and window mullions and repaint walls to a more sympathetic colour scheme.

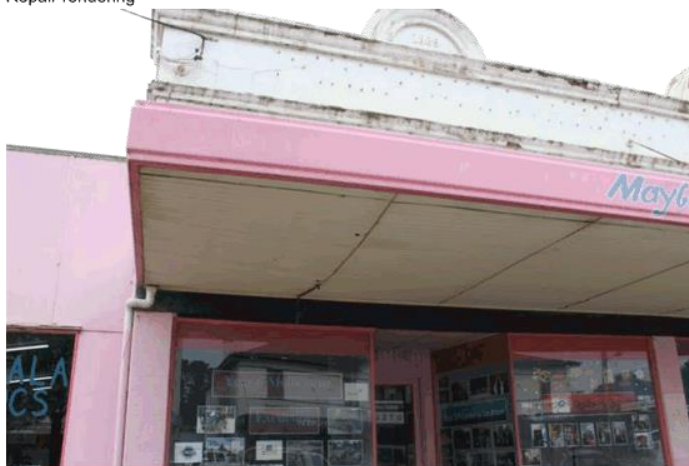
Repair awning

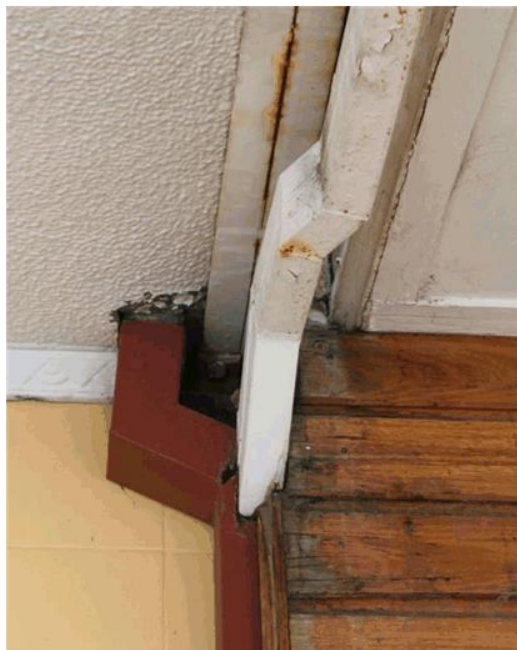
Repair leaking awning and downpipe

Control signage on masonry parapet so that the architecture remains the primary element.
Use font (Bombala Supermarket) to match historic font in the 1940s image,
Change fluorescent tubes to reflect period lights,
Paint the elevation to reflect the traditional styling
Paint shopfront,
Control advertising at ground level
Repair awning and downpipe leaks.

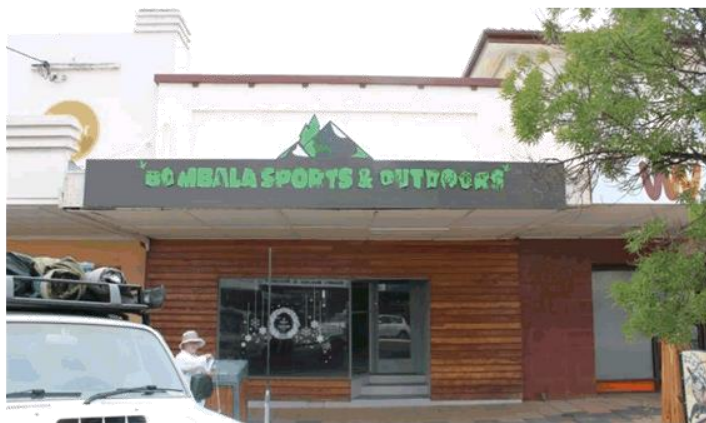
Note staining adjacent to downpipe

Awning signage to fit within the edges of the awning,
Check awning roof and downpipes for leaks,
Make good to stains on the timber panelling,
Check to see if the original shopfront lies buried beneath the timber,
Upgrade the under-awning lighting.

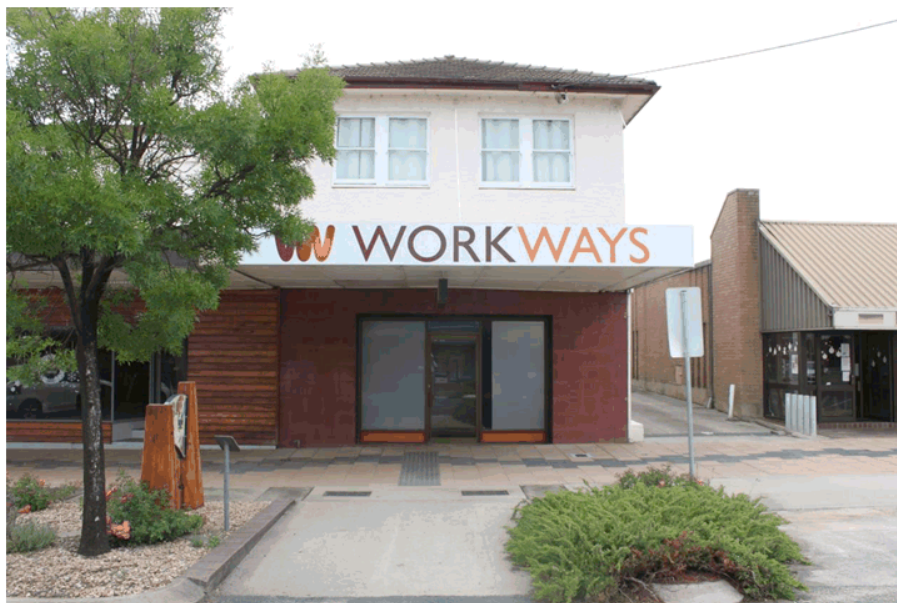
The awning and downpipes are leaking badly and need attention, and the eaves lining is decaying and coming away from the building.

Leaking awning

Repair leaking awning and downpipes,
repair decaying eaves and
refresh the paintwork as appropriate.

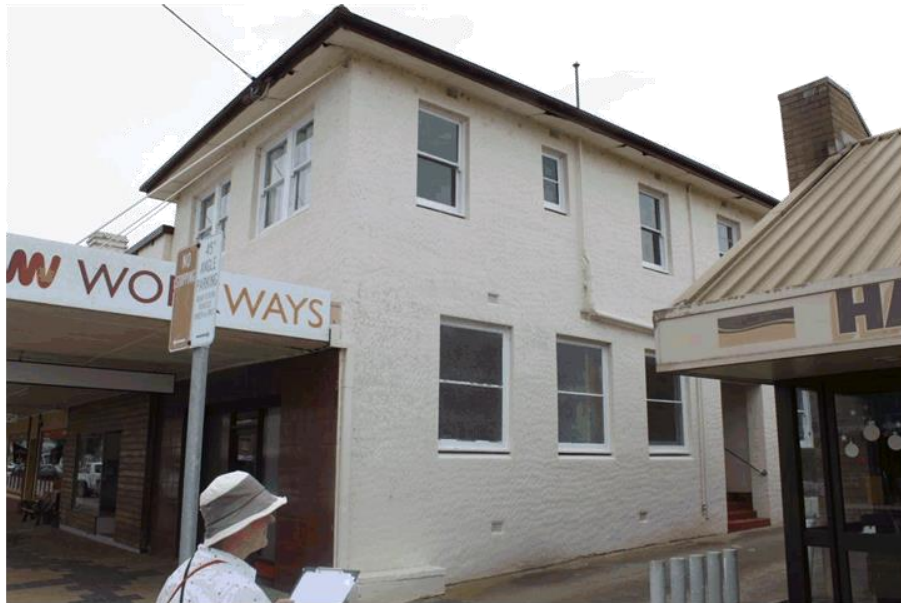
Deteriorating eaves

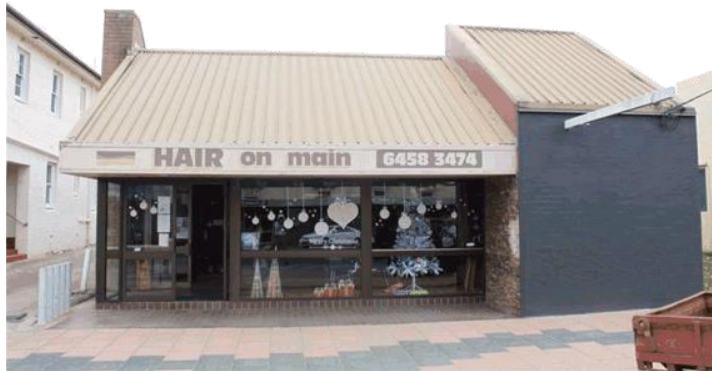
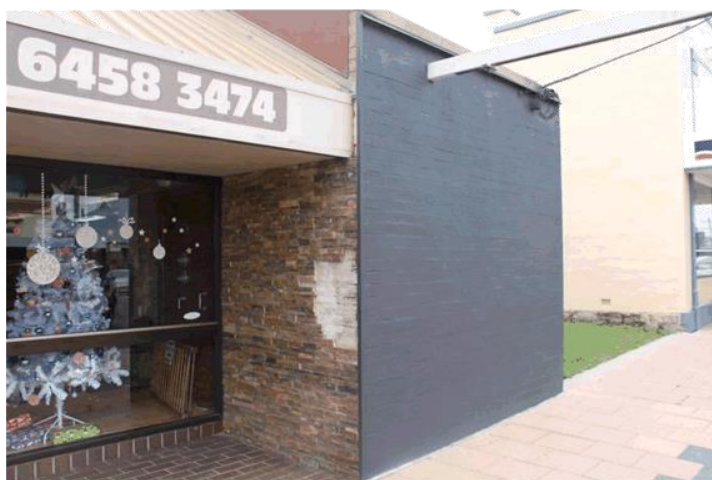
Apart from the missing tiles the building is in good condition and integrity.

Note missing tiles on wall

Repair the missing tiles.

The wall could be retiled.

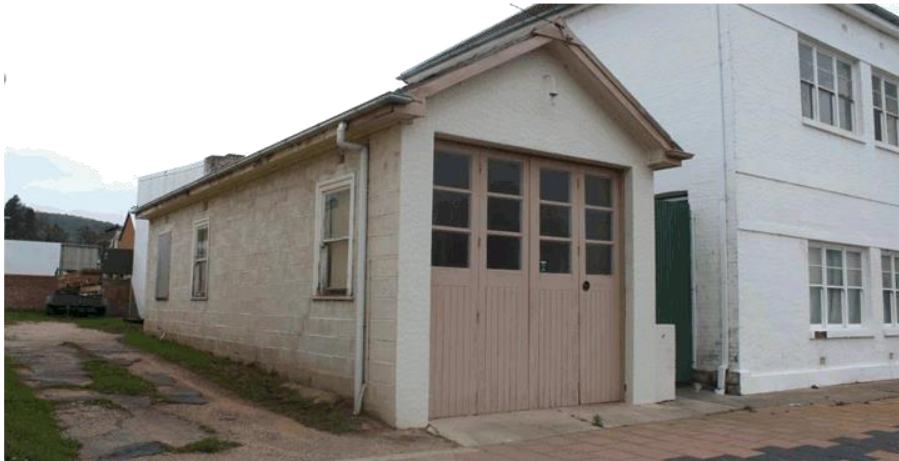
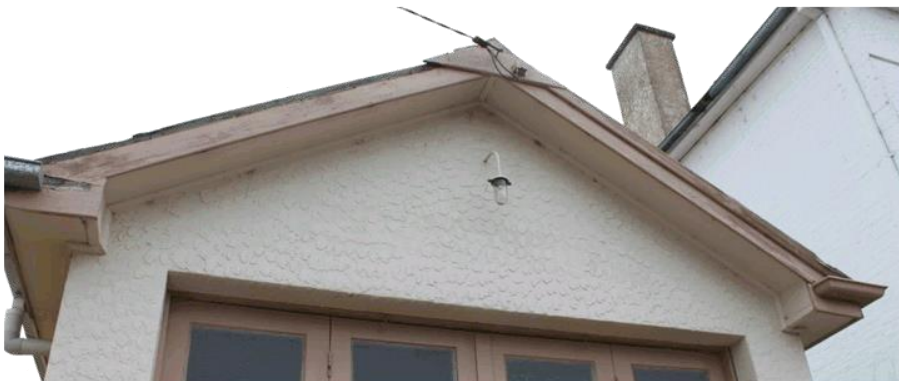
Barge capping is missing and the building needs a coat of paint, but otherwise this is a good building with most of its original form and fabric intact. Note the rendering is typical of that on many of the town's buildings.

Note damaged barge cap at the fascia.

Repair damaged trim and repaint to traditional colour scheme

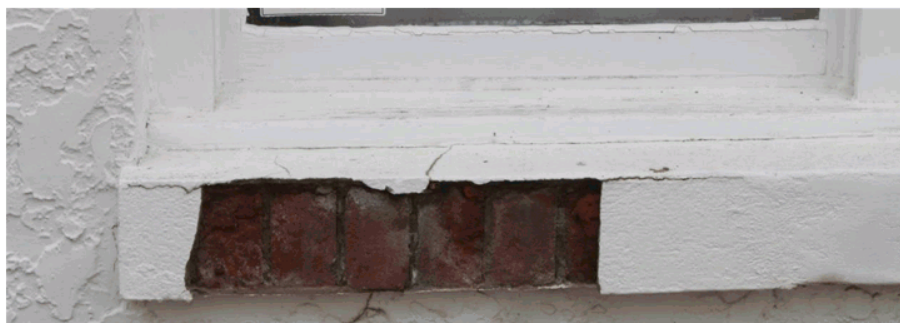
Condition is generally good although on close inspection repairs are required to rendering and soffits, and repainting needed to windows.

Lost rendering

Undertake minor repairs and painting
Upgrade entry light over central door
Research its history

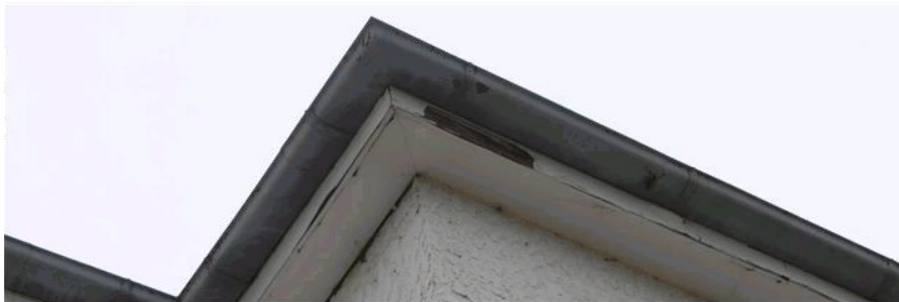
Paint fascias and repair soffits

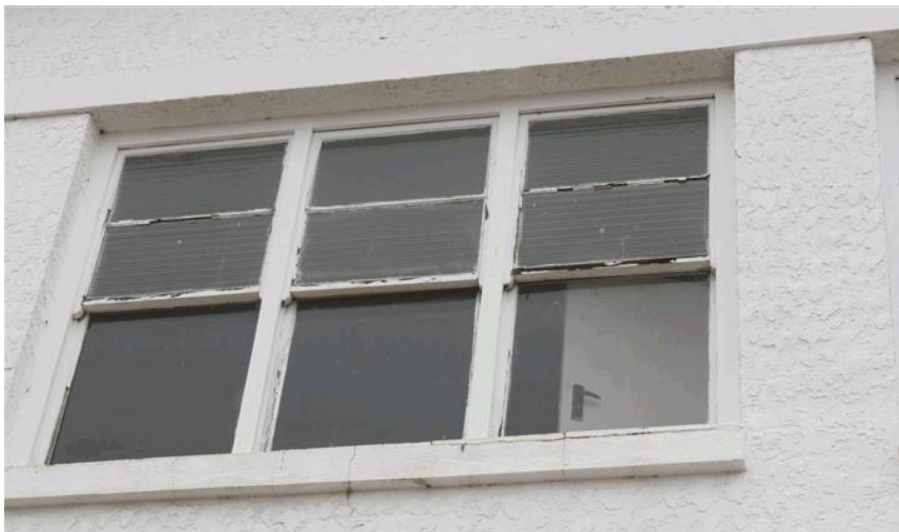
Paint windows

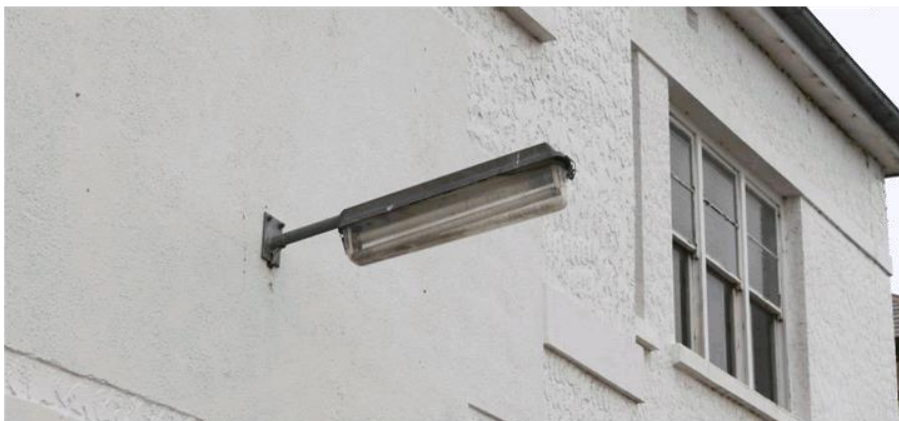
Replace with traditional light

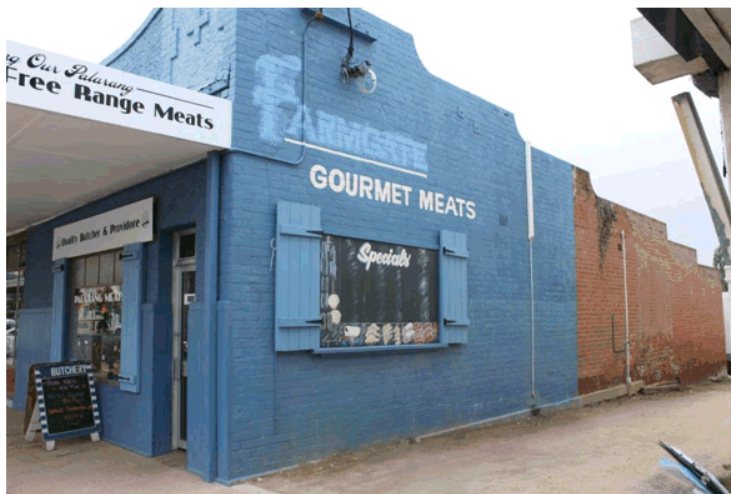
Condition appears good although rising damp can be seen at the end of the side wall.

Note damp brickwork at rear of side wall

The building is fine as it is, but alternatively could be restored to more original condition. Damp brickwork at the rear of the building should be rectified.

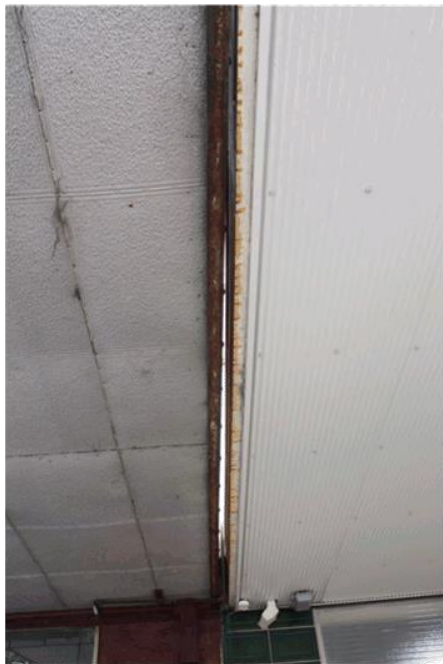
Rusting at edge of awning

Check for rusting at edge of awning, apply new varnish to doors, polish chrome glazing bars, refresh or clean parapet wall.

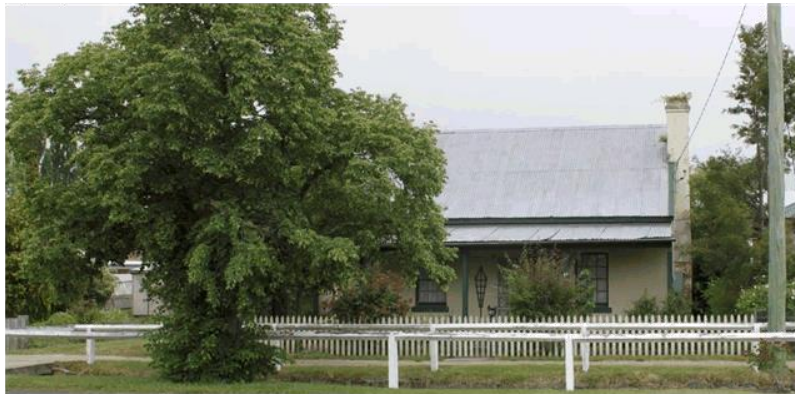
Chimney in need of attention

Remove plant from chimney and repair render at its base,
Resecure loose iron on verandah roof,
Continue to maintain in good condition.

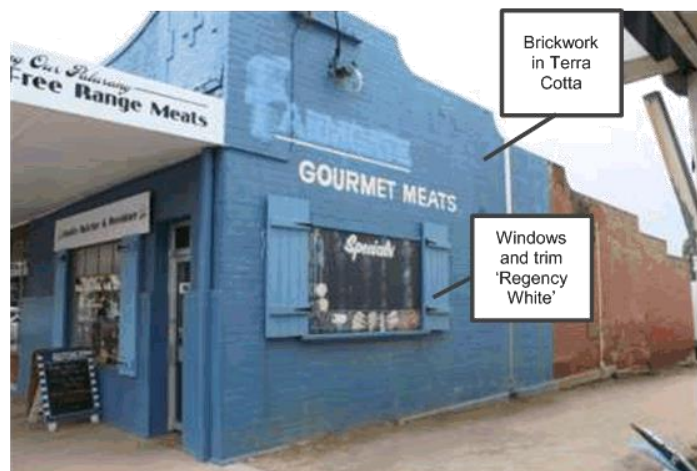
Note damp brickwork at rear of side wall

Damp brickwork at the rear of the building should be rectified.

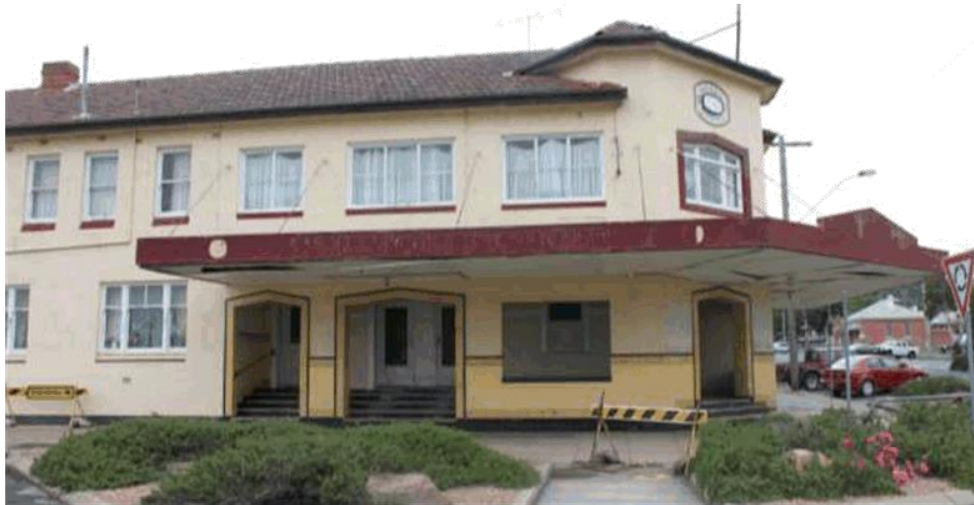
2016. The 1938 wall tiles are largely intact. Note poor condition of awning which will need to be repaired before being repainted. The brick wall below windows was initially darker presumably natural red brick or stained with red oxide.

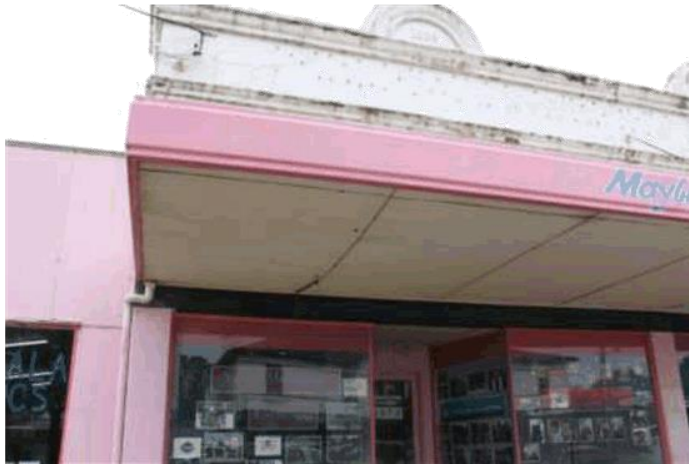
Repair awning underside

- Repair renderings on parapet,
- repair upper and lower sides of the awning,
- strip paint off decorative tiles and window mullions and
- repaint walls to a more sympathetic colour scheme.

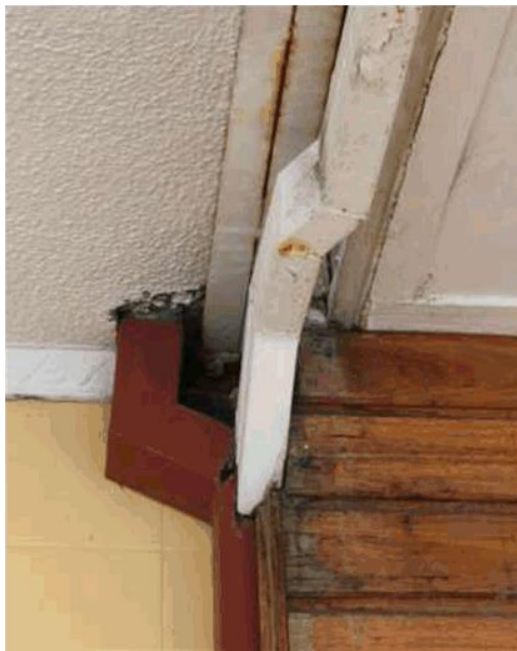
Repair leaking awning and downpipe

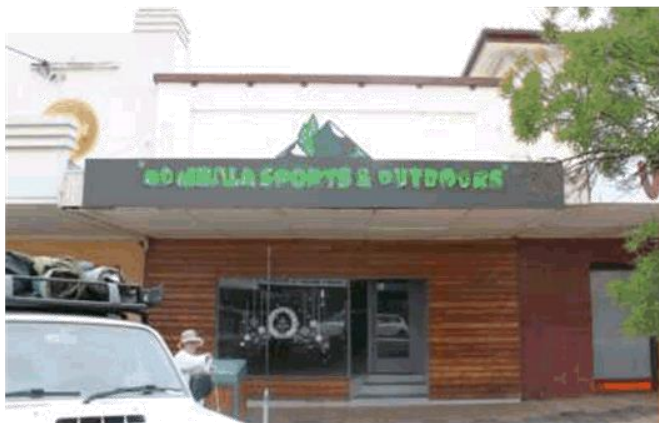
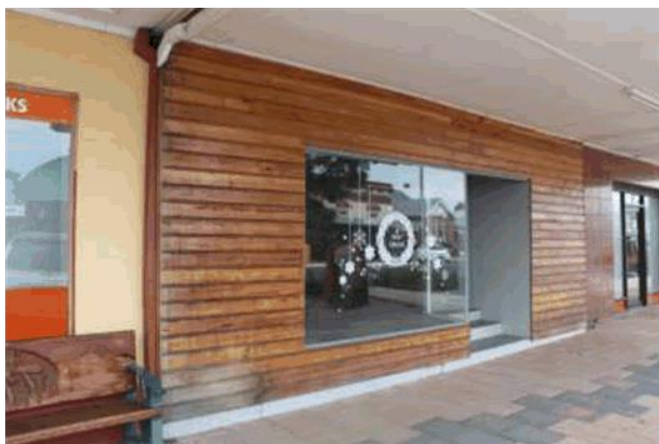
Note staining adjacent to downpipe

Awning signage to fit within the edges of the awning,
Check awning roof and downpipes for leaks,
Make good to stains on the timber panelling,
Check to see if the original shopfront lies buried beneath the timber,
Upgrade the under-awning lighting.

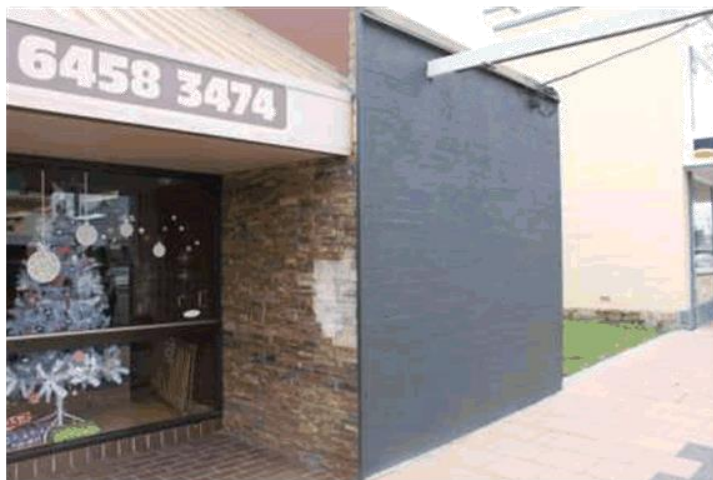
Note missing tiles on wall

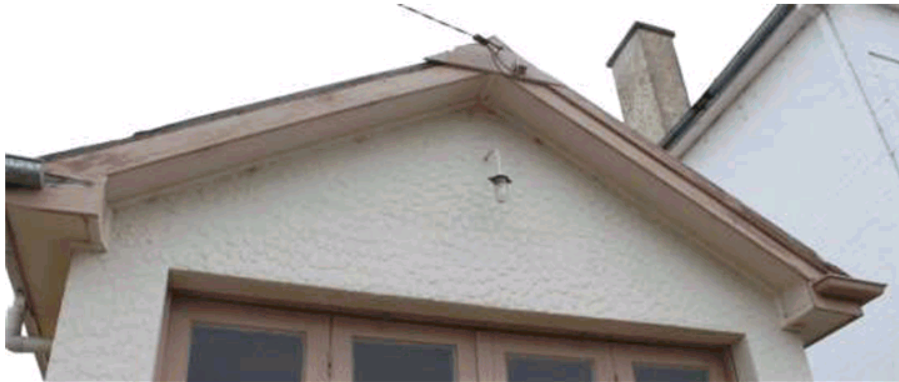
Note damaged barge cap at the fascia.

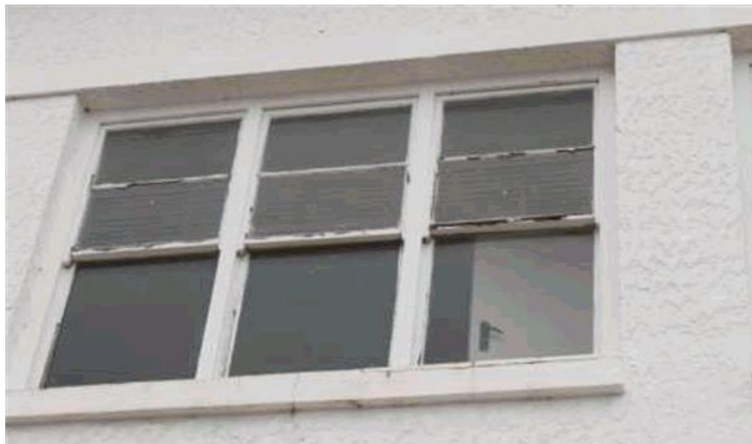
Paint windows

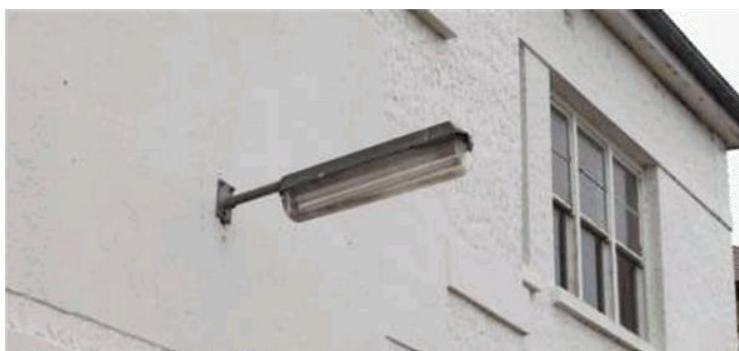
Replace with traditional styled light
