Monaro Rail Trail

Trail Development Plans – Stage 1a

MONARO RAIL TRAIL TRAIL DEVELOPMENT PLANS

FINAL REPORT

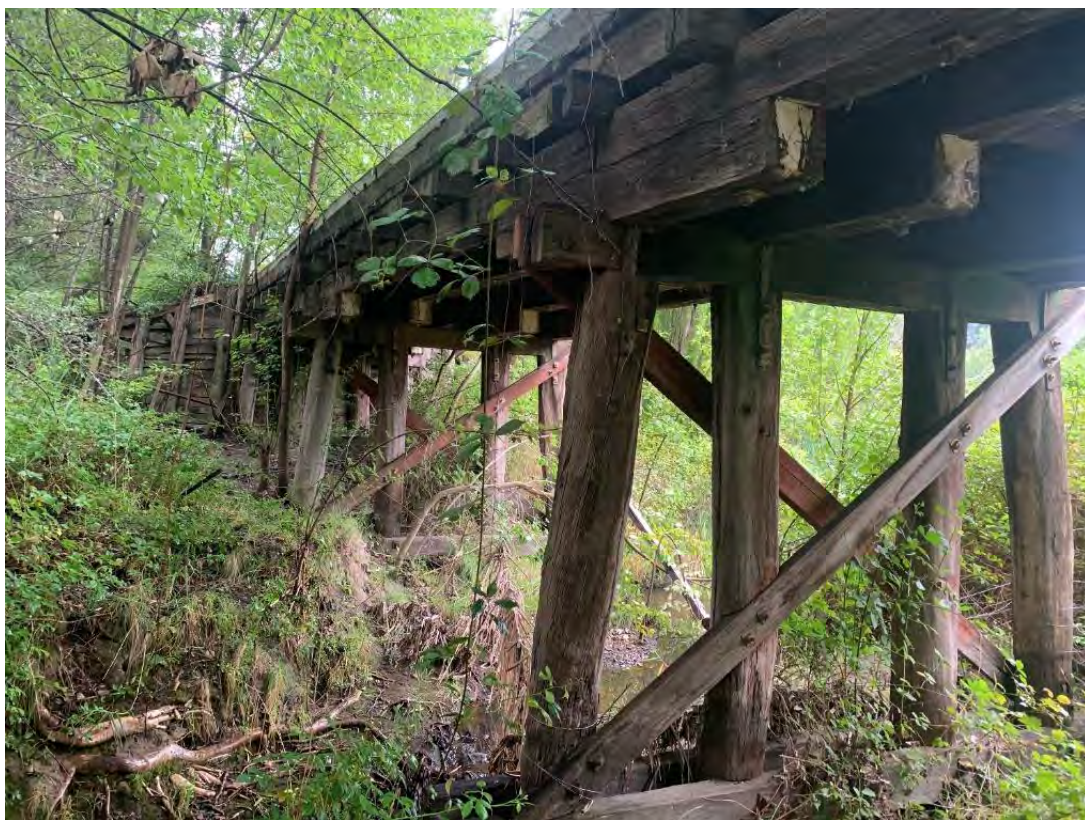
Figure 4-1: View of Guises Creek Bridge from end 1. The timber bridge is 3 spans long and approximately 24m metres long (8 metre spans). Note at all bents each girder has a corbel. Note that the corbels and girders are dimension timber when typically, they will be round log. At the time of inspection there was only water underneath span 2 with an approximate depth of 0.5m. There is a large amount of vegetation growth around the timber bents which keeps the moisture content of the timber high. When the moisture level in the timber is above 22%, decay-causing fungi can start to grow; when the moisture content drops below this level, the fungi become dormant, and decay will be arrested until the moisture content rises again. It is noted that a resin treatment has been used to fill existing cavities in majority of the girders. Note the rounded drip edge on the corbels. A positive detail. However, plenty of poor detailing vertical fasteners originating from the top of the girders are in use.

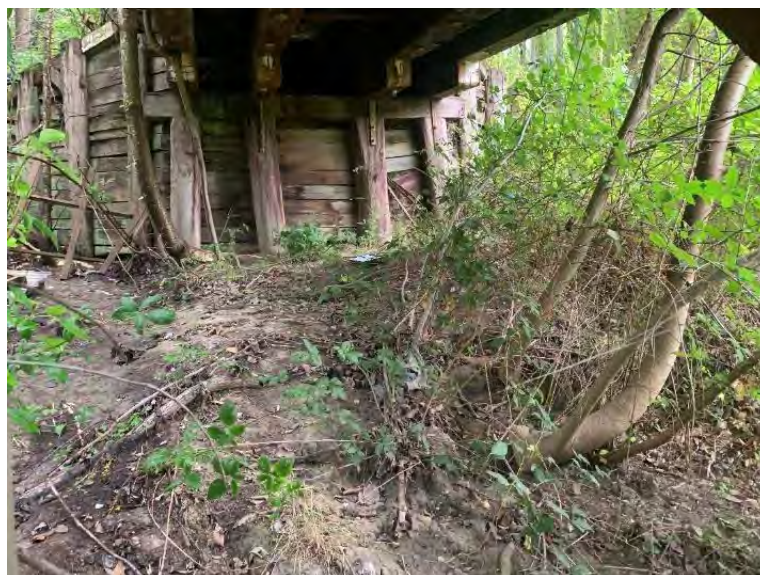
Figure 4-3: Both abutments consist of 4 timber piles, timber headstock, timber corbels and timber sheeting. It was noted that the bottom section of several piles has started to undergo decay. Note abutment sheeting is rotted and failing. Timber pile and sheeting wing walls present on both sides of each abutment. Once the moisture content in the timber elements reaches 22%, decay causing fungi are activated and the decay process begins. Large trees need to be cleared as their root systems apply lateral pressure on the substructure elements as will the branches and trunks on super structure elements.

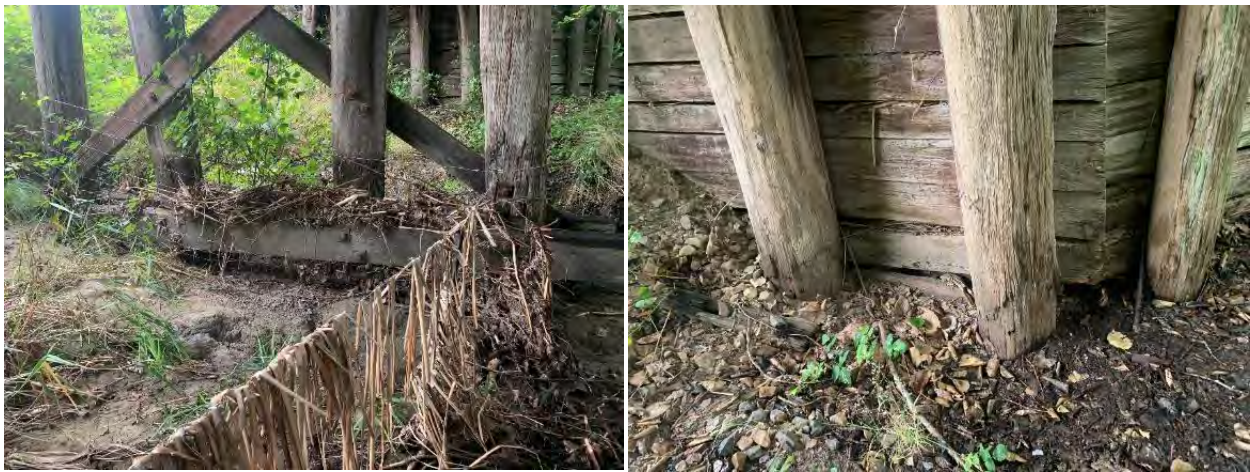
Figure 4-4: The bottom sections of the timber piles were determined to be a ‘hotspot’ for decay, this is caused by the moisture retained by debris increasing the moisture content in timber members. Sapwood decay in the timber piles is photographed on the right-hand side. Refer to Section 4.1 below for a full list of recommended repair options for refurbishment to a pedestrian/cycle bridge.

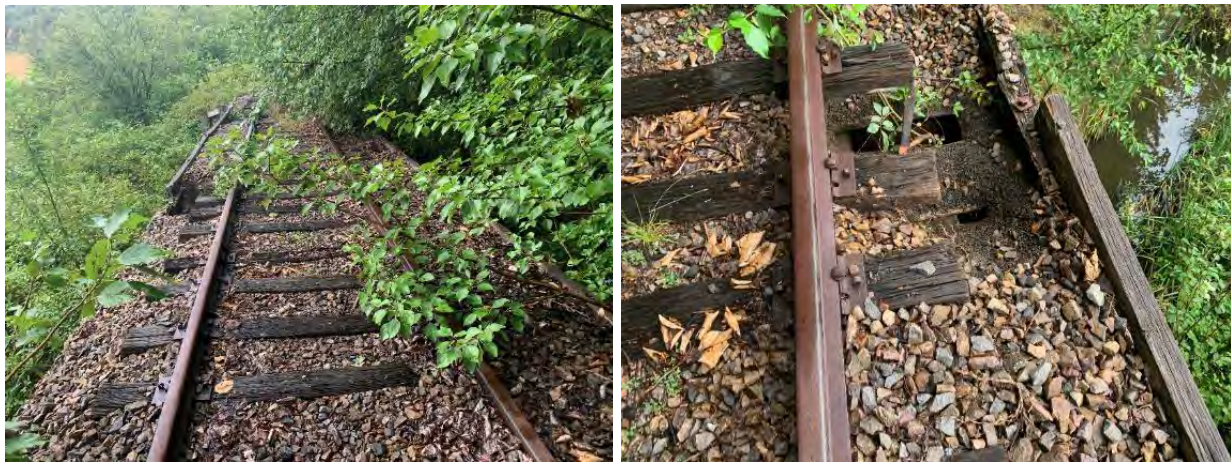
Figure 4-5: The timber transoms were found to be in a very poor (unsafe) condition. The timber ballast tray side walls and rock ballast were in poor condition with erosion of material found in several locations. If the bridge was to be repurposed for pedestrian and cycle use the timber transoms, railway line and rock ballast would need to be removed. Depending on the condition the existing ballast tray side boards they can left in place to act as a kerb/kick rail in the re-purposed bridge. To meet the current standards and Australian codes; vertical balustrade panels and a 1.4m high cycle rail will need to be installed. Note: Significant vegetation growth. The ballast tray will provide a great subgrade for the walking track.

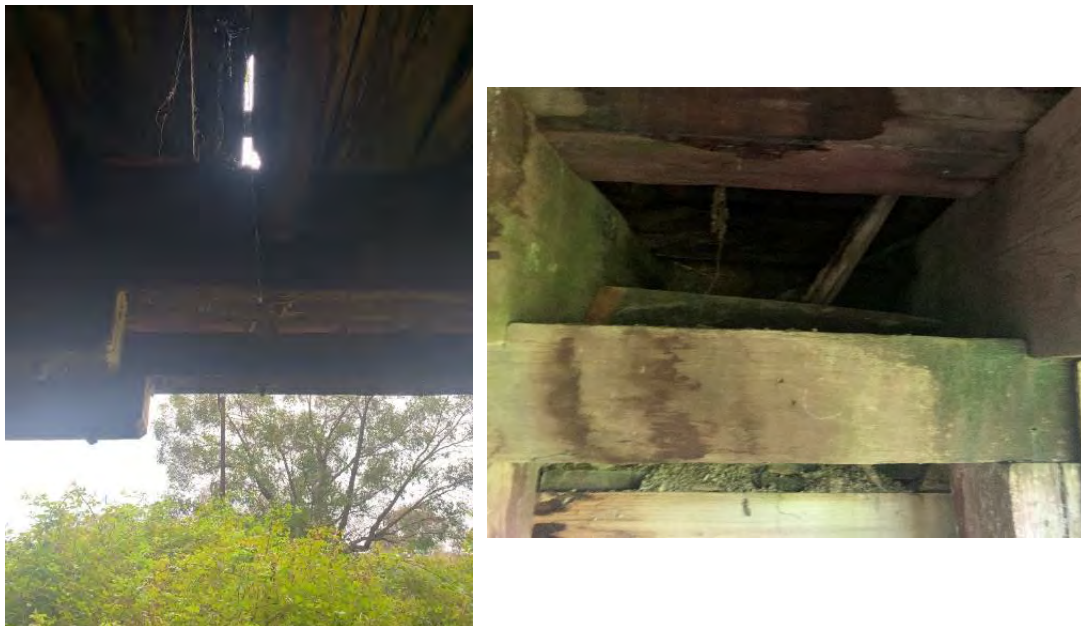
Figure 4-7: The photo on the left shows a failed deck plank from below. The photo on the right shows another failed deck plank located above the abutment. Decking failure causes the above rock ballast to erode and elements below experience excess weathering and load. These planks will require replacement before the bridge can be reopened for pedestrian and cycle use.

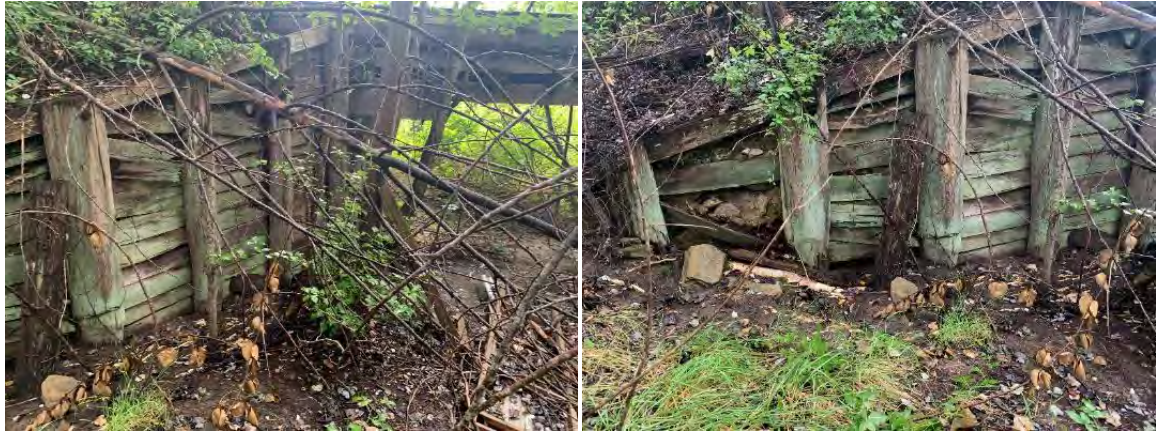
Figure 4-8: The timber wingwalls have undergone significant deterioration with timber sheeting completely rotted and failing in several locations. Due to this the walls' ability retain the approach fill material is poor leading to erosion and excessive loading.

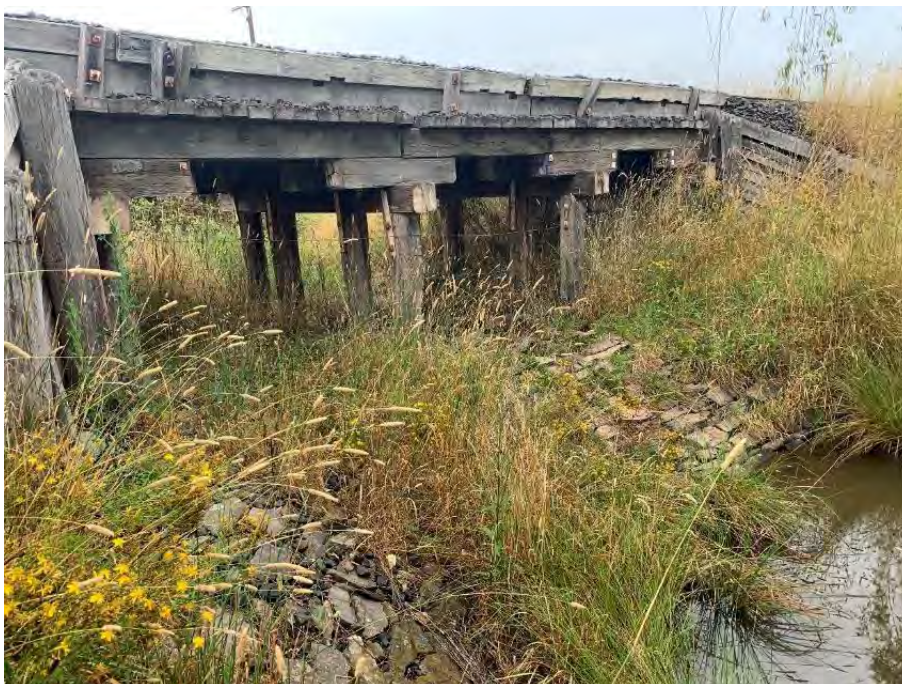
Figure 5-1: The top image shows a general view of the minor 10m Bridge from an abutment. The timber girder under bridge consists of 3 spans of 3.3m. Each bent consists of 4 driven timber piles and a single headstock. Headstocks are attached to the piles using a vertical steel bracket on either side. Note kerb support completely split vertically through middle.

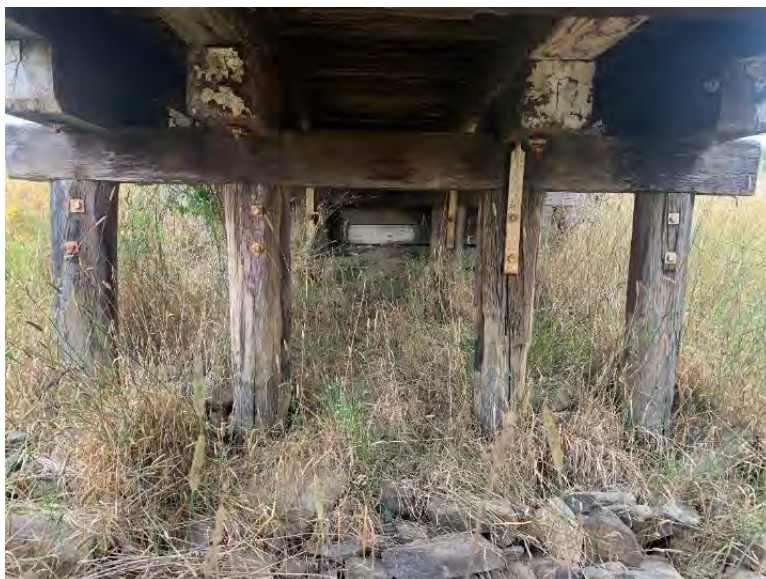
Figure 5-2: General configuration of each pile bent. Large vegetation growth and cobbles located around the base of piles. All piles were found to be in very poor condition with large splits and sapwood decay are present in majority of piles, predominately at ground level. Excess vegetation growth leads to an increase in moisture content within timber members resulting in accelerated decay.

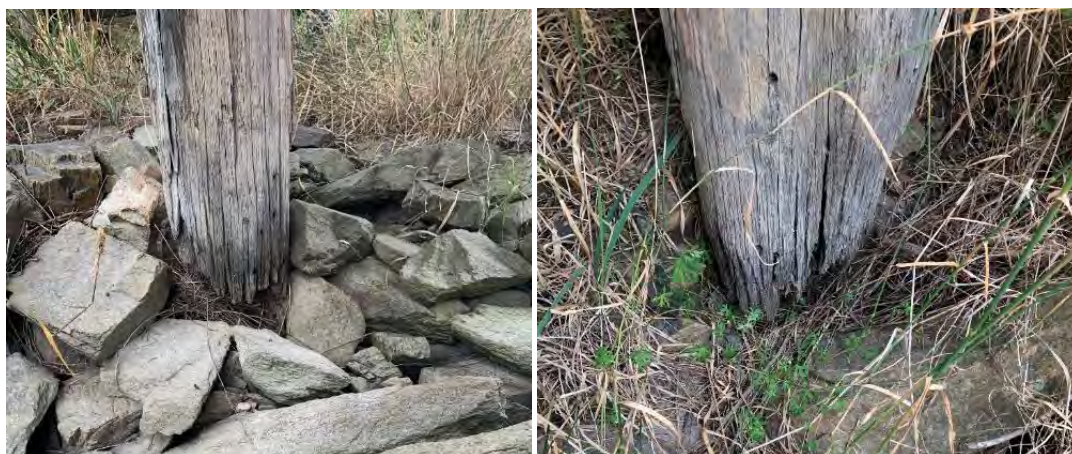
Figure 5-3: View of piles at PB1, pile 3 and PB2 pile 4, both are in very poor condition and were found to be completely decayed at ground level and hanging freely above ground.

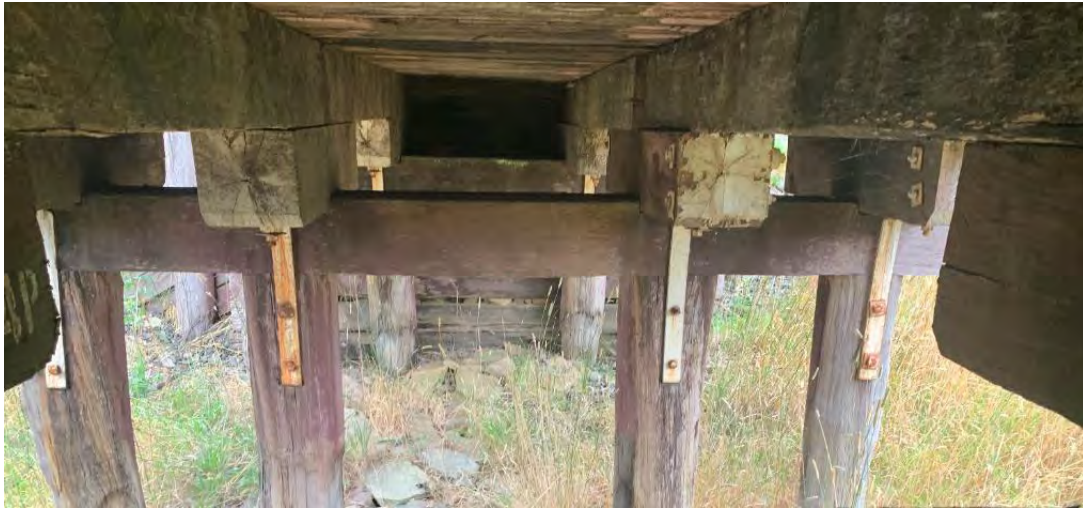
Figure 5-4: View from in between internal girders, all girders were found to be in fair condition with no major deterioration present. Corbels and bent caps were found to be in fair to poor condition throughout with evidence of minor decay present. Brief NDT testing was completed using non-destructive methods, such as EPHOD® Stress Wave Technology. Refer to Appendix A for more information of this type of testing method. Readings for girders were found to be between 300-500 μ s, Corbels – 400-100 μ s and caps 300-800 μ s. This is the time taken for the compression wave to travel across the section of the member tested. This was recorded on most elements and aids in verifying the condition of the elements. The pile tops are in better condition due to the use of horizontal connectors with side plates.

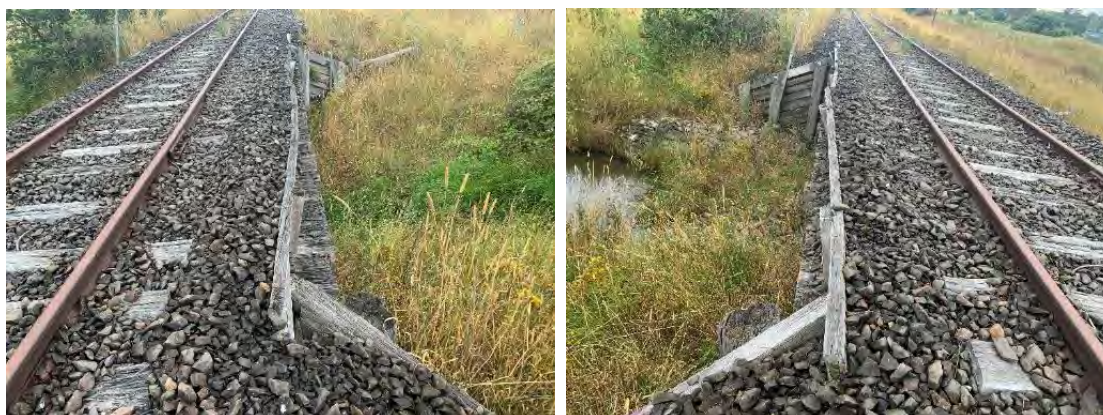
Figure 5-7: View of both ballast tray side walls. Both side walls were found to be in fair to poor condition, with minor deterioration of sapwood present at all lengths. Photo on the right shows the side walls support leaning backwards creating a deformation in side wall length. Photo on the left shows a significant bow in middle length due to bearing the load from the rock ballast.

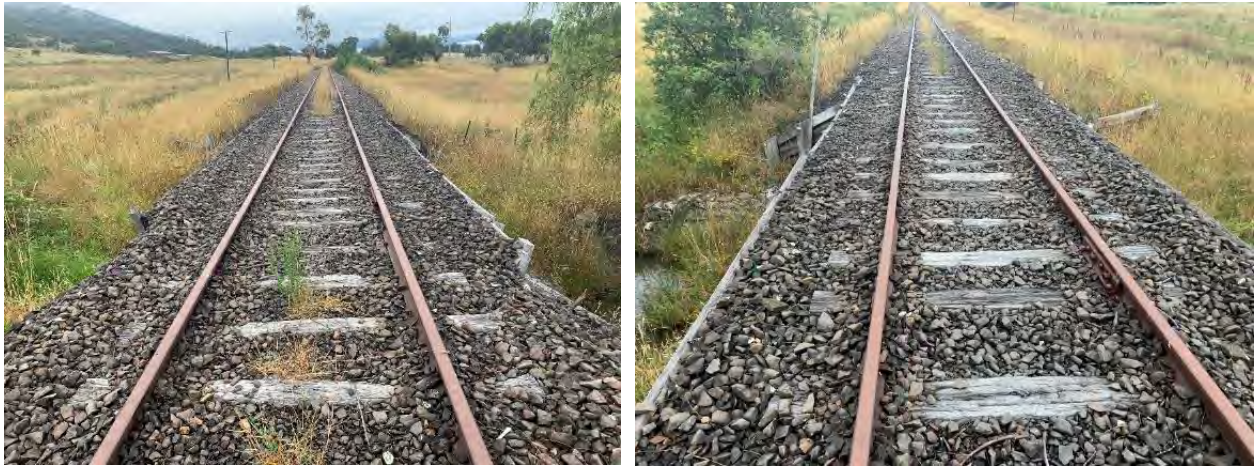
Figure 5-8: Top view of rock ballast looking in opposite directions. The rock ballast was found to be in fair condition with no major erosion present, no holes were found in bridge decking. Transoms were found to be in fair to poor condition with moderate deterioration and decay found.

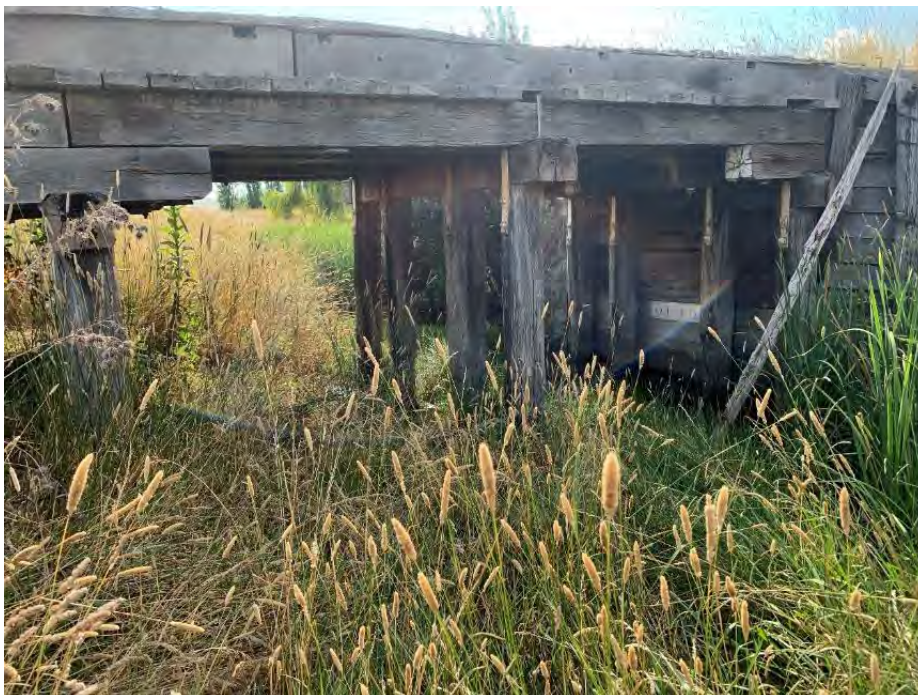
Figure 6-1: General view of Lobbs Hole Creek Bridge from the side of the bridge. The Creek that flows underneath span 1 at the time of inspection was flowing very slowly/still. The configuration of the bridge is a girder under and consists of 3 spans, 2 abutments and 2 pile bents. The span length is 3m equating to a total length of 12m. Note: abutment 1 and abutment corbels as does one of the bents.

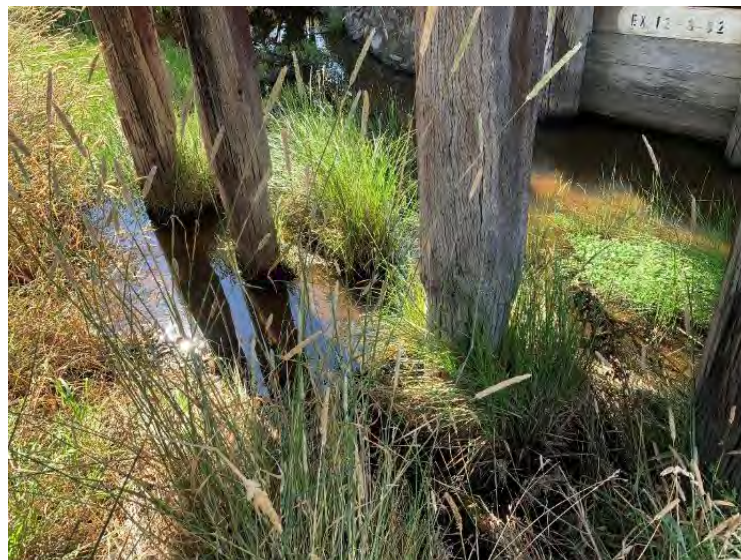
Figure 6-3: A view of Bent 2 shows the timber piles were driven into the creek. Significant sapwood decay is present in the lower length of each pile as seen by the noticeable change in cross section. This is seen as a length that is subject to temporary exposure to moisture which causes accelerated decay compared to constant saturation. Once the moisture content exceeds 22%, timber consuming fungi are activated, and the decay process begins. Refer to Figure 3-2 for a detailed description of how and where the decay occurs due to these vertical bolts.

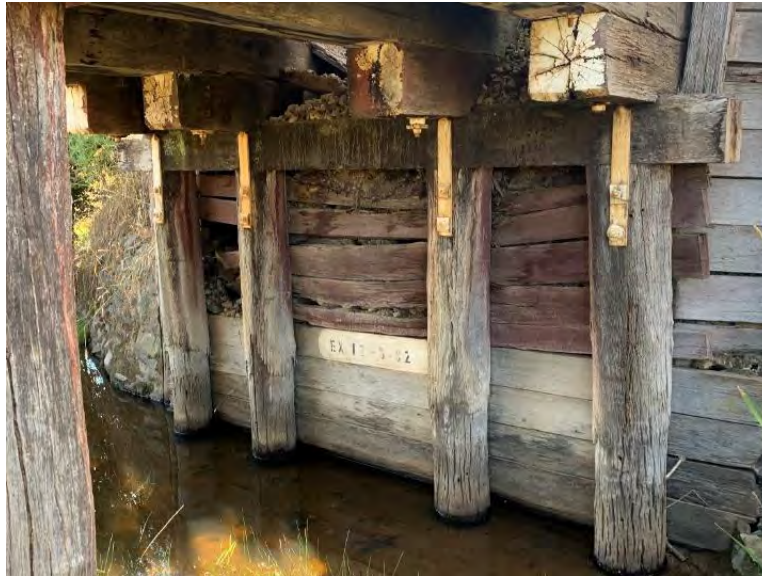
Figure 6-4: General view of Abutment 1 shows the timber sheeting in very poor condition as top half is failing and backfill material is eroding. Note: Hole in decking above abutment causing significant material loss from rock ballast above.

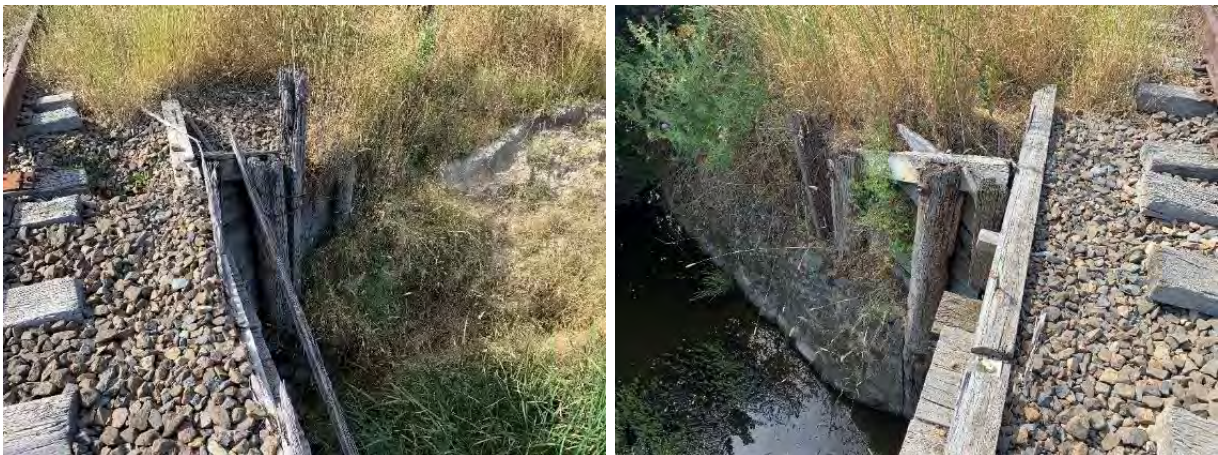
Figure 6-5: Above photos show the existing condition of the wingwalls. The wingwalls were found to be in a poor to very poor condition, multiple members had failed, and significant deterioration was present throughout.

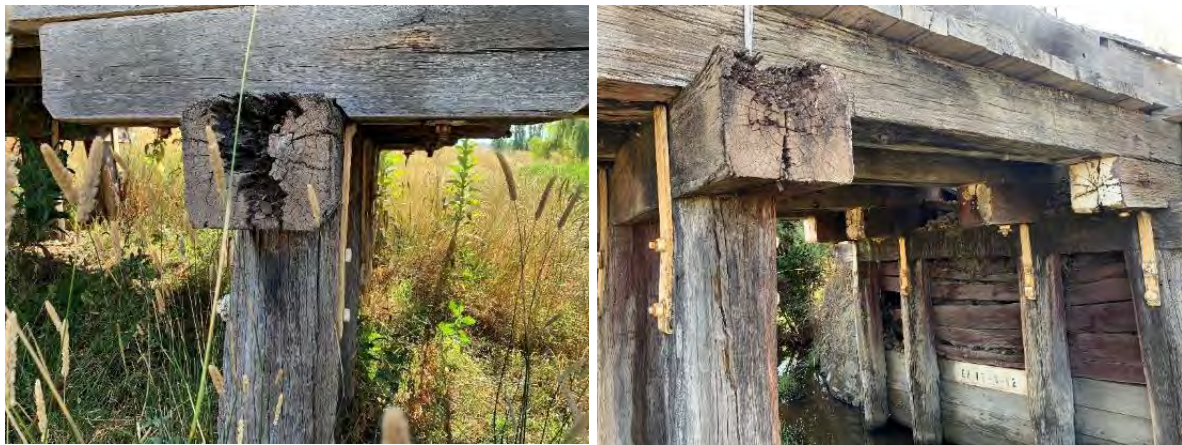
Figure 6-6: Above photos show the ends of the pile bent caps at PB1&2. Minor deterioration and cavities were found at all ends of caps. Overall, the caps were in poor condition. Brief NDT testing was completed at the mid length using non-destructive methods, such as EPHOD® Stress Wave Technology. Refer to Appendix A for more information of this type of testing method. Readings for bent caps were found to be between 200-1000µs. This is the time taken for the compression wave to travel across the section of the member tested. This aided in verifying the overall condition of the elements.

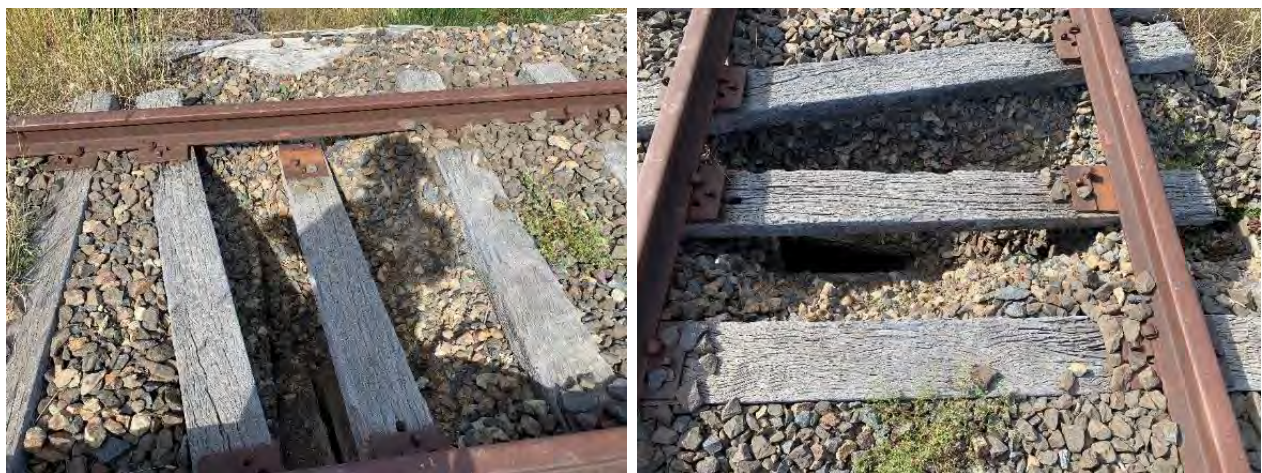
Figure 6-7: Above two photos show 2 of 3 deck collapses. The ballast tray floor boards are in very poor condition with major deterioration and rot present throughout.

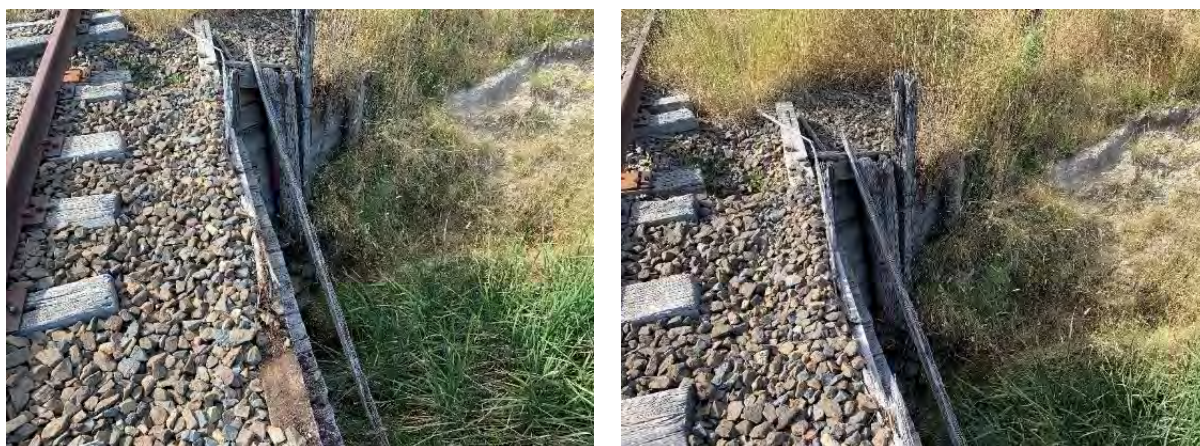
Figure 6-8: View of timber ballast tray side walls, spacing between side walls was 3.5m. Side walls were found to be in very poor condition with significant rot and decay present.

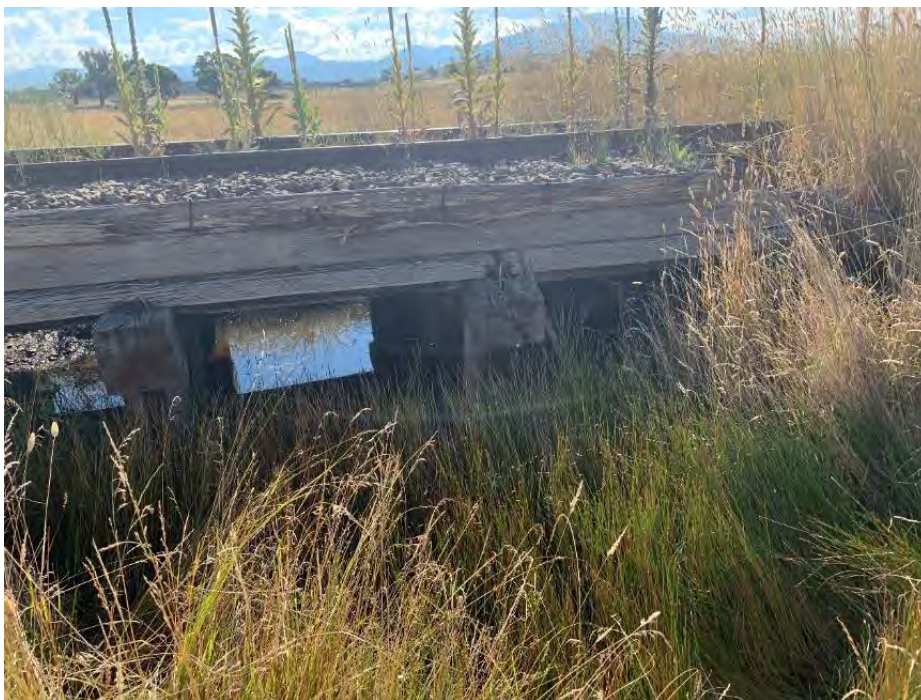
Figure 7-1: The image above shows a general view of the 7m minor bridge (Williamsdale Rd). The consists of 3 spans each span is 2m in length, substructure includes 2 pile bents and 2 abutments that each have 4 driven piles, a pile cap and 4 girders. At the time of inspection there was water approximately 0.5m deep in Spans 1-3. There is a large amount of vegetation growth around the substructure which keeps the moisture content high in the timber. When the moisture level in the timber is above 22%, decay-causing fungi can start to grow; when the moisture content drops below this level, the fungi become dormant, and decay will be arrested until the moisture content rises again.

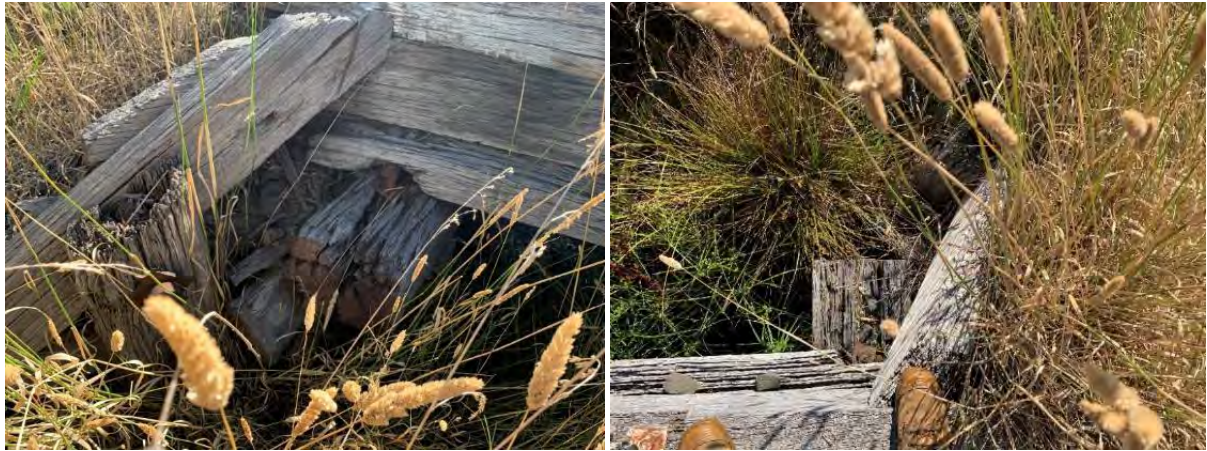
Figure 7-4: Top view of abutment cap connection. Cap is in very poor condition; severe deterioration is present in the ends and at the vertical connection. When a vertical connection is not sealed appropriately it exposes the heart wood to excess moisture accelerating decay. As seen in the photo a large crack is present at the end and a cavity is present at the top of the vertical connection.

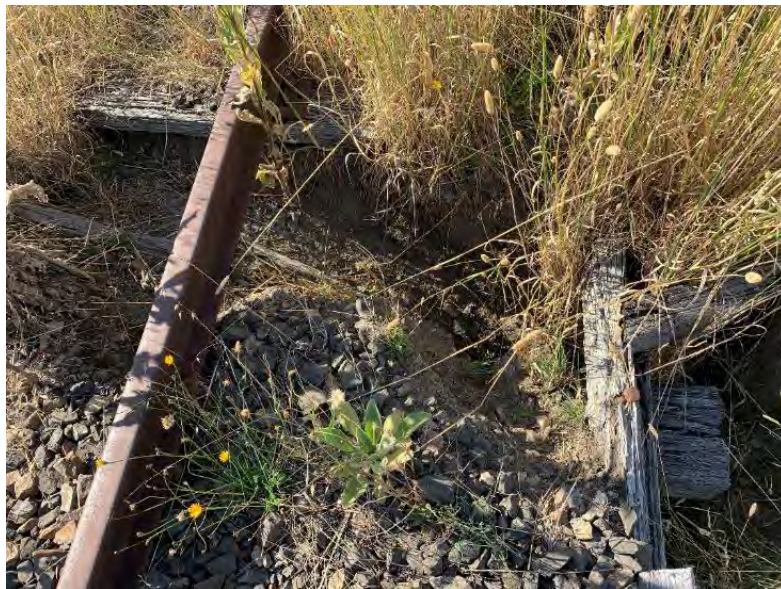
Figure 7-5: Top view of floorboards in the ballast tray at abutment. Large hole caused by abutment/ballast tray failure allowing significant erosion of ballast to occur.

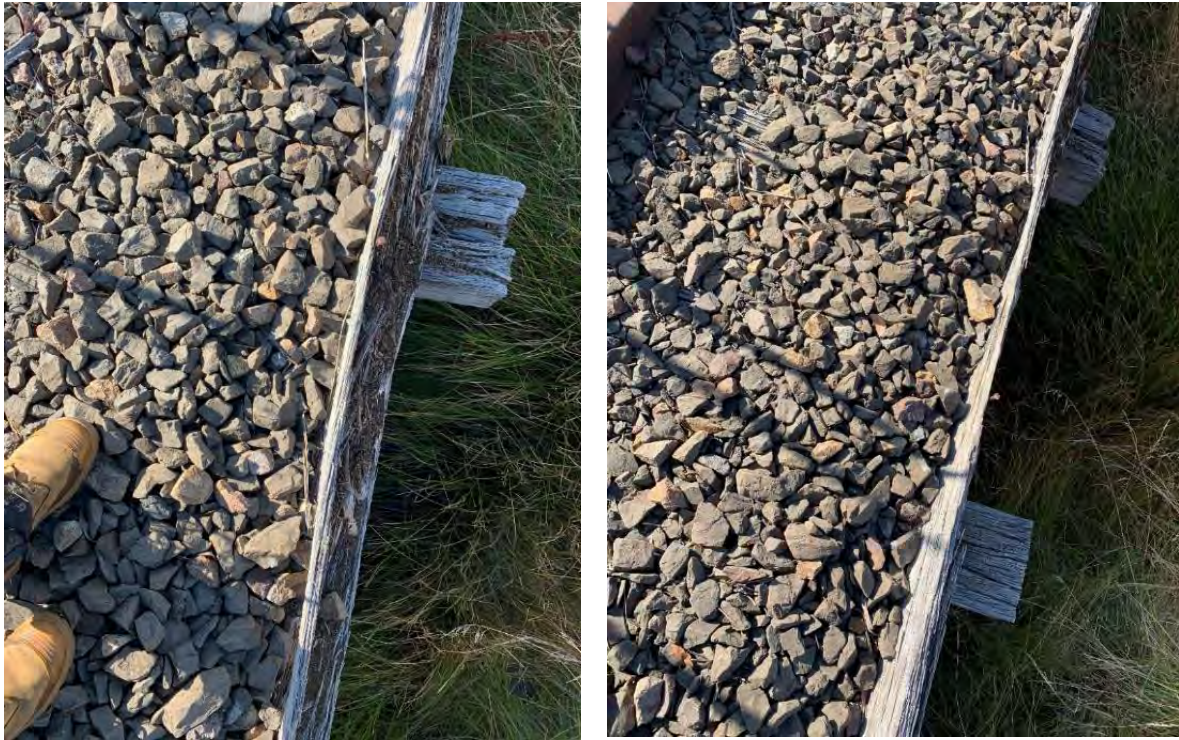
Figure 7-6: Above photos show a ballast tray side wall lengths that have completely rotted away, significantly reducing its ability to retain the ballast material.

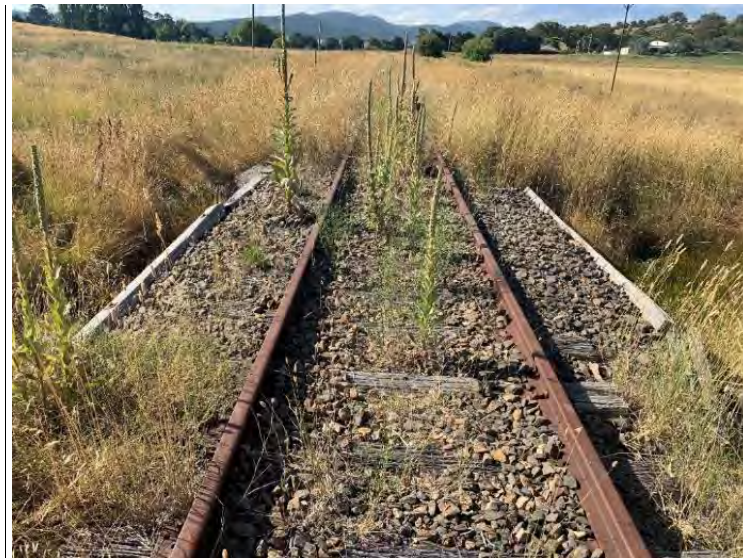
Figure 7-7: The photo above shows the general view down the rail line. Significant overgrown vegetation present through rock ballast and surrounding the substructure. Note: Ballast is 450mm thick.

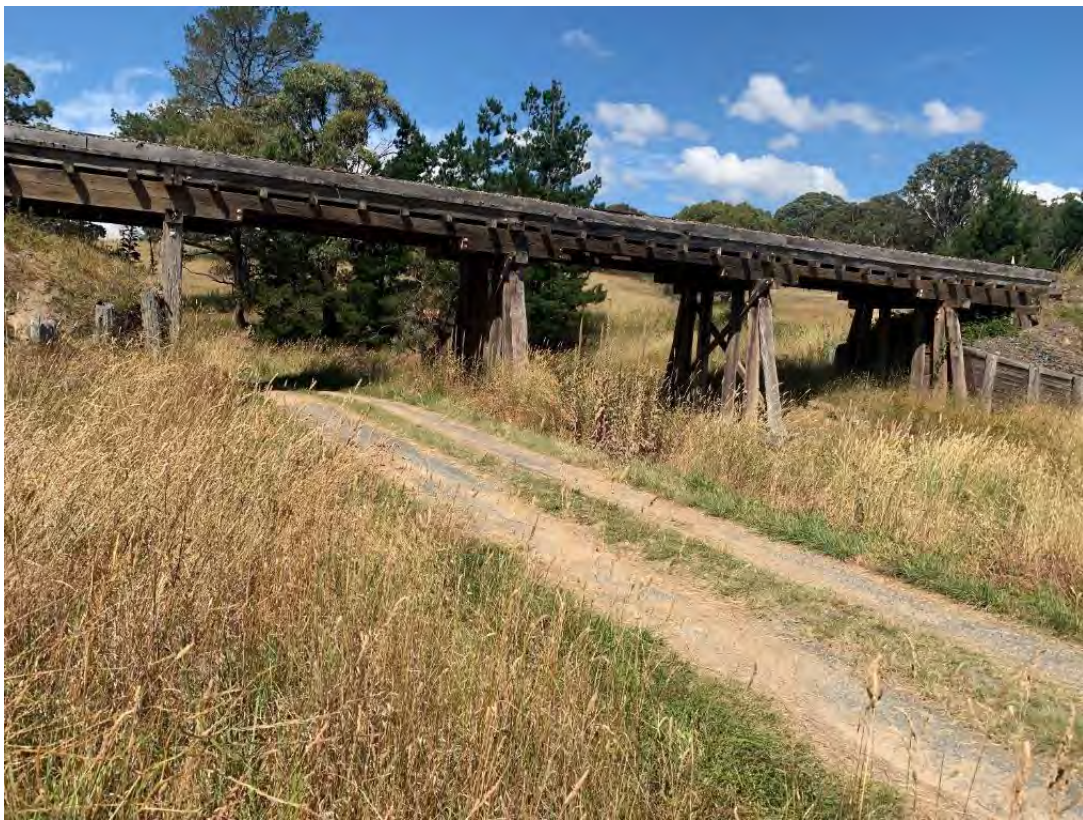
Figure 8-1: General view of Deep Creek Bridge from abutment 1 looking towards abutment 2. The timber bridge is 5 spans long and approximately 32 metres in length (Spans 1 & 5 – 4m and spans 2, 3 and 4 – 8m). Note span 2 passes over the road (4.2m Clearance) and span 3 passes over a creek 2m wide and 0.5m deep.

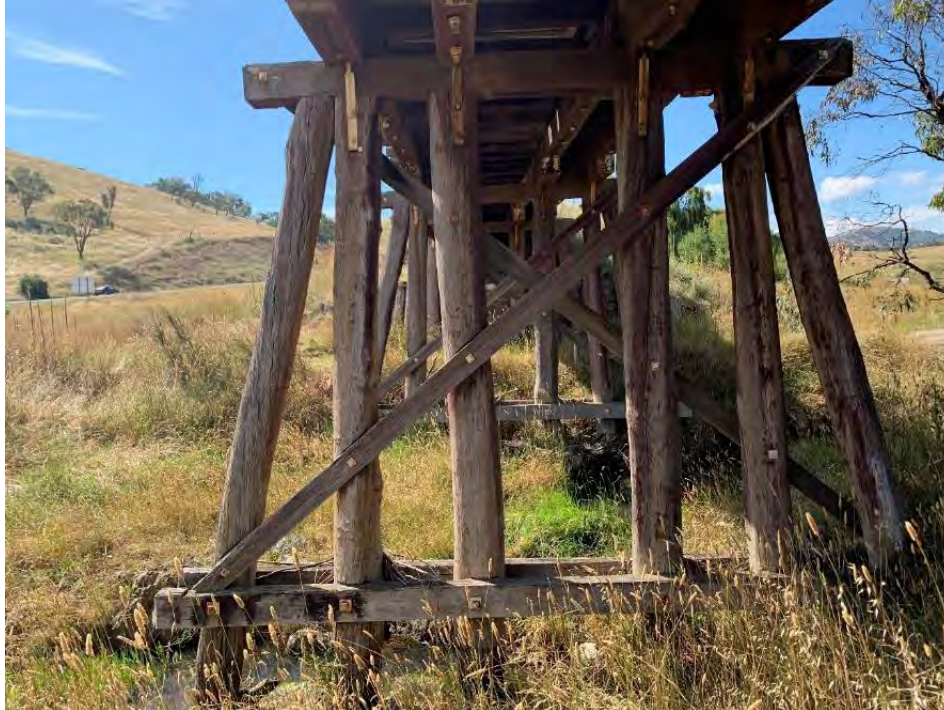
Figure 8-2: View of the typical timber pile bents configuration. The bents comprise of 6 driven piles (4 Plum piles directly under the girders and 2 batter piles on either side). Pile bent 2 and 3 are supported by cross bracing and timber wales at the bottom of the bent. Pile bent 3 was constructed on a concrete footing. The two abutments do not contain the cross bracing and wales. It was noted that the bottom section of several posts and timber cap wales have started to undergo decay. This can be expected due to the timber posts bearing directly on the concrete footing which typically has a high moisture content. Over time the timber post undergoes capillary action and draws up the moisture like a 'straw'. Once the moisture content in the timber elements reaches 22%, decay causing fungi are activated and the decay process begins. Overall, the timber bents were found to range from fair to very poor condition.

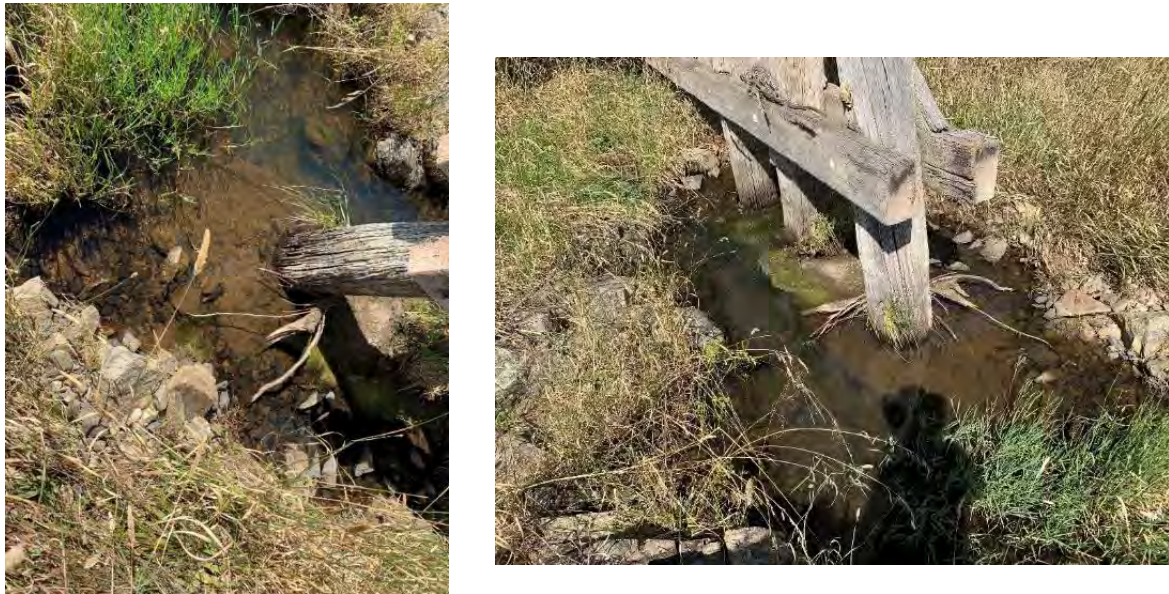
Figure 8-3: General view of pile bent 3 bearing on a concrete sill, piles were found to be in poor to very poor condition. The bottom sections of the timber piles were determined to be a ‘hotspot’ for decay and determined to be an ideal area to test using non-destructive methods, such as EPHOD® Stress Wave Technology. The timber piles were estimated to produce SWT data ranging between 300-1400 μ s. Readings above 700 μ s indicates that there is significant decay present and are required to be monitored. Reading of above 1000 μ s indicate severe decay is present resulting in the member being unable to support its own dead load.

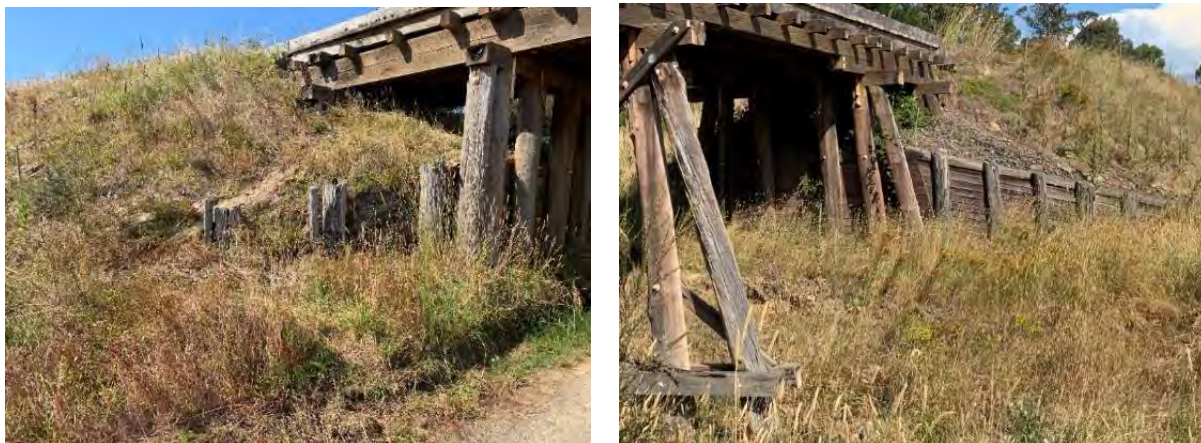
Figure 8-4: The images above show the condition of the breast wall at PB1 & 4. The left photo shows the breast wall at PB1 to be poor to very poor condition with significant decay in timber elements present, surrounding overgrown vegetation and erosion of back fill material. The right image shows the breast wall at PB4 to be in fair to poor condition, it was noted that the back fill material had forced the wall to “lean” forward. Note: Severely decayed batter pile at PB3.

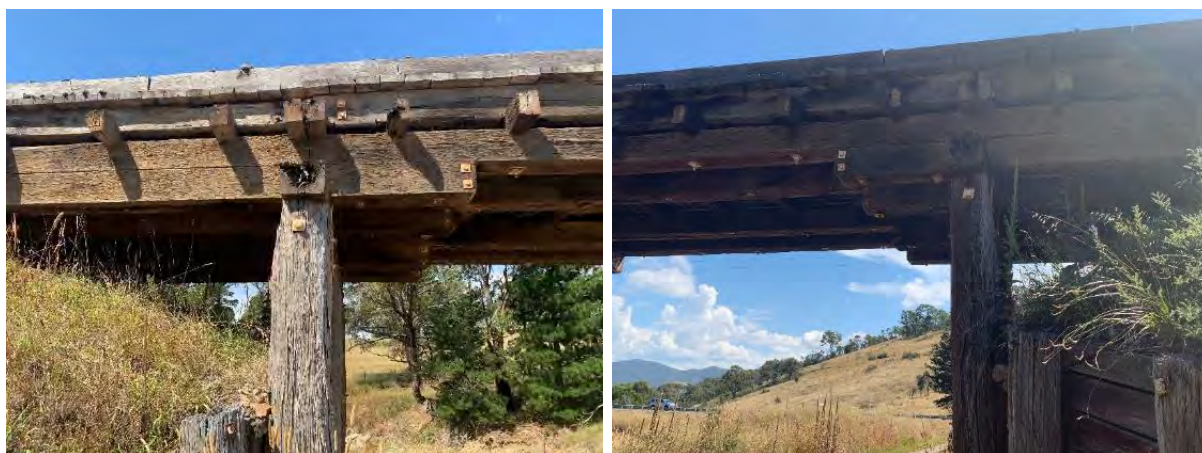
Figure 8-5: View of pile caps at PB1 & 4. Caps were found to be in very poor condition due to the significant cavities present in both ends of each cap. Note: The right photo also shows the backfill from PB4 pushing the breast wall forward.

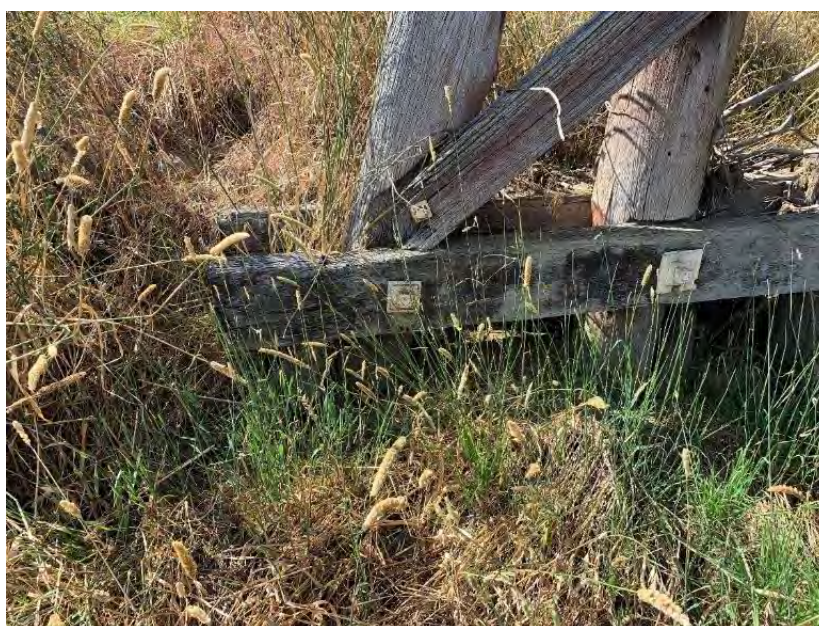
Figure 8-6: A view of a cross bracing plank connection. Plank was found to be in very poor condition as the end has completely decayed away to the connection point. Timber wales were found to be in poor condition with significant water stains and decay present throughout.

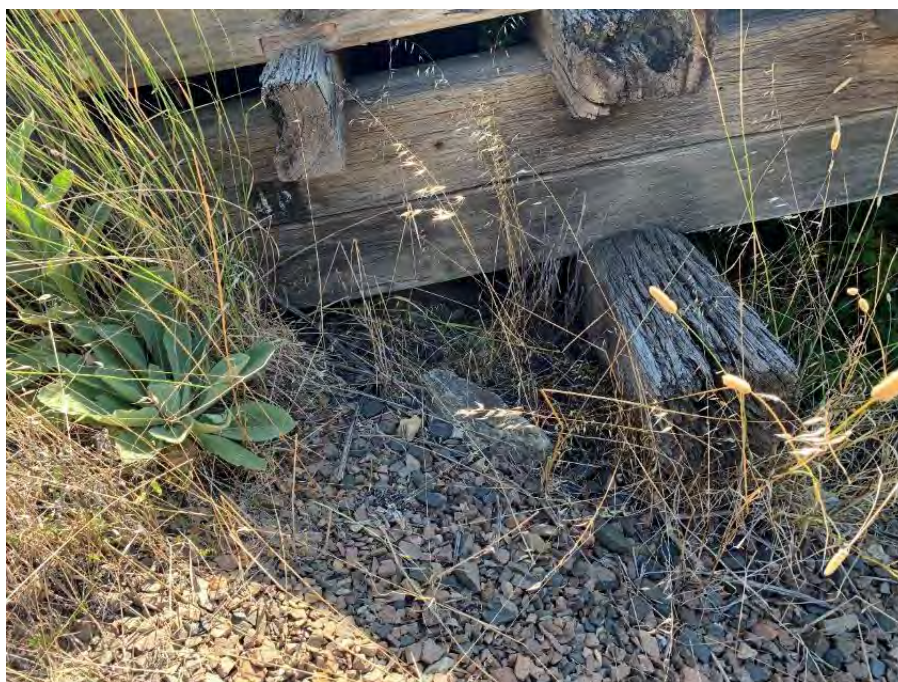
Figure 8-8: View of Abutment cap and spacing logs, cap is in very poor condition due to the large cavity and significant decay present at both ends. Spacing members were found to be in fair to poor condition with sapwood decay and cavities present.

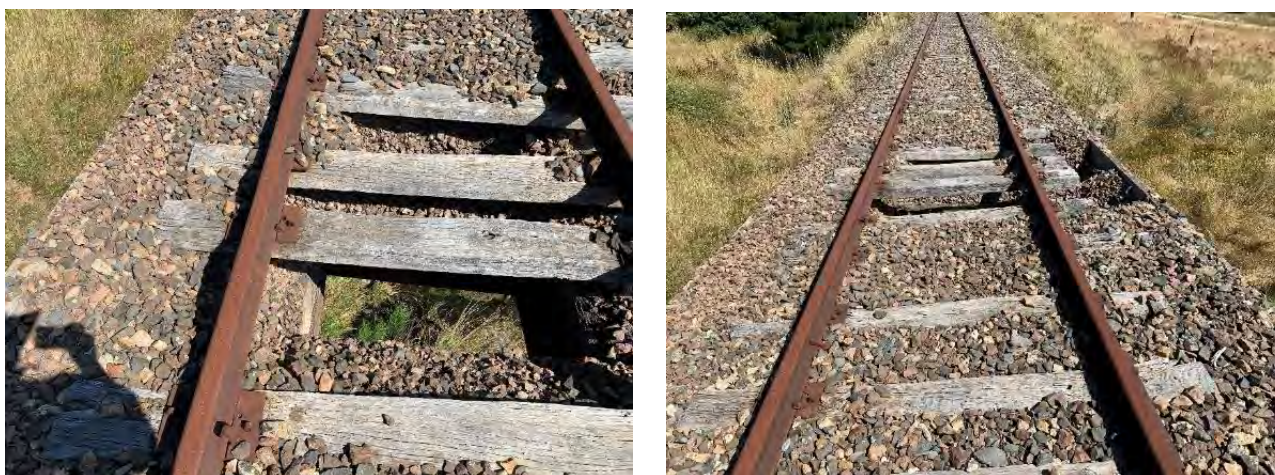
Figure 8-9: Top view of ballast, found to be in very poor condition due to bridge ballast tray floor board degradation and failure leading to a significant hole in the ballast. Transoms appear to be in fair to poor condition with no major decay or defects present.

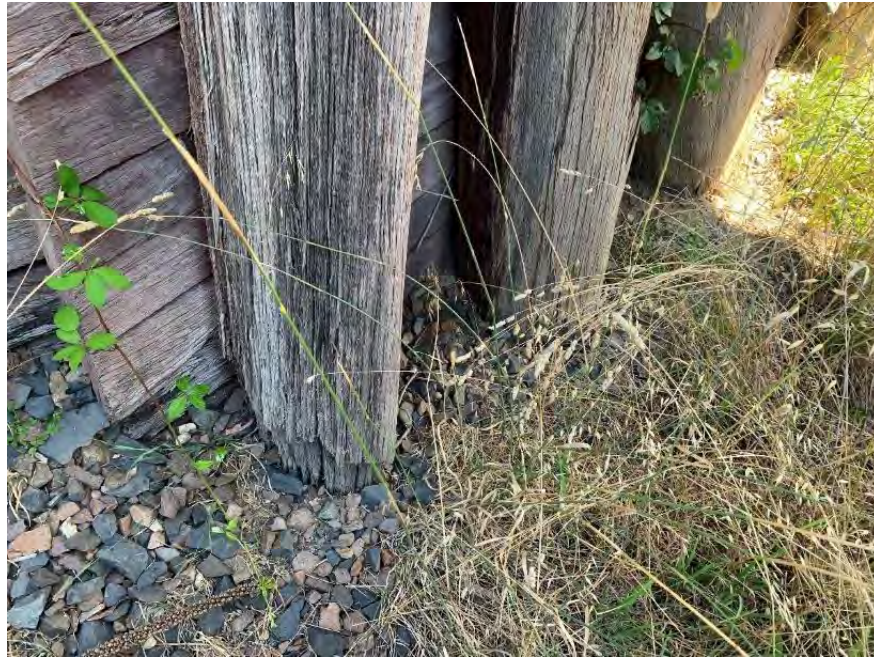
Figure 8-10: View of pile at PB4. Pile was found to be in very poor condition with significant decay present. Decay of approximately 50% of the cross section.
