Monaro Rail Trail

Trail Development Plans – Stage 1a

MONARO RAIL TRAIL TRAIL DEVELOPMENT PLANS

FINAL REPORT

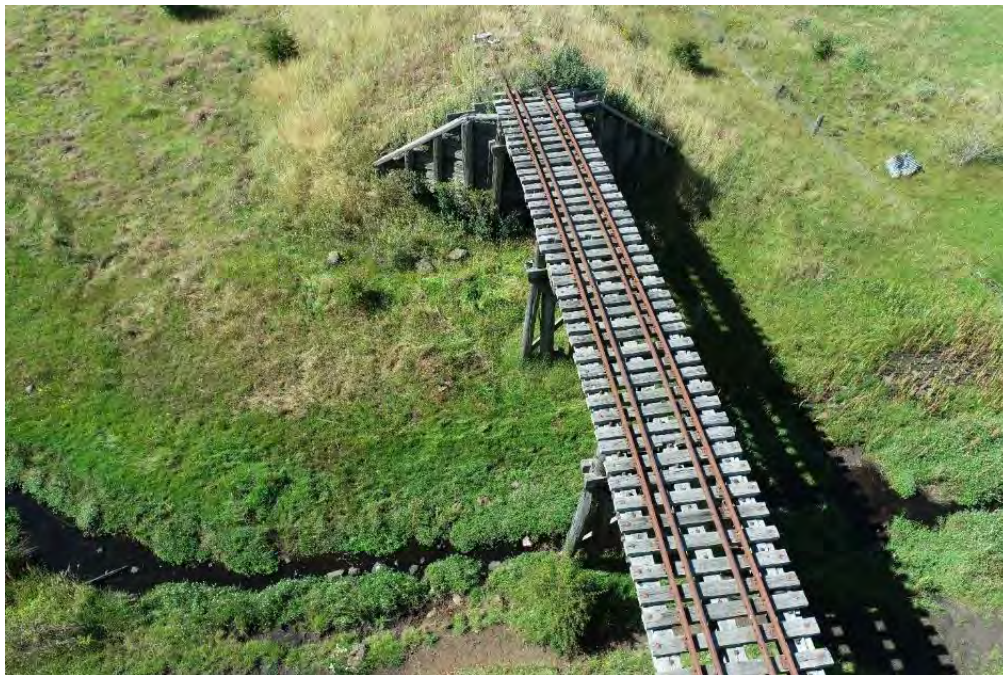
Figure 9-1: General view of Bobundara Creek Bridge from abutment 1 looking towards abutment 2. The timber bridge is 3 spans long and approximately 22.5 metres in length (7.5m spans). Note Bobundara creek runs underneath span 2 and is approximately 1m wide and 1ft deep. note the inner guard rail to prevent derailment leading to the train going off the bridge when train operations were occurring.

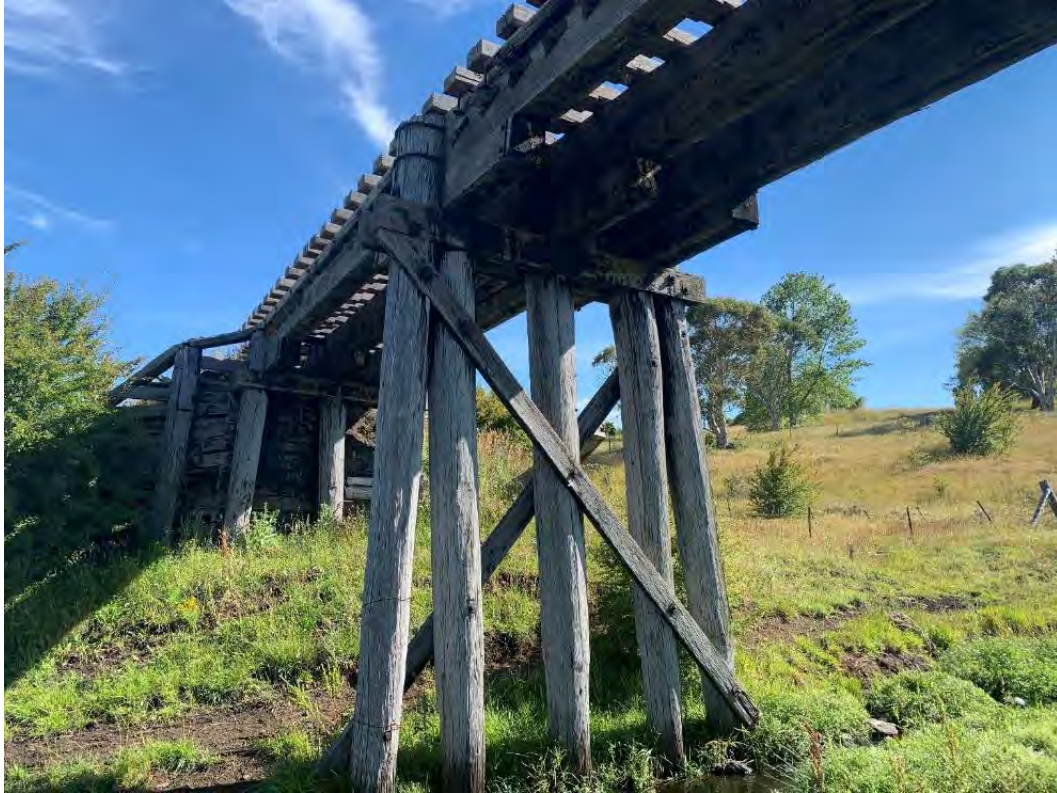
Figure 9-2: View of the timber pile bents configuration. PB 2 and 3 comprise of 5 driven piles (3 Plum piles directly under the girders and 2 batter piles on either side). Pile bent 2 and 3 are supported by cross bracing. The two abutments do not contain the cross bracing and are support by timber sheeting to retain backfill. It was noted that the bottom section of several posts has started to undergo decay. This can be expected due to the timber posts being exposed to increased moisture in overgrown vegetation, debris, and the nearby creek. Once the moisture content in the timber elements reaches 22%, decay causing fungi are activated and the decay process begins. Overall, the timber bents were found to range from poor to very poor condition.

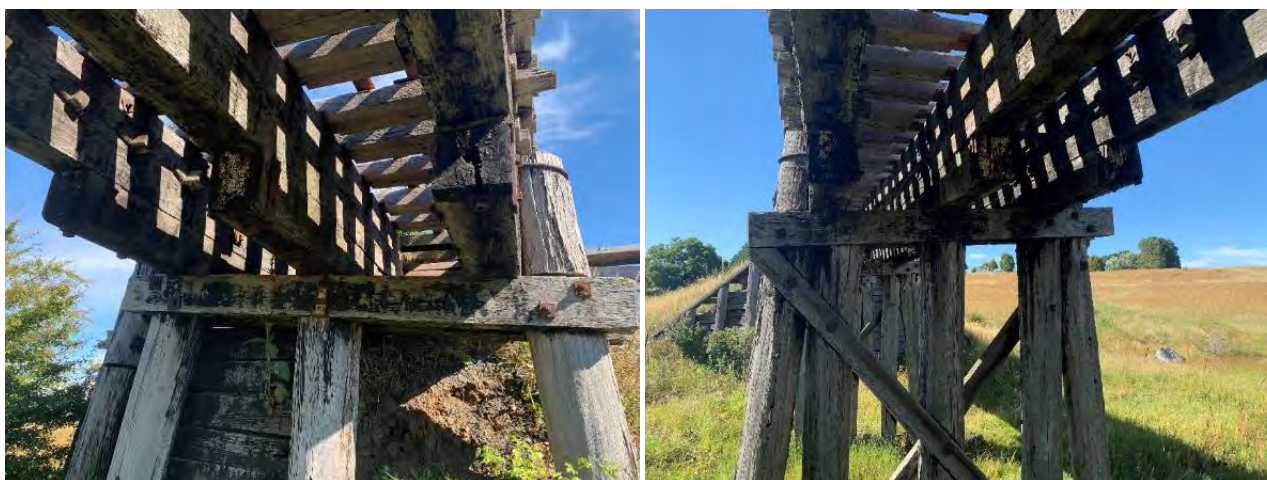
Figure 9-3: The images above show the substructure configuration. It is seen that double stacked girders have been used in addition to split headstocks and corbels. Both images show significant water stains and decaying of corbel ends. The left image identifies a large cavity present in the end of corbel 1 AB1. It was noted that AB1 sheeting has failed.

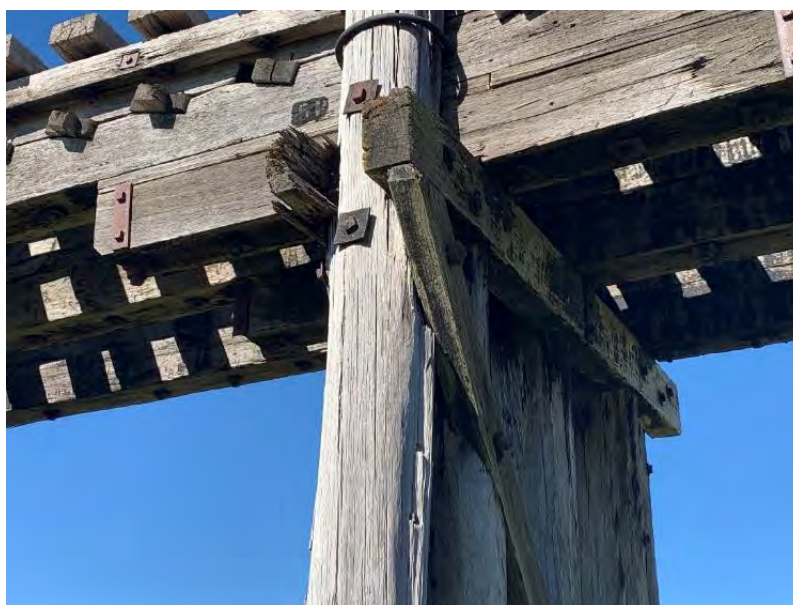
Figure 9-4: The images above show the condition of the split headstocks. The majority of headstocks were found to be in poor to very poor condition. The left member in the image above is completely decayed through the end and in very poor condition.

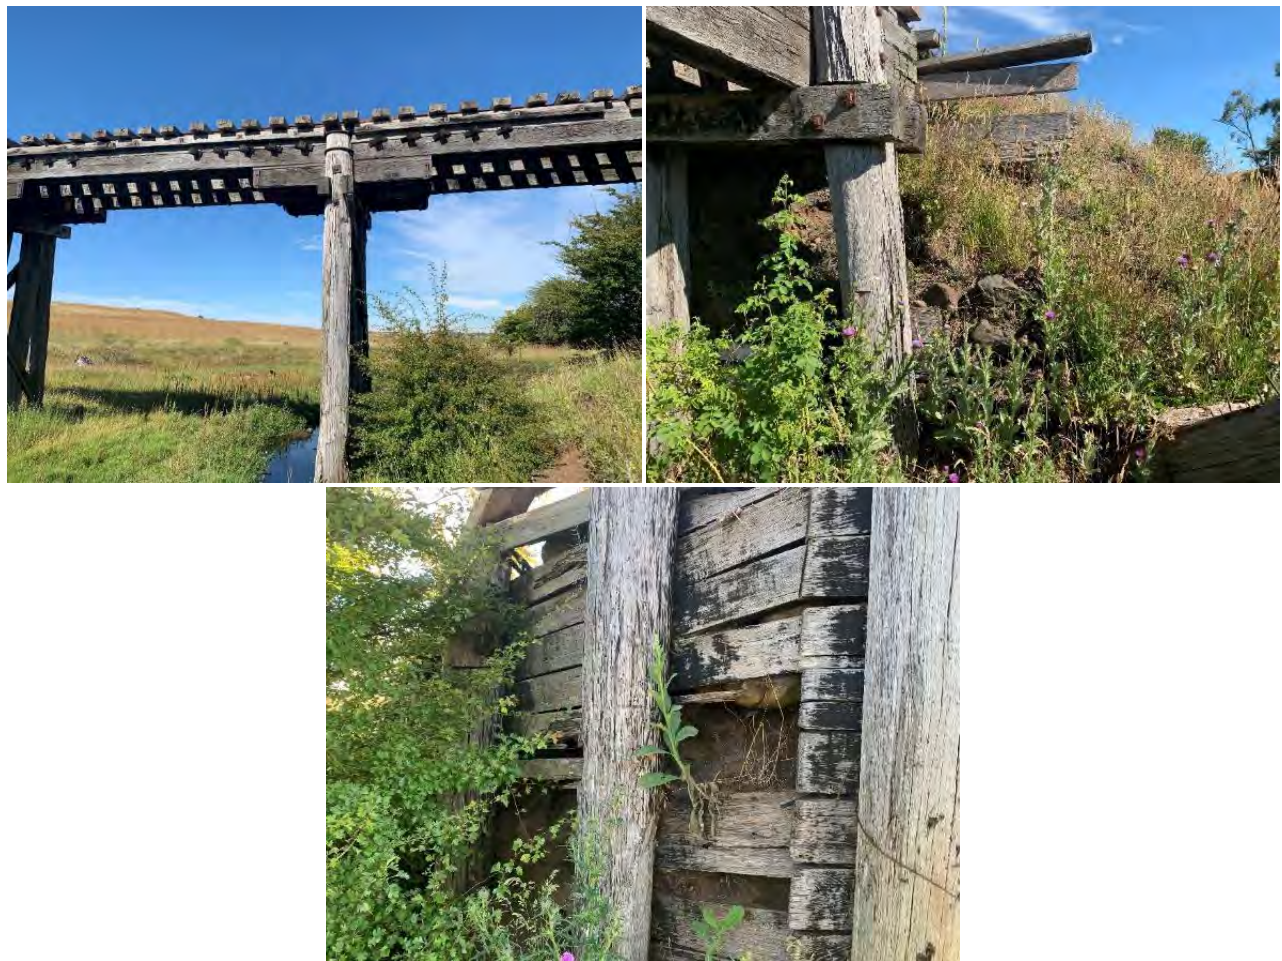
Figure 9-5: Large amounts of sapwood decay is present throughout the structure piles. It is recommended that this is monitored and removed appropriately.

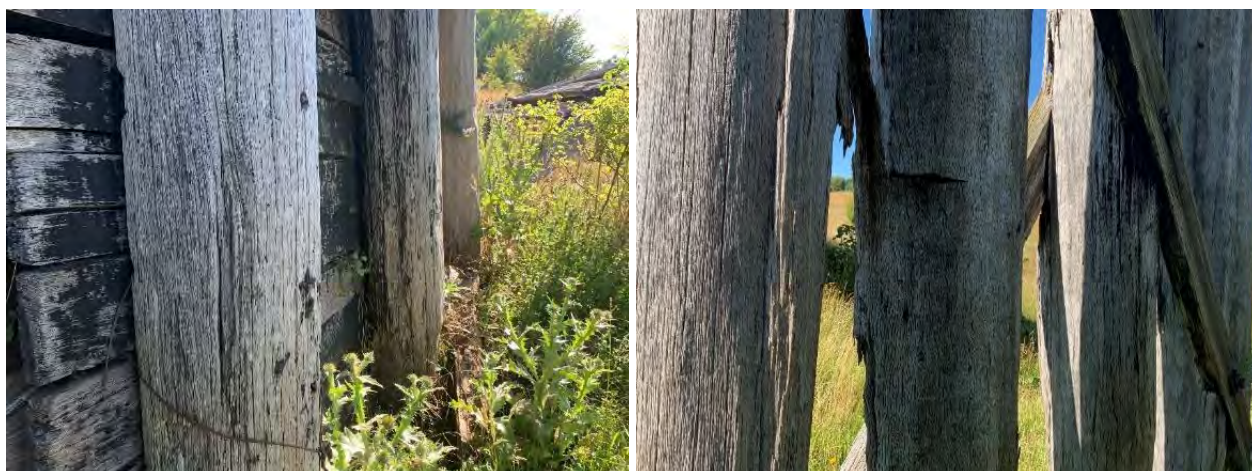
Figure 9-6: A view of two pile defects located at AB1 and PB2. The left image shows decay of sapwood forming a vertical cavity. The right image shows significant deterioration of sapwood (Peeling off).

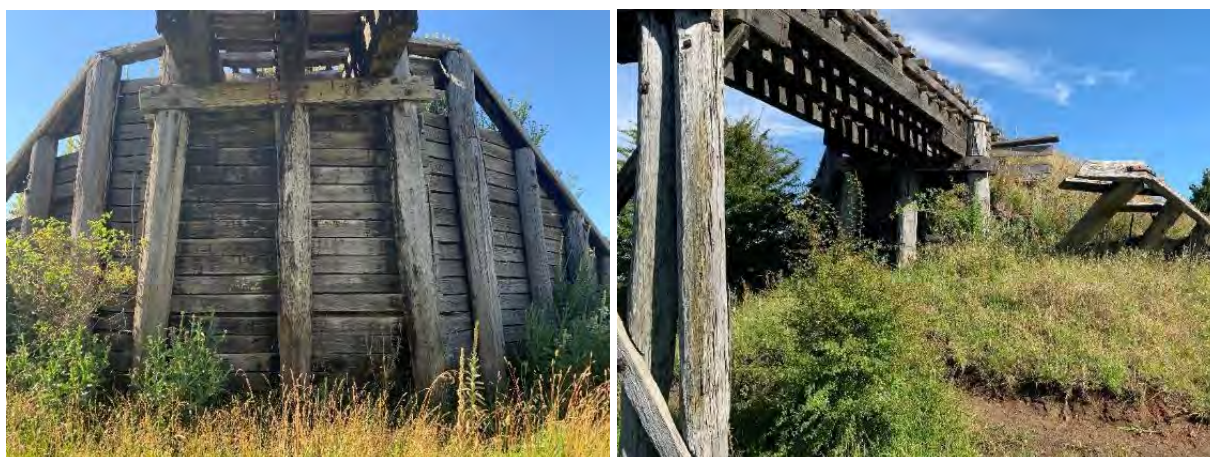
Figure 9-7: View of Abutment 1 and 2 and respective wingwalls. Abutment 1 breast/wingwall was found to be in poor condition due to the missing members and gaps between planks causing erosion of backfill. Abutment 2 was found to be in very poor condition with missing elements throughout and the right side wingwall had failed (collapsed).

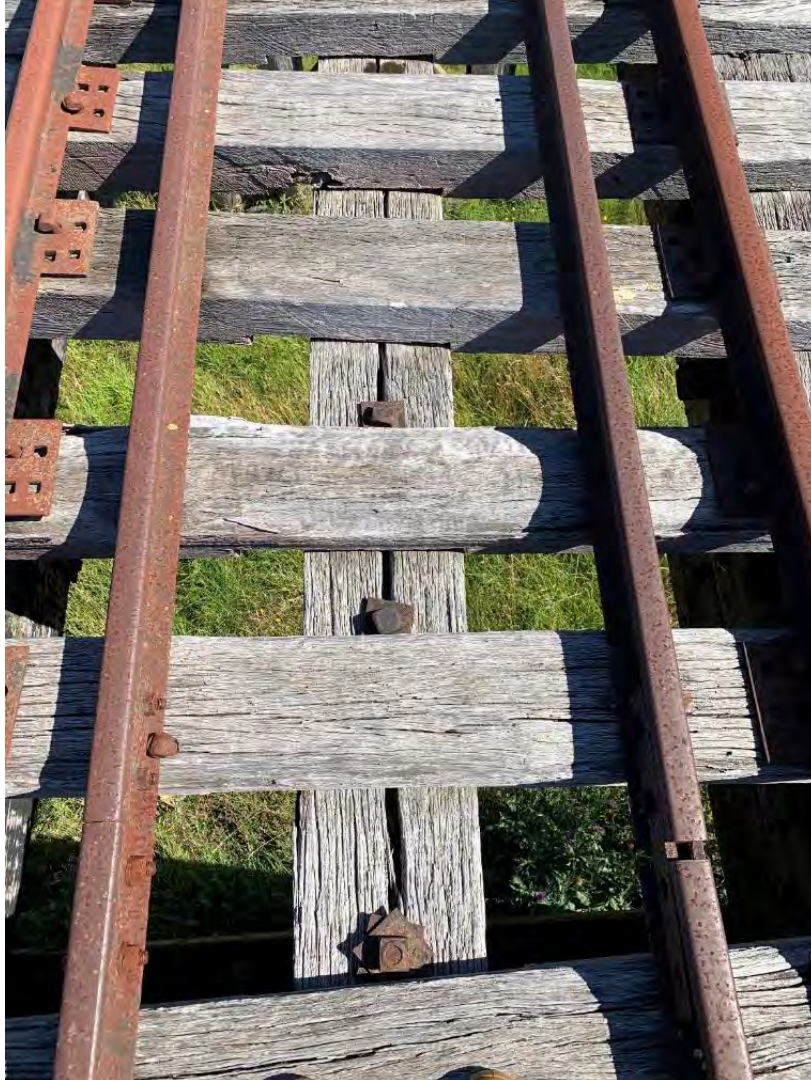
Figure 9-8: Top view of bridge surface, found to be in poor to very poor condition due to major vertical crack through the middle girder and major decay present in all other girder lengths. Vertical connections expose the bright wood to weathering and funnel watering, this leads to accelerated decay and higher moisture content. Transoms appear to be in fair to poor condition with no major decay or defects present. Note the smaller guard inner guard rail on this open deck railway bridge

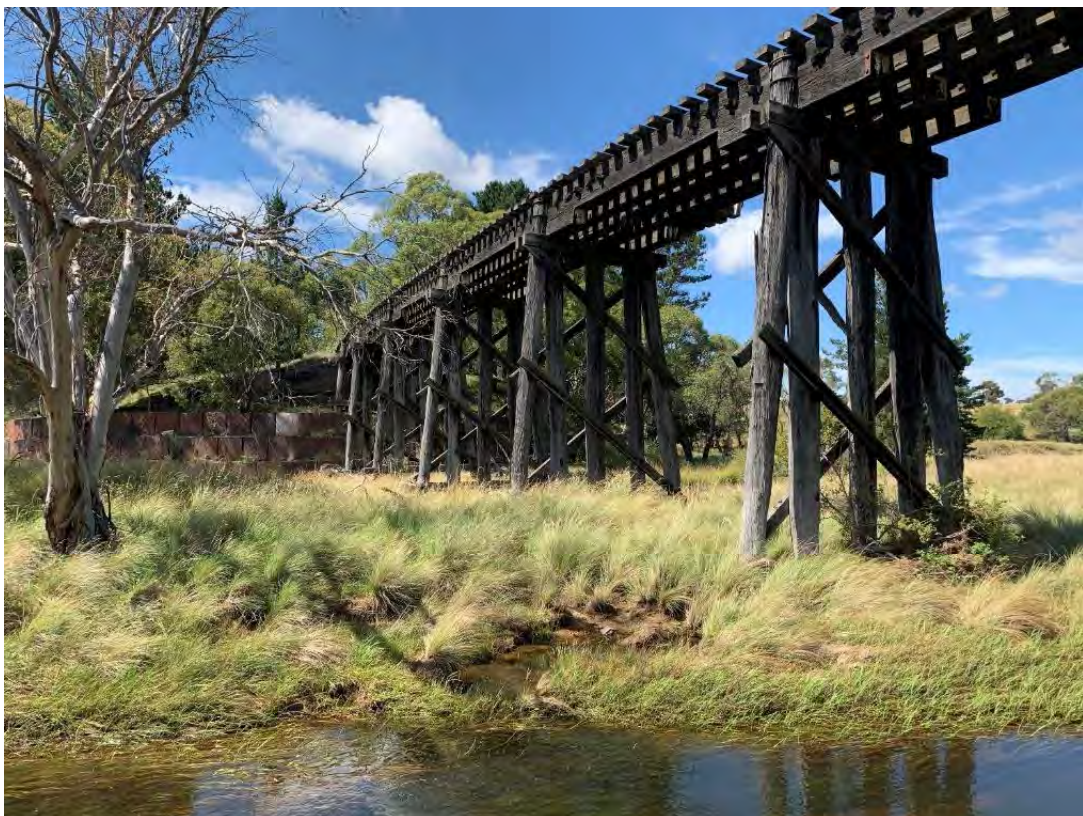
Figure 10-1: General view of MacLaughlin River Bridge from abutment 2 looking towards abutment 1. The timber bridge is 8 spans long and approximately 60 metres in length (7.5-8m spans). Note MacLaughlin River runs underneath span 3 and is approximately 3m wide and 0.7m deep. It was also noted that the bridge curved left and had appropriate camber. Note the double cross bracing on the bents as well the absence of a sash brace.

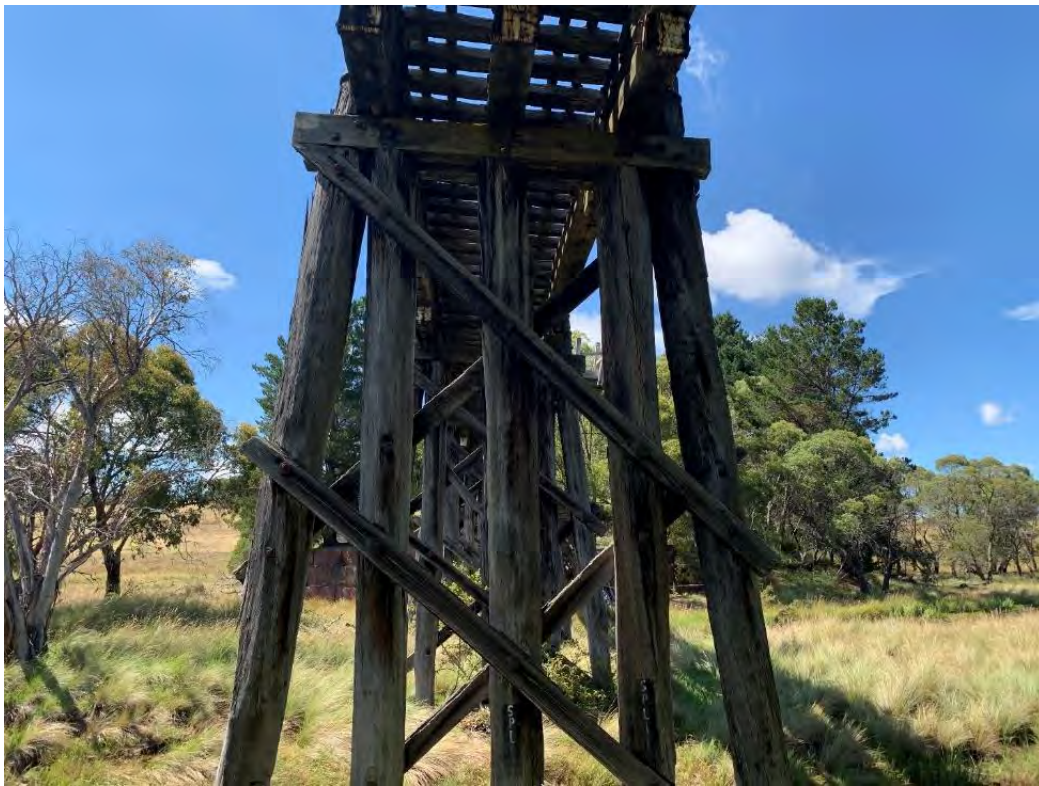
Figure 10-2: View of the timber pile bents configuration. Each pile bent comprises of 5 driven piles (3 Plum piles directly under the girders and 2 batter piles on either side) and are supported by double cross bracing (“X” at top and bottom of piles) and timber wales at the bottom. The two abutments do not contain the cross bracing and only exhibit 3 plum piles. It was noted that significant water stains were present on all timber members of each pile bent. This indicates a high moisture content, when timber elements reach 22%, decay causing fungi are activated and the decay process begins. Overall, the timber bents were found to range from fair to poor condition. Sapwood decay is present at on the piles within the image above. Note that the cross braces do not go all the way to the head stocks.
