# NIMMITABEL WATER SUPPLY LAKE WALLACE DAM

PROGRESS REPORT 9 December 2016

SNOWY MONARO REGIONAL COUNCIL

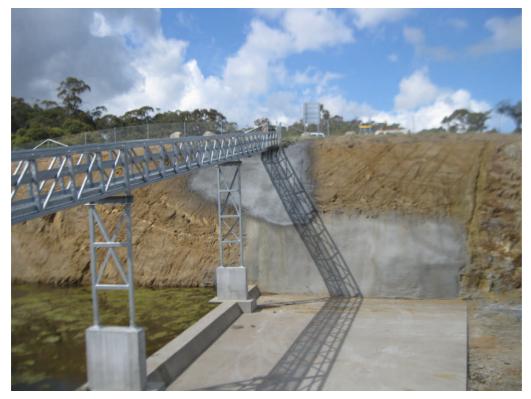
Lake Wallace Dam: Shotcrete anchoring of spillway wall under footbridge

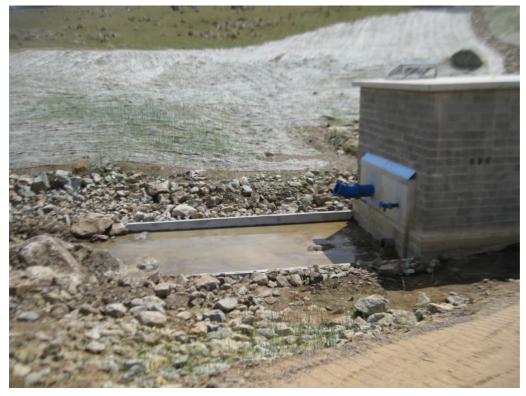
Lake Wallace Dam: Bunded dissipation pad downstream of discharge point
