**SNOWY MONARO**  
REGIONAL COUNCIL

**ATTACHMENTS TO REPORTS  
FOR  
ORDINARY COUNCIL MEETING  
WEDNESDAY 28 SEPTEMBER 2016**

<b>15.3</b>	<b>DA3192/2016 Earthworks Construction of a Shared Trail from Curiosity Rocks to Hatchery Bay</b>	
	Attachment 1 Attachment 1 Draft Conditions of Consent DA3192/2016 .....	2
	Attachment 2 Attachment 2 Statement of Environmental Effects including all Plans and Supporting Documents .....	7
	Attachment 3 Attachment 3 General Terms of Approval OEH .....	61
	Attachment 4 Attachment 4 Response from RMS .....	64
	Attachment 5 Attachment 5 Submission .....	65
	Attachment 6 Attachment 6 DA Form .....	68
	Attachment 7 Attachment 7 Aboriginal Cultural Heritage Assessment Report .....	74
<b>15.4</b>	<b>DA 10.2016.1006.1 - Installation of the 'Nimmity Bell'</b>	
	Attachment 1 North South Elevation .....	207
	Attachment 2 East West Elevation .....	209
	Attachment 3 Site and Landscape Plan .....	211
	Attachment 4 Draft Notice of Determination .....	213
	Attachment 5 Public submissions (redacted) .....	215

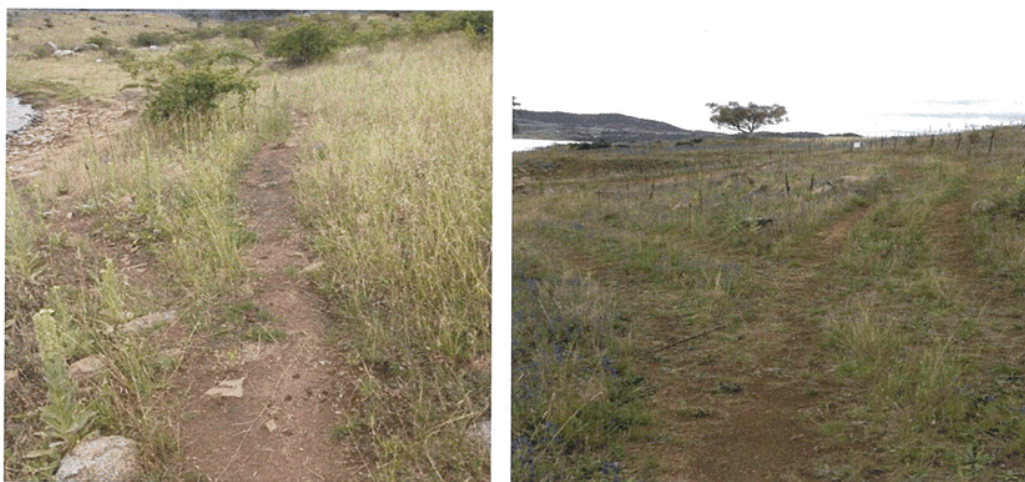
4wd and walking tracks exist in some places on-site. Some vehicle tracks may have previously been used by adjoining property owners who manage stock. Other existing trails are used by bike riders and walkers. Any existing disturbed areas that are within the trail corridor will be revegetated.

Existing disturbed areas

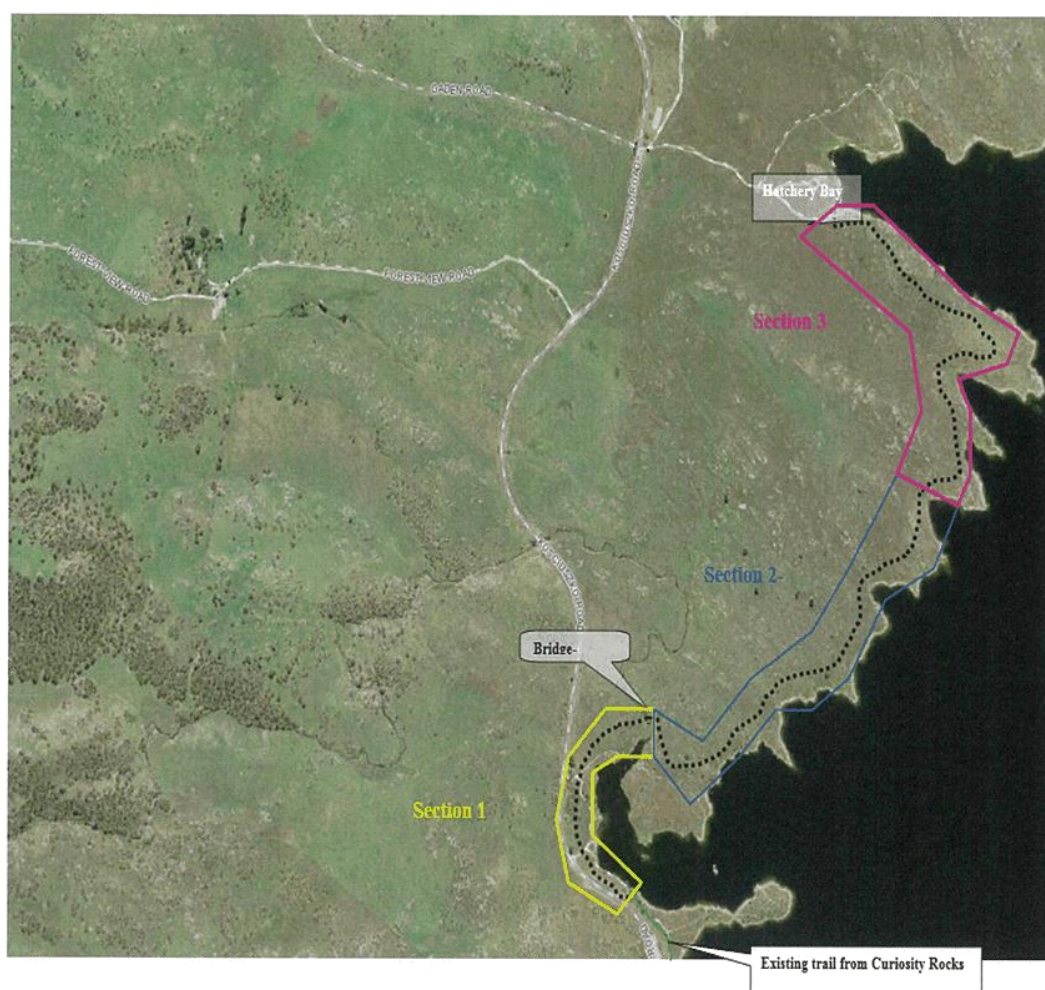
Figure 1 Shared Trial Proposal Overview

The proposed shared trail link from Curiosity Rock to Hatchery Bay has been broken up into 3 sections. Refer to *Appendix A* for detailed maps. The position of the proposed trail will remain above the full supply levels of the lake and also outside private property. The trail alignment will remain high in elevation to prevent inundation by flooding or changes to lake levels. To ensure that this is achieved a large section of the full supply level and private property boundary has been surveyed and pegged onsite (refer to Appendix E boundary and full supply level survey data). The trail will remain above 915-917m apart from the entrance to and including the bridge crossing at Wollondibby Creek. Techniques such as steel mesh platform and use of granite material will be used in this area to minimise damage during the occasional flood.

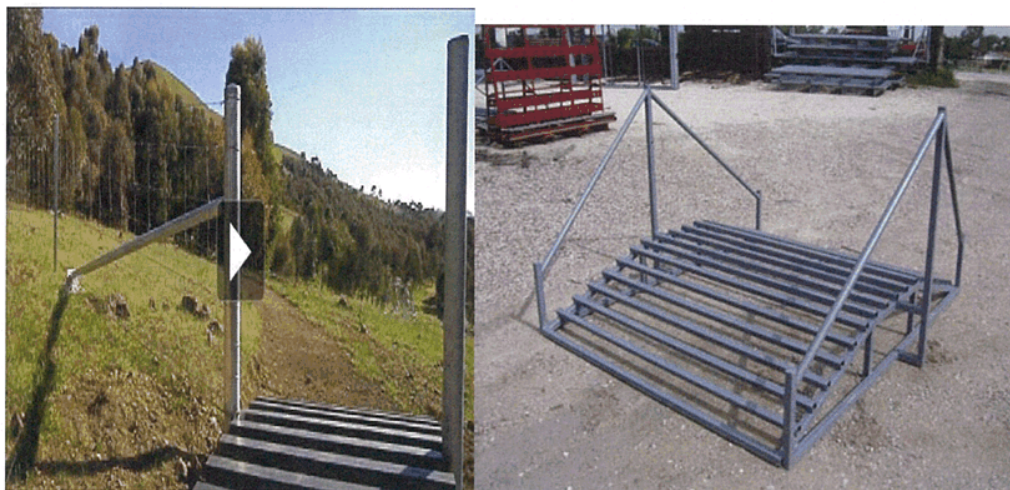
Figure 2. Stock grid/ramp example Centennial Trail Canberra.

Install pedestrian grid to allow access through existing stock fence. Refer to figure 1 below.

A condition of our agreement to amend the licence is that stock control measures will be incorporated in the construction wherever the track passes through fence lines. This will include stock grids and self closing gates for mountain bike riders and walkers, of a design and construction approved by us.

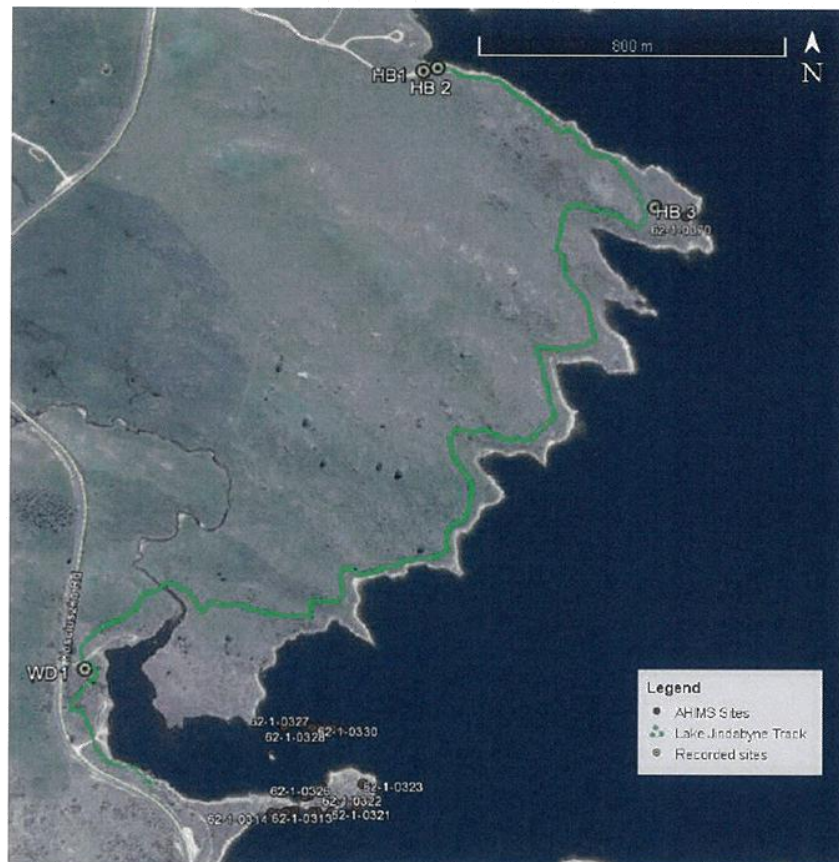
**Figure 3. Recorded Aboriginal Sites**

An Aboriginal Cultural Heritage Assessment (ACHA) was complete for the proposed trail alignment by archaeologists Sue Feary and Gerard Niemoeller (Refer to attached report). The assessment also included the Lower Thredbo Valley Track proposal by National Parks and Wildlife. Both trail proposals were included in the one assessment for convenience and at a cost saving to both stakeholders. The results of the assessment specifically for the Lake Jindabyne Shared extension are as follows:

The Aboriginal Cultural Heritage Assessment (ACHA) report recommends that no further archaeological investigations are required unless there are significant deviation from the proposed trail alignment.

The ACHA report also recommends an Aboriginal Heritage Impact Permit (AHIP) is sought for partial harm to sites WD1 and HB1-2. The ACHA report has been provided to the NSW OEH to support the AHIP determination process. Works will not take place until the AHIP is obtained.

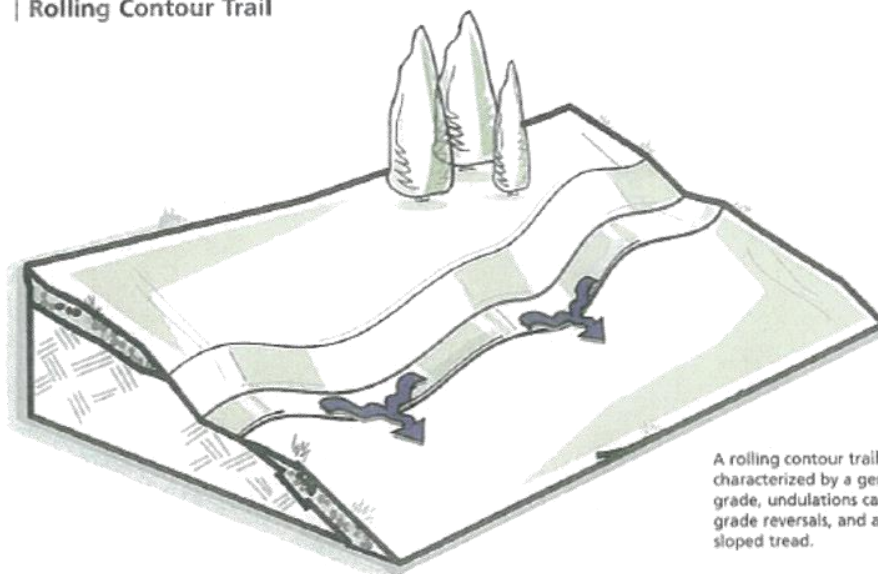
Rolling Contour Trail

A rolling contour trail is characterized by a gentle grade, undulations called grade reversals, and an out-sloped tread.

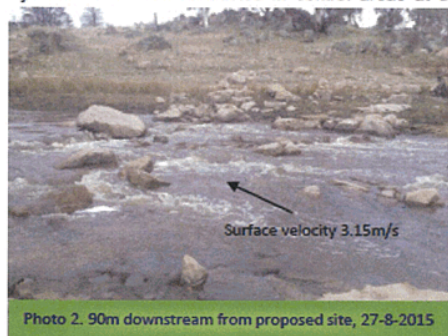
It is easy to overlook the potential power of Wollondibby Creek when it is viewed during normal flow. Dynamic float tests conducted in control areas at the site, over two days, one week apart and during normal flow (no significant rain for a week preceding the test) revealed an average surface velocity of just 0.45m/s.

In flood, this tributary produces a tremendous force and brings large debris with it all the way to the lake. Fortunately for reporting purposes, the creek has been in moderate flood during the last few days of the reporting period. Unfortunately I was away for the peak of the flood but managed to get to the site the day after the rain ceased to gather flow data and take some photos.

Photos 1- 4 show Wollondibby Creek in moderate flood with visible turbulence, erosion and debris collection within 100 metres of the proposed site.

Large debris can be dislodged and carried at this velocity (some evidence of which is shown in photo 1.) and at this speed has the potential to damage a structure that has not been adequately designed.

Evidence of the water reaching the floodplain just downstream from the site can be seen in photo 4. This evidence suggests that the water level was up to 600mm higher during the peak of the flood event making the estimated peak

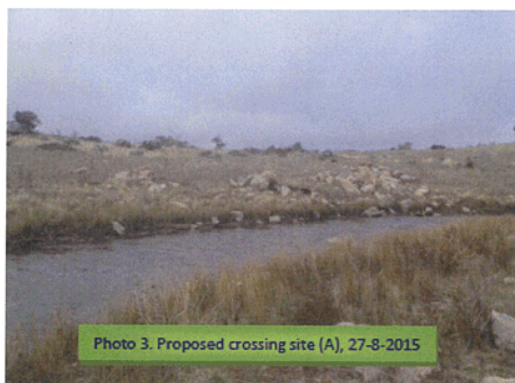
The same dynamic float tests were conducted in the same control areas around the proposed site a full day after the rain had ceased; and found the average surface velocity to be 3.15m/s, seven times faster than during normal flow (0.45m/s)

Given the tests were taken 24 – 36 hours after the peak of the flood event, it should be considered that the water velocity would have reached significantly higher levels than what was recorded (estimated at least 4.5m/s).

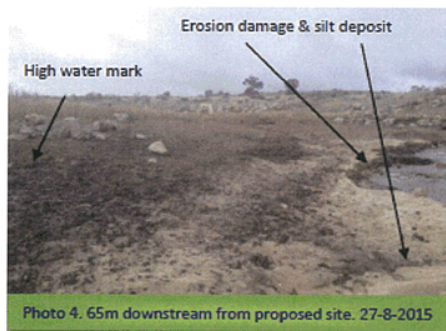
The forces generated in the type of peak flow we have experienced this week would require significant ground works to ensure adequate support and anchoring of the new structure. Large box culverts would be required to allow for flow, to give adequate height clearance above the max water level and to resist the loads applied.

Undertaking significant ground works in a creek prone to flood and in a culturally sensitive area is a very risky process and highly likely to result in cost over runs.

Approximate mass of the concrete box culverts required is about 6.8 tonne each and four of them would be required to cross the main section of the creek. The footings required to support the mass & turn-over effect alone, are considerable in size and would likely involve diversion of the main creek flow to complete their construction.

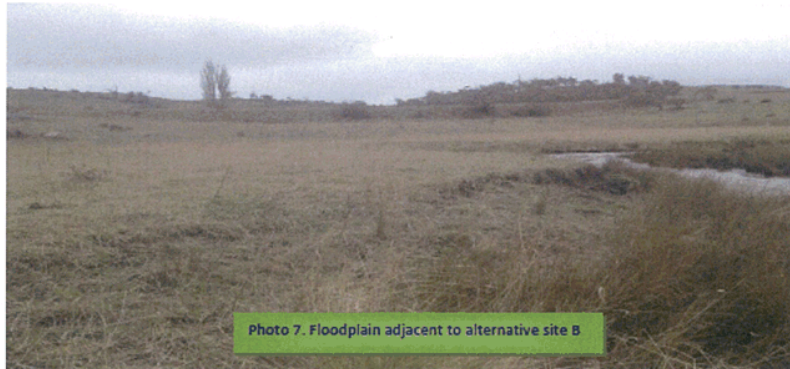
Photo 7. Floodplain adjacent to alternative site B

Approximately 80 metres to the west of the proposed site is a straight section of the creek, which would also make a viable site without major trail deviation (see map site B and photos 5 & 7).

The water velocity at site B was measured to be only 2.9m/s during flood, 10% slower than at the proposed site.

Whilst the flood plain on either side of the creek is significantly wider (approximately 25m to the south and 20m to the north), there is virtually zero erosion on either side of the creek. There are also no boulders in this area which makes construction of footings considerably easier.

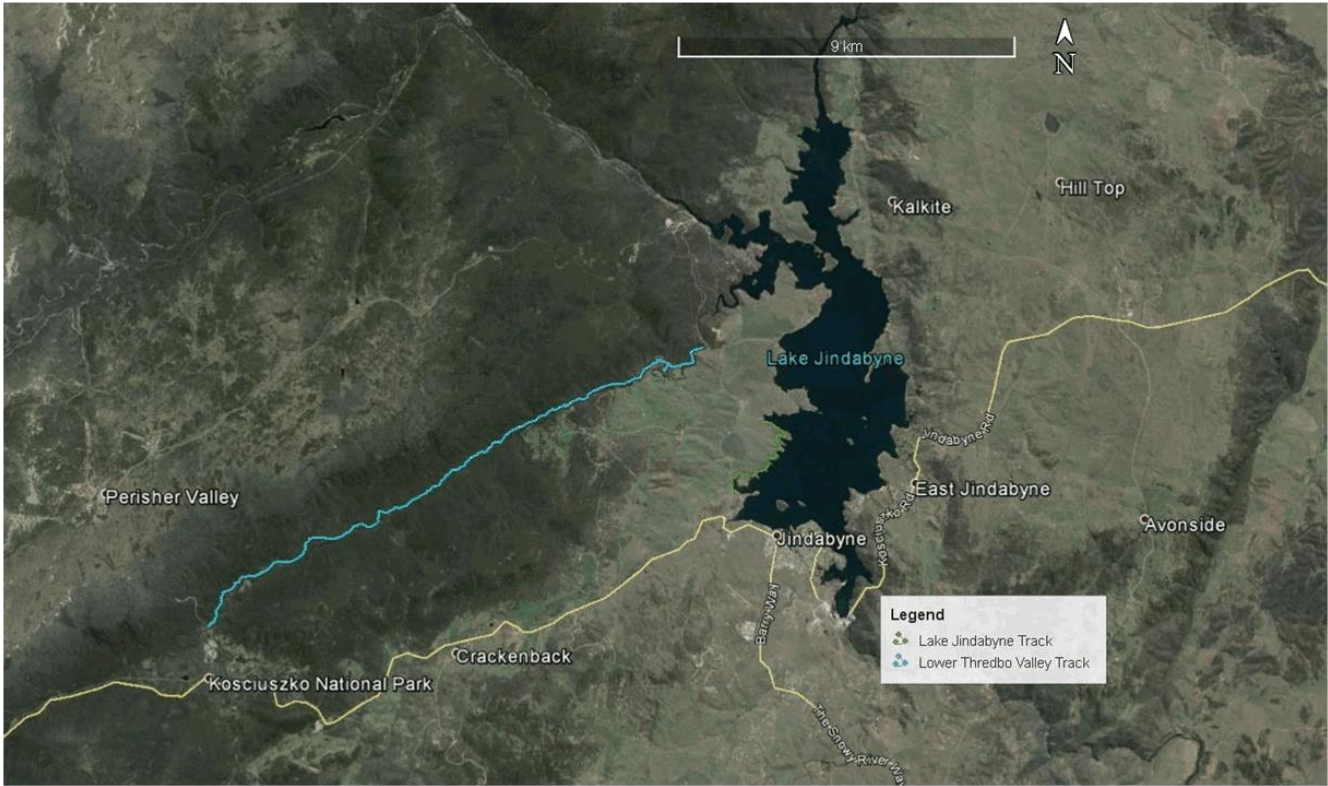
Figure 2: Aerial photo showing location of two proposed shared path extensions

The subject area for the shared path in KNP is a 20 kilometre long corridor of 50 metre width on the northern slopes of the lower reaches of the Thredbo valley between Bullocks Flat [55-629210/5966732] and the Thredbo River Picnic area in KNP [55-6292105966637] (Figure 2) .

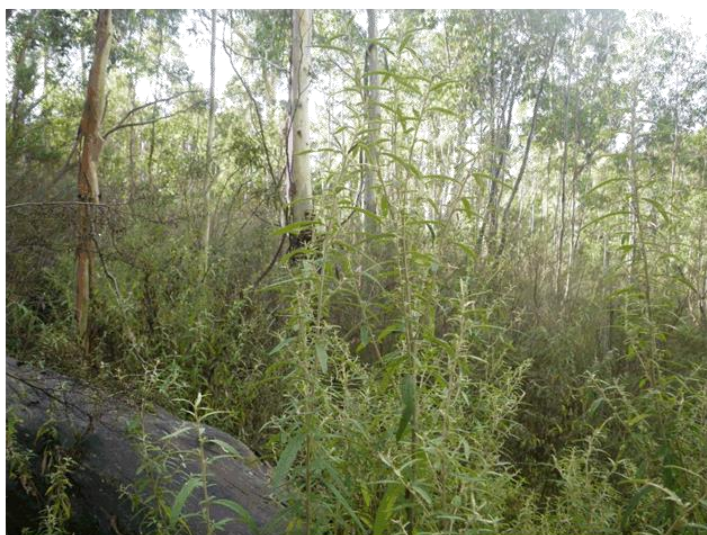
Figure 4: proposed path alignment, mid slope in lower Thredbo River valley

The landform of the study area is highly variable due to the length of the proposed track. In some sections the track follows the relatively flat river plain adjacent to Thredbo River while in other sections the landscape is very steep where the track deviates greater distances from the edge of Thredbo River. Some of these sections would have slopes greater than 25 degrees. The track crosses many small tributaries to Thredbo River most of which are very minor and most likely ephemeral or intermittent. At the higher elevations of the track, typically above about 1050 metres ASL, there was a distinct lack of surface rock and significant rock outcrops. Below this elevation there was a higher occurrence of rock outcropping and loose surface stone. Generally the surrounding landscape is steep to very steep (Figure 4). Adjacent to the proposal, slopes are consistently greater than 25 degrees. The study area is part of the east-west river valley of the Thredbo River, in between two significant east-west ridge lines with elevations of greater than 1500 metres asl to the north and 1400 metres asl to the south (EnviroKey, 2015). Thredbo River is impacted by seasonal changes in climate resulting in high flows during the spring snow melt and subject to snow and ice during the winter seasons.

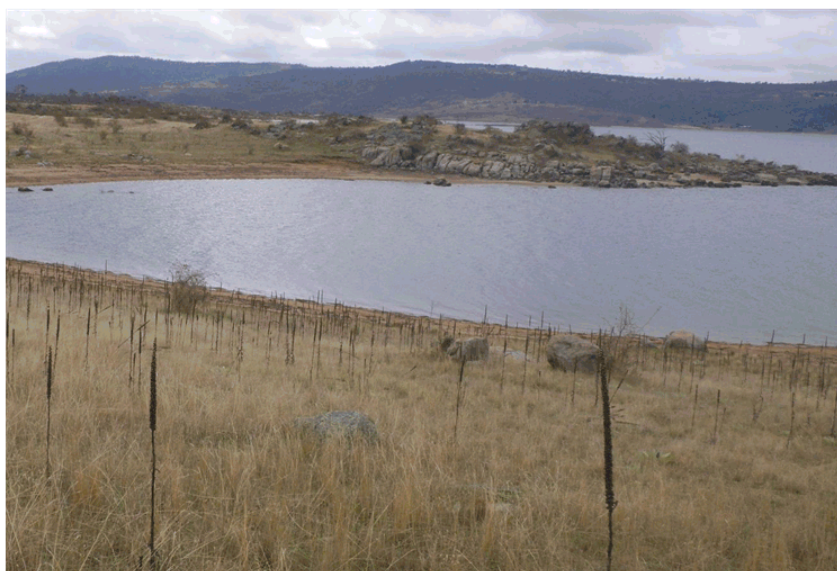
Figure 5: Lake Jindabyne with a rocky granite headland

modified through landscaping and construction of trout pools and a picnic area. The land around the lake is gently to steeply undulating, characterised by prominent headlands with distinctive granite outcrops (Figure 5). The proposed path is designed to be above the highest dam level; hence it is sometimes cut into quite steep slopes.

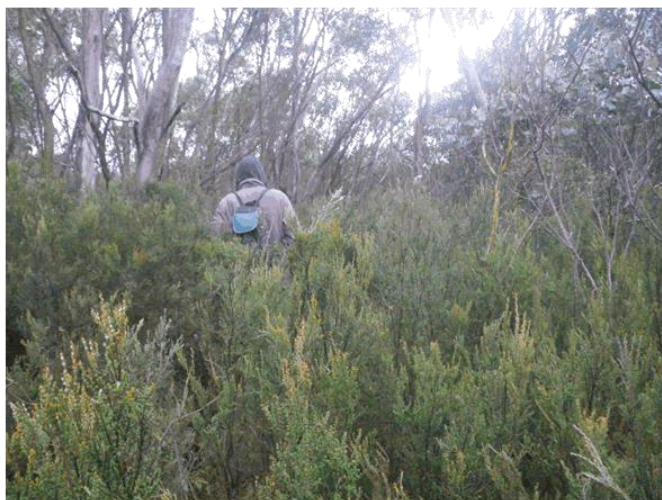
Figure 16: typical understory, near Bullocks Flat

The level of visibility and exposure for this survey was generally very low (<3%) and this was especially true of the Lower Thredbo Valley section within Kosciuszko National Park (Figure 16). The highest visibility was afforded either along existing tracks such as the Pallaibo Track (Figure 17), vehicle tracks nearer Jindabyne or around the eroded margins of Lake Jindabyne. Observations for the different sections and transects of the proposed track and survey are described in Table 8.

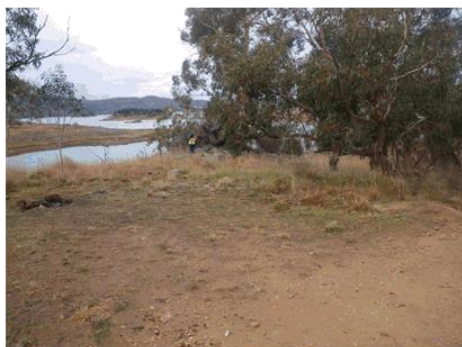
Most of the recorded sites contained flaked stone artefacts whilst two also contained manuport / anvils which were likely utilised within the stone artefact manufacture process of bipolar flaking (LTVT 2 and Hatchery Bay (HB) 3). Site WOLLONDIBBY (WD) 1 exhibited the highest number of artefacts (30+) (Figures 18 and 19), followed by LTVT 2 (20) and Hatchery Bay (HB) 2 (10+). A low density possible quarry site of porphyritic material was also recorded (BULLOCKS FLAT (BF) 3). Although no cores were recorded at this site, the flakes were manufactured from the associated porphyritic material outcropping at this location. Table 11 provides details of site types recorded.

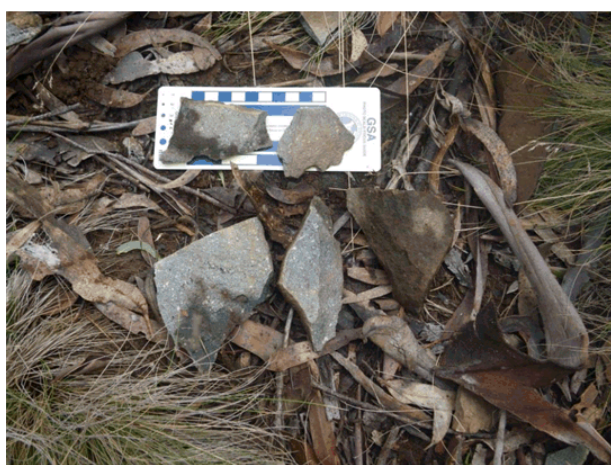
Figure 20: non-quartz artefacts from BULLOCKS FLAT3

The majority of flaked stone artefacts were manufactured from quartz and quartz is the dominant stone raw material and is represented at 22 (84.6%) of the 26 recorded sites. In contrast silcrete was represented at 4 sites (15.4%), porphyritic at 3(11.5%) (Figure 20), and chert was represented at 1 (3.8%) of the recorded sites. Table 12 below shows a simple measure of assemblage complexity and compares the number of raw materials and artefacts recorded at each site. Most of the recorded sites (21 or 80.8%) contained a single artefact type (predominantly flakes) manufactured from one stone raw material, predominantly quartz.

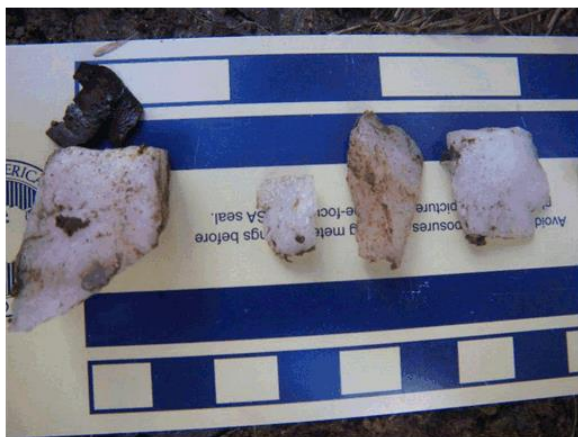
Figure 21: selection of quartz artefacts from site LTVT2

Although much of LTVT was steep with a low archaeological potential, isolated finds and small artefact scatters were still found (Figure 21). Their locations were not on the steeper slopes but on relatively flat spurs above the river and often between gullies which carry water on a temporary basis. This pattern is similar to that on the Thredbo valley further upstream and also in the Snowy River valley, where extensive scatters occur where major tributaries join the Snowy River. The reduced numbers of sites compared to further up the Thredbo valley can be explained by lack of visibility (although similar problems were encountered further up the valley) and the alignment of the track being generally along a steep mid-slope.

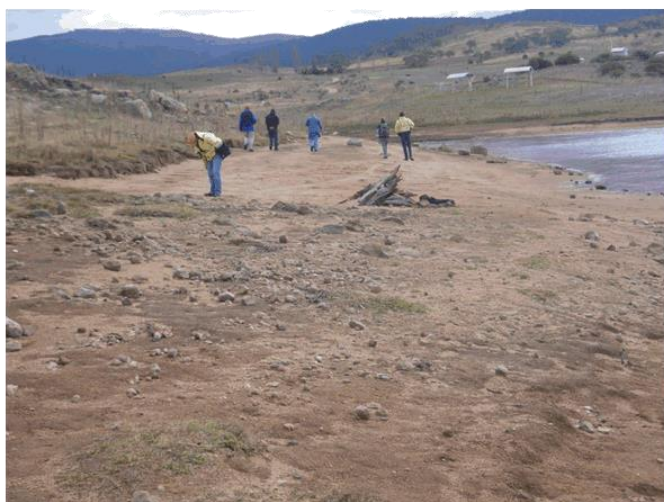
Figure 22: Lakeshore at location of Hatchery Bay2

Few objects were found around Lake Jindabyne, when compared to other previous studies conducted around the lake, probably because the alignment is away from prior rivers. The two largest sites WOLLONDIBBY1 and Hatchery Bay 2 are in highly disturbed contexts, due to vehicle damage and changing dam levels respectively (Figure 22).

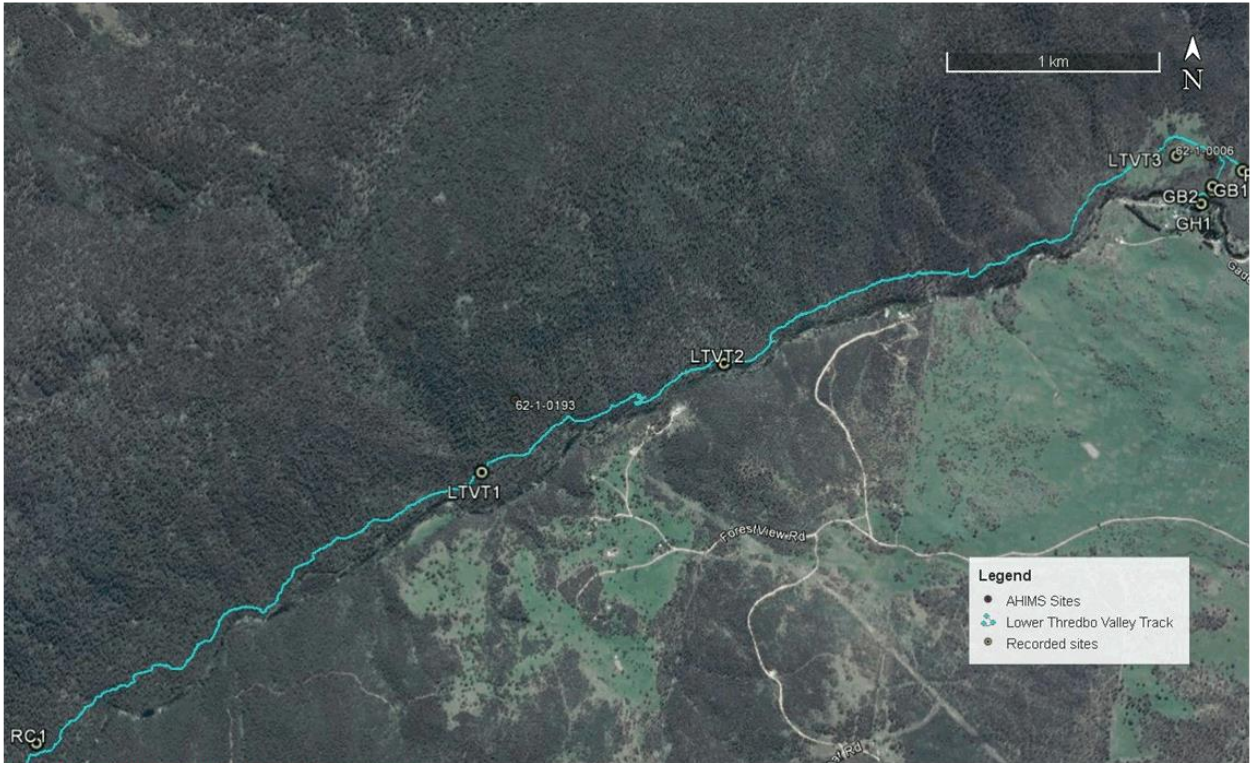
Figure 25: Recorded sites Penderlea to Robertsons Crossing

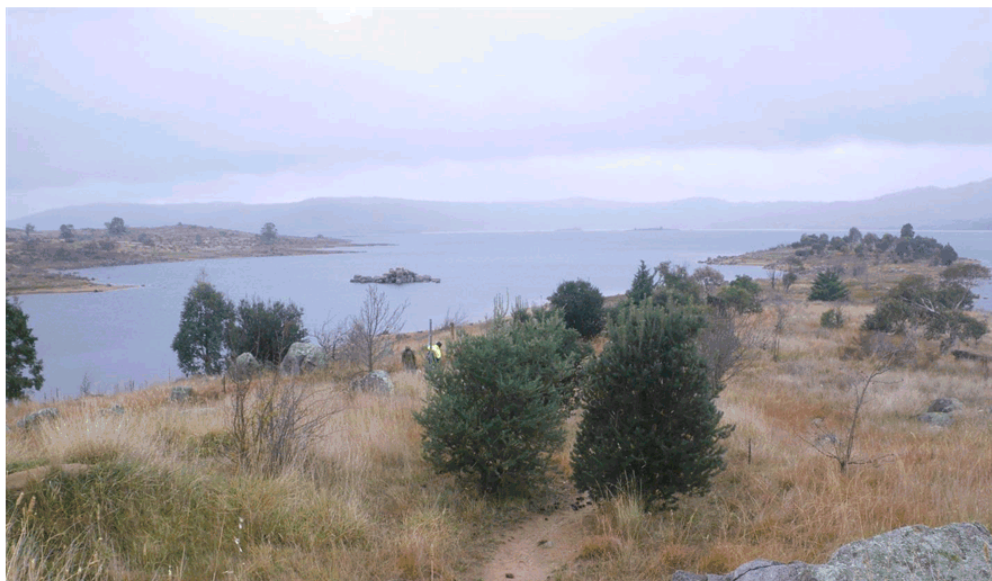
Figure 28: Curiosity Rocks - peninsula in foreground with rock formation in lake

**Aesthetic value:** Curiosity Rocks is a visually arresting rock formation and has aesthetic value for this reason and also because it evokes emotional responses from knowledge holders (Figure 28).

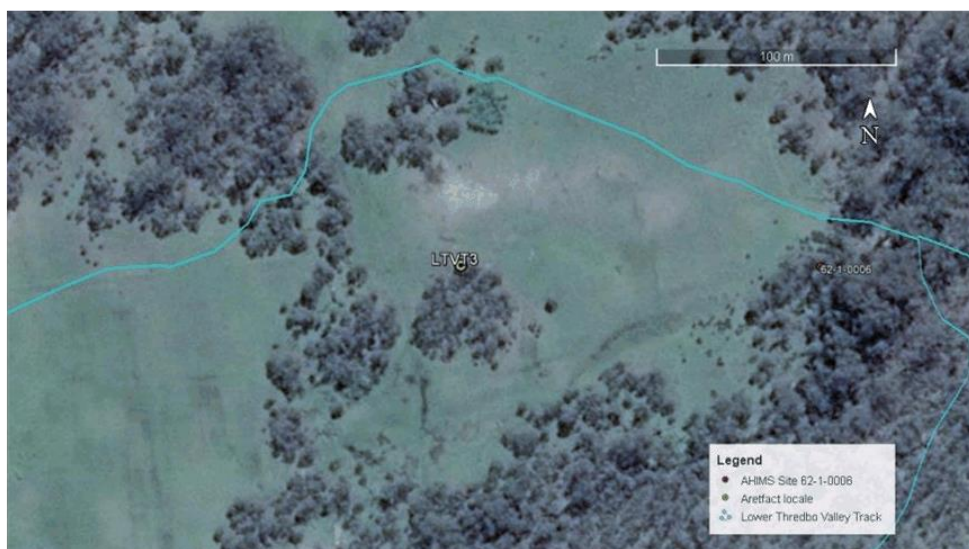
Figure 377: Location of site LTVT 3 in relation to proposed alignment (shown in blue).

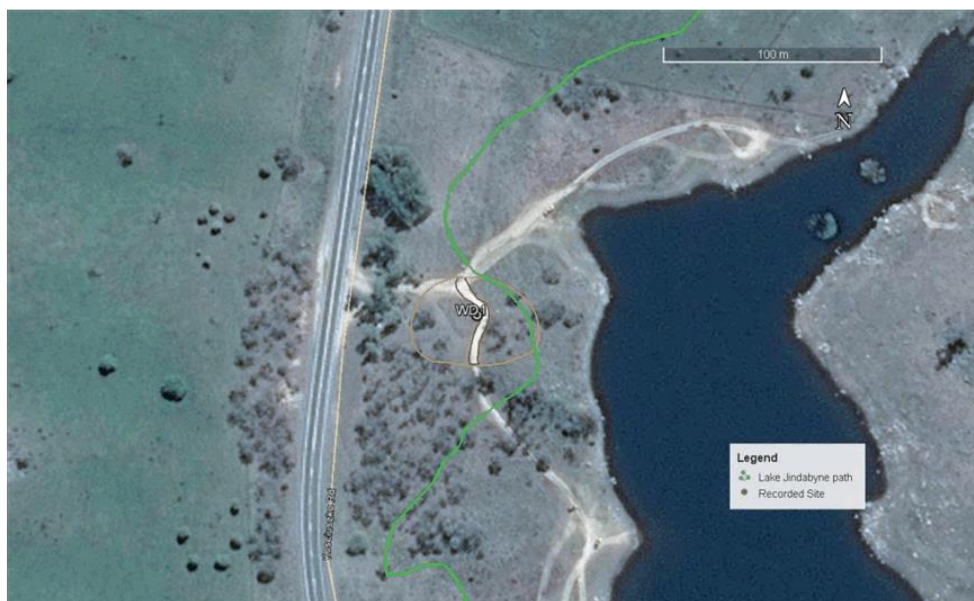
Figure 39: Visible extent of WOLLONDIBBY1 (in red) and estimated extent (orange) following the crest of the spur (approximate).

**Site WOLLONDIBBY1** was observed on an existing informal vehicle track adjacent to Lake Jindabyne and is likely to extend beyond the visible area each side of the road, along the ridgeline (Figure 39). The proposed path (green in Figure 39) goes to the east of the visible extent of WOLLONDIBBY1 and may impact on it. The extent of the site has been estimated as associated with crest and northerly sloping knoll spur.

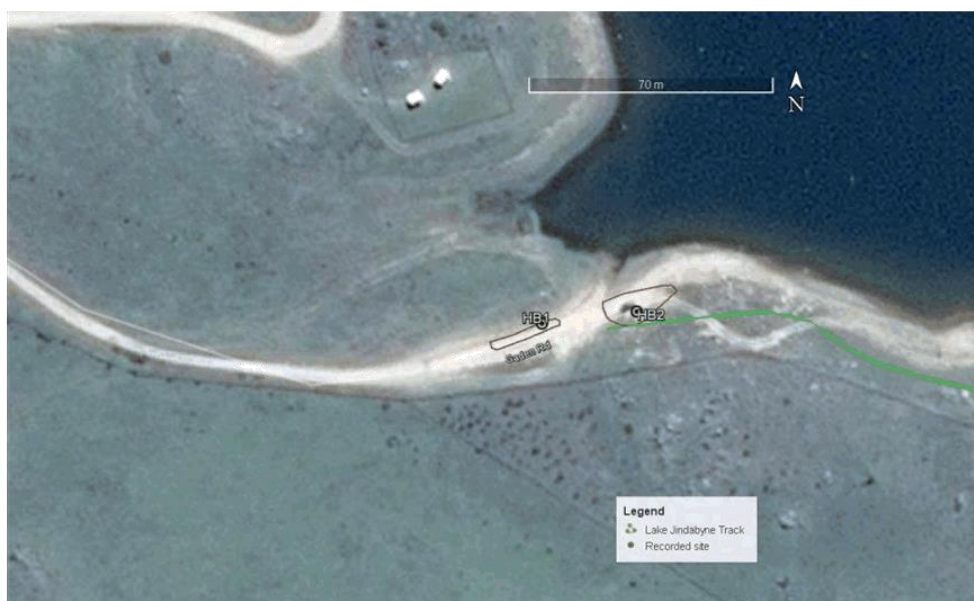
Figure 40: Possible extent of HATCHERY BAY2 and HATCHERY BAY1

**Site HATCHERY BAY2** extends along the Lake Jindabyne shoreline and up the slope and it likely to be larger than what was observed. Because the extent of this site cannot be reliably determined, it is possible that the proposed path will cause impact on the southern edge of the site as shown in Figure 40.

The estimated extent of site **HATCHERY BAY1**, a dispersed artefact scatter on and beside the existing informal vehicle road is also shown in Figure 40. This road may be closed to vehicles and rehabilitated, which will result in impact to HATCHERY BAY1.

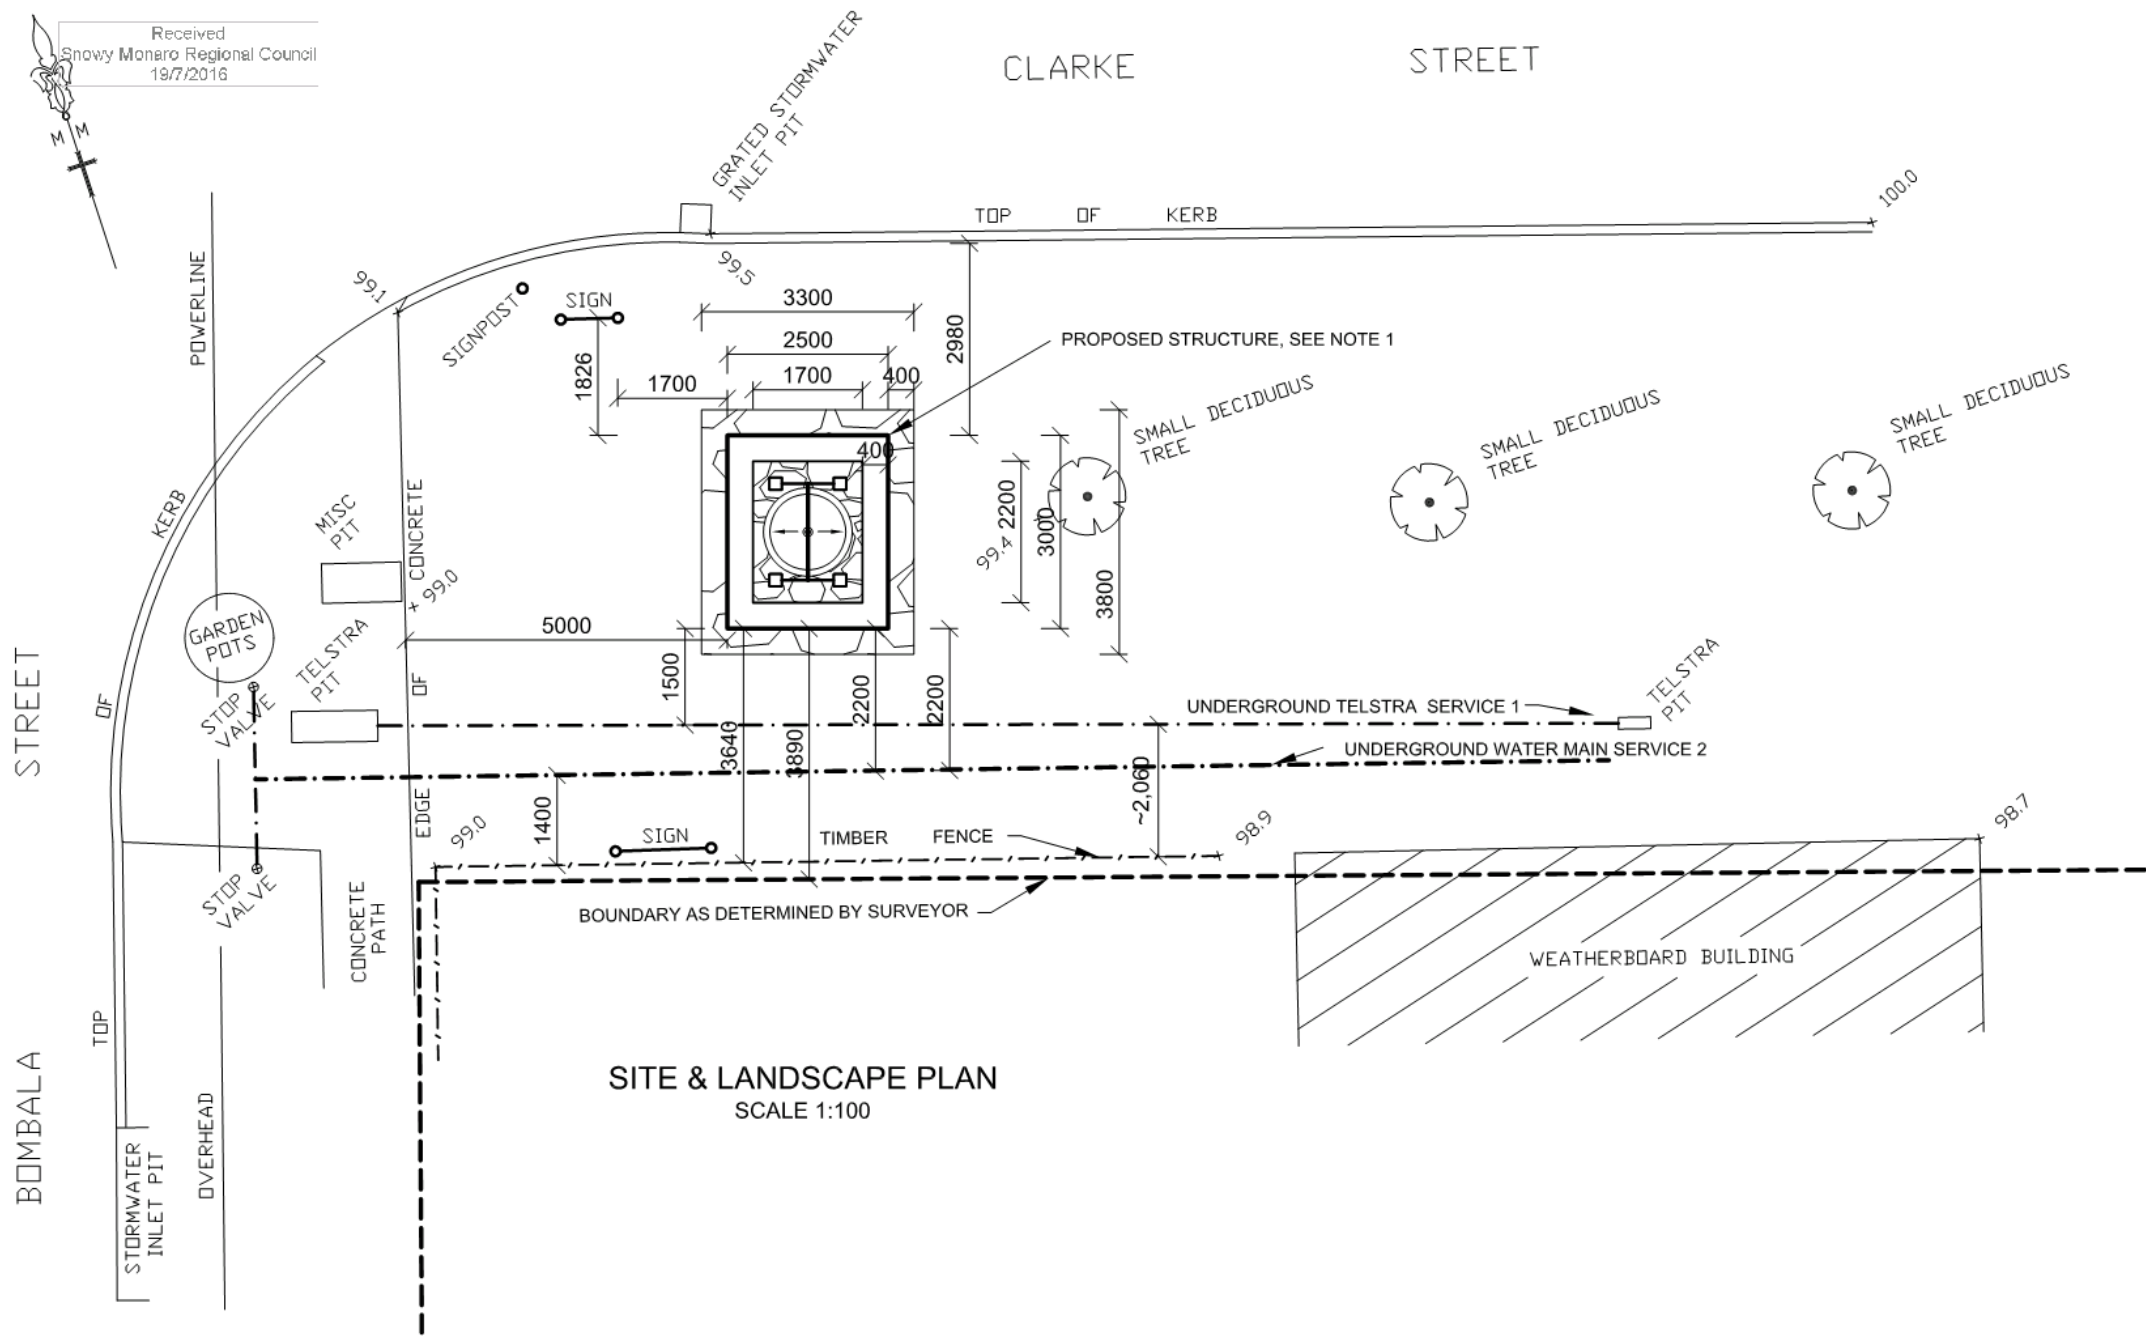
- NOTES:**
- 1. PROPOSED BELL SUPPORTING STRUCTURE - 2,500 WIDE x 3,000 LONG AND SURROUNDED BY A FURTHER 400mm ROCK PAVING PLINTH AT GROUND LEVEL.
  - 2. UNDERGROUND TELSTRA SERVICE 1 AS IDENTIFIED BY PETER CHAPPLE ON 29.06.2016. TWO TELSTRA SERVICES - MAIN AND OPTICAL FIBRE RUNNING THROUGH ONE 100 mm DIAMETER CONDUIT AT APPROXIMATELY 400 mm UNDER GROUND BETWEEN THE TWO PITS. PETER CHAPPLE OFFERED TELSTRA SERVICES THAT AT THE TIME OF SET OUT, HE WILL BE PRESENT TO CONFIRM THE LOCATION OF TELSTRA SERVICES. VERBAL INSTRUCTIONS FROM PETER CHAPPLE ARE TO KEEP THE EDGE OF THE MAIN STRUCTURE AT A MINIMUM 1,500mm DISTANCE.

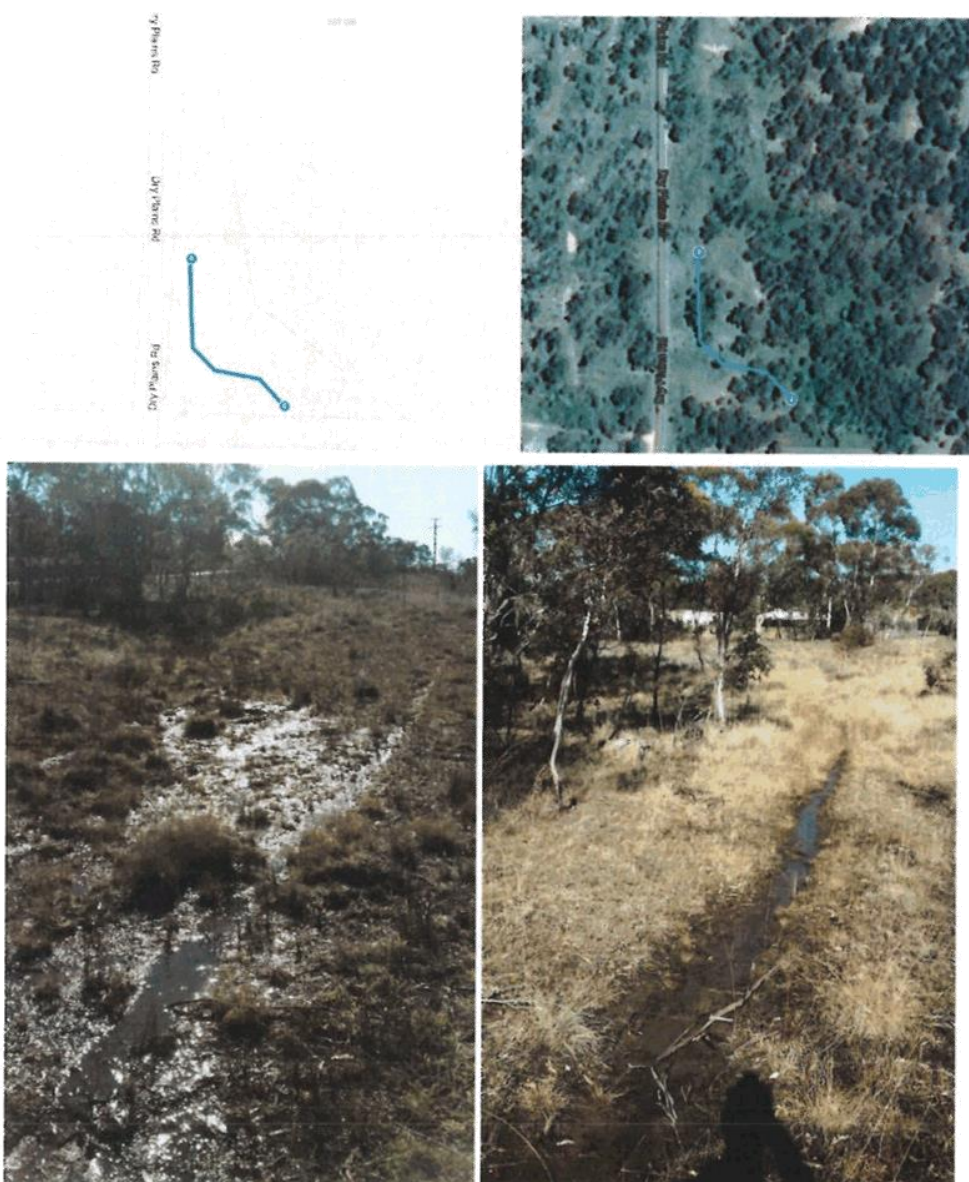
Looking North adjacent to power lines.

Looking South adjacent to power lines.
