**SNOWY MONARO**  
REGIONAL COUNCIL

**16.1 Integrated Property, WHS, Public Liability Risk Assessment & BCA/DDA  
Compliance Report for Council Offices, Council Depots and Hostels &  
Community Buildings.**

Integrated Property, WHS, Public Liability & BCA/DDA Report  
Snowy Monaro Council Offices

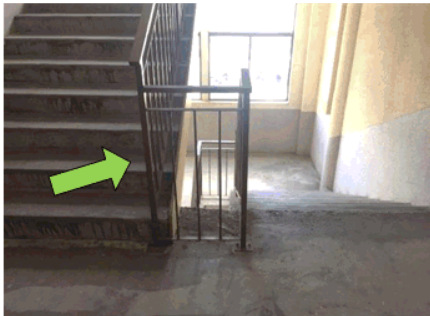
Stairs were installed with handrails	Emergency Response and Evacuation procedures

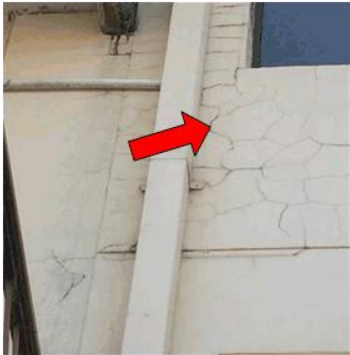
- Considerable cracking and likely spalling was noted on the building external wall which could result in falling concrete on Bombala Street.
- Residual current devices, RCDs (safety switches) are not provided.
- The last annual fire evacuation and fire warden training could not be confirmed.
- Electrical hazards were observed with exposed cabling and unsafe leads.
- Unsafe storage was noted on top of a compactus which can result in an impact injury.
- Storage was observed within fire stairs which is a statutory breach of regulations.
- The Basement area was dank due to water entry and indoor air quality needs to be investigated.
- A considerable amount of cash may be kept on site which poses a security risk.
- The training room was observed to have a number of electrical leads and a blow heater providing electrical, fire and trip hazards.

<p>Concrete exterior wall deterioration facing Bombala Street</p>	<p>Unsafe storage on top of compactus</p>

- Rectify electrical deficiencies noted above as a high priority.
- Upgrade the exterior wall facing Bombala Street with concrete cracking to prevent concrete spalling and possible injury to persons below.

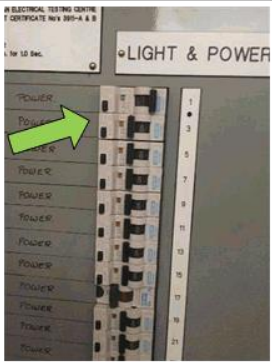
RCD safety switches provided	First Aid and Emergency procedures

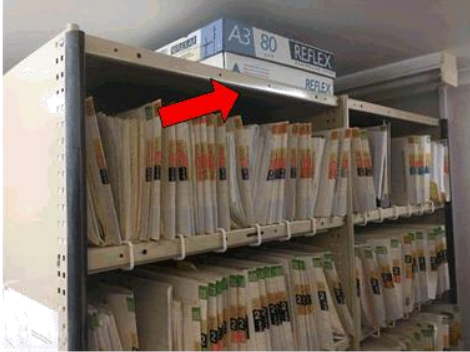
- Unsafe storage was noted on top of a compactus which can result in an impact injury.
- The HR switchboard should be provided with RCD safety switches.
- Emergency evacuation exercises and fire warden training is not provided annually.

Trip hazard in car park driveway	Unsafe storage on top of compactus

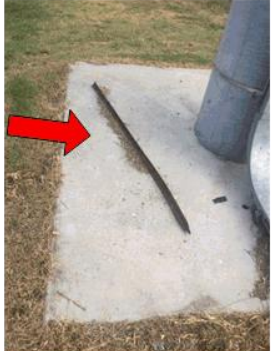
- The receptionist is isolated and has little security protection at the public counter.
- A number of trip hazards were noted in the car park area.
- A picket was left on the ground which could result in vandalism and is a trip hazard.

Picket left on the ground	Public access leaves receptionist vulnerable

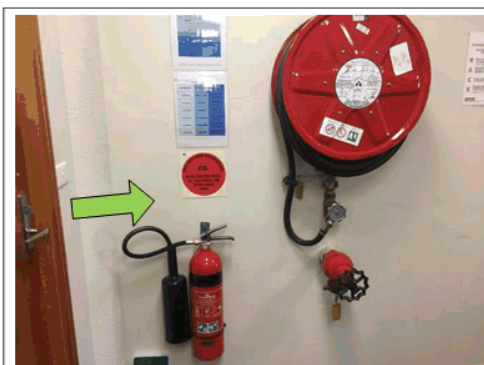
Fire-fighting equipment was located on each floor

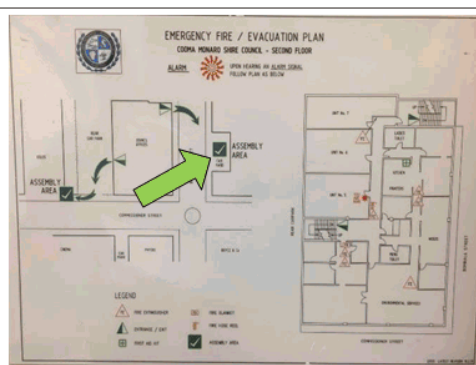
Emergency evacuation plans are provided on each floor

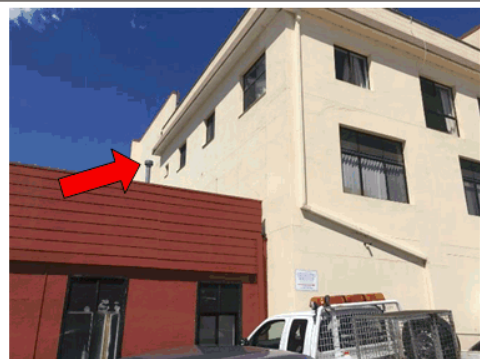
- The northern wall has unprotected openings from an external fire source exposure. Unprotected openings were also observed for cable and pipe penetrations.

Window openings in northern wall exposed to a fire source

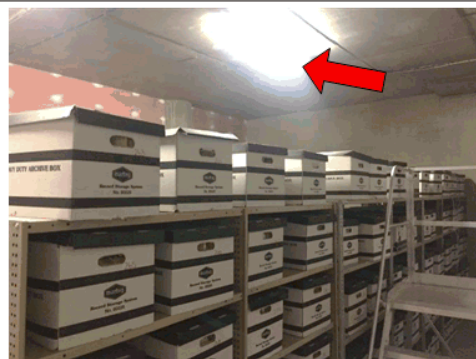
No smoke detection provided in basement archive storage rooms or Floor 2 units

- Fire protection should be upgraded with a smoke detection alarm system as per AS 1670 and BCA E2.2 Table 2.2a including connection to a main fire indicator panel and an automatic sound alarm system.

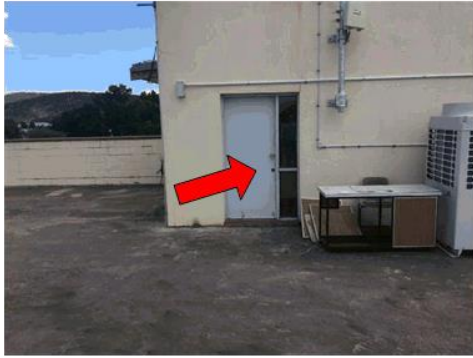
<p>Fire Exit Door on roof no illuminated Exit Sign, no safety door signage and non-compliant latch.</p>	<p>Fire Hydrant not located within fire isolated stairway. Extinguisher cabinet locked and MCP not connected.</p>

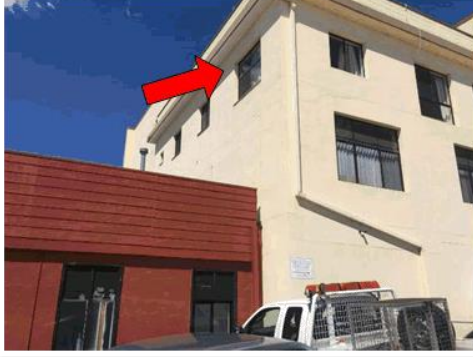
<p>External windows exposed to neighbouring fire source</p>	<p>Old style Directional Exit signs</p>

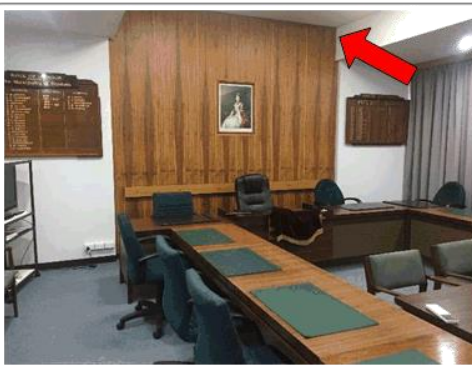
- A main fire indicating panel, MFIP and automatic fire sound alarm system is not provided.
- The smoke detection system does not comply with AS 1670 with inadequate smoke detectors provided.
- The last annual fire evacuation exercises and fire warden training could not be confirmed.
- Fire door signage is not provided and or needs to be upgraded.
- A number of illuminated fire exit were non-operational and additional illuminated Exit Signs are needed. In addition, the old-style 'Exit' signs should be upgraded for consistency with the current moving man type exit signs.

No fire alarm system is provided	Illuminated Fire Exit signs are not provided

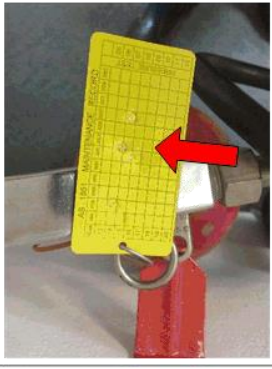
Last maintenance was provided in June 2016	No smoke detection provided in basement archive storage rooms or Floor 2 units

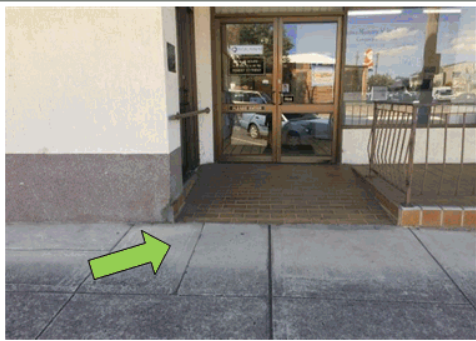
Ramp access to Council building for members of the public.	Disabled car parking space provided.

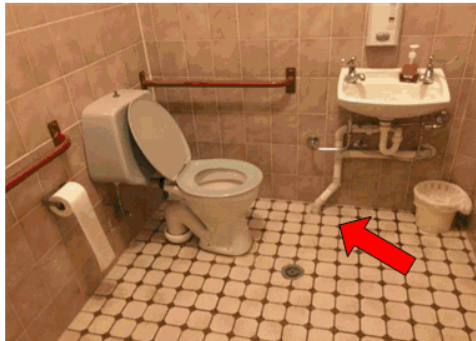
Current disabled toilet needs to be upgraded to comply with AS 1428.1.	No disabled access to Council Chambers and no TGSIs for step

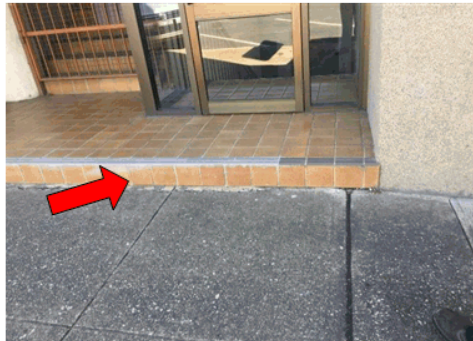
- Access is not available to the Council Chambers or to all floor levels including tender lodgement or town planning. A lift will be needed.
- Tactile Ground Surface Indicators, TGSIs are not provided.
- The accessible car parking space does not satisfy BCA 3.6 AS1428.
- The door entrance to the main building does not facilitate disabled access.
- Sanitation facilities for disabled access does not meet current standards and is not available on each floor.
- Ambulant disability sanitation facilities are not provided.
- Hearing augmentation it is not provided for the Council Chambers.

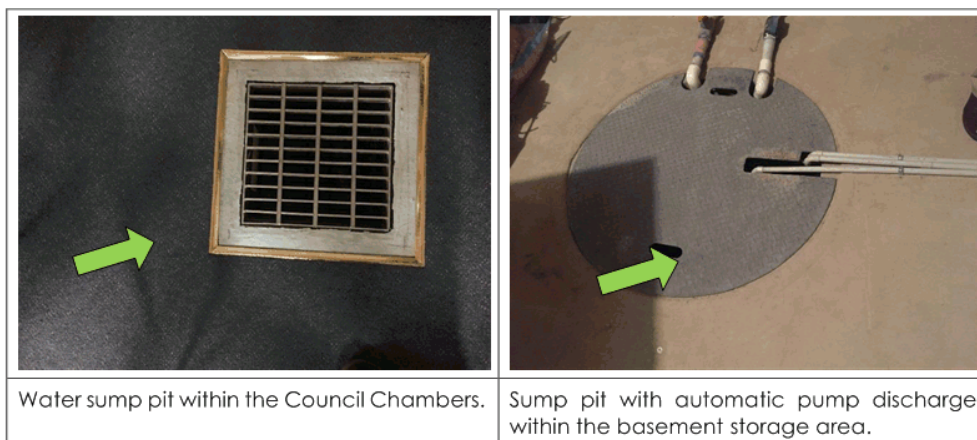
- A dank smell was noted in the basement storage areas.
- The Council Chambers are located in the basement level. A floor pit is located within the Council Chambers and RiskTech were advised that this is emptied by bucket on a routine monthly basis. There were signs of water damage within the Council Chambers.
- A sump pit which is automatically discharged by pump is located in the record storage area. A dank smell was evident.

- An indoor air quality assessment should be conducted for the building in particular for the council chambers and basement areas.

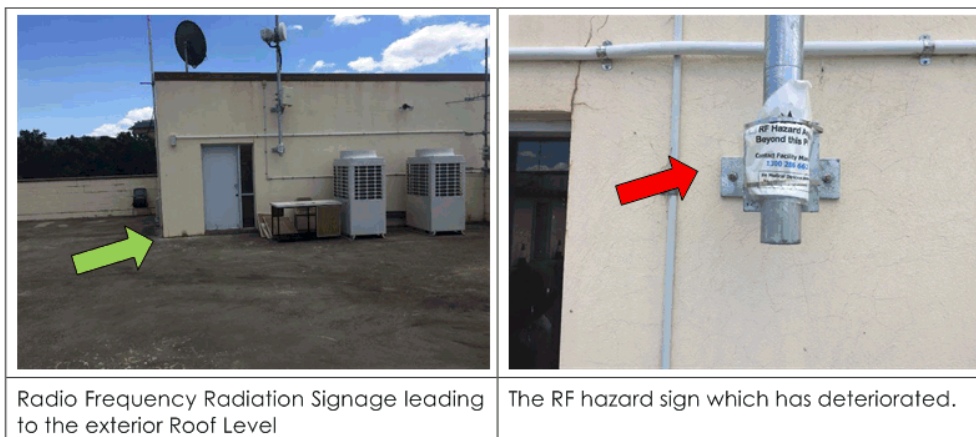
- The RF hazard sign has deteriorated.

- The RF hazard sign should be replaced with a permanent sign.

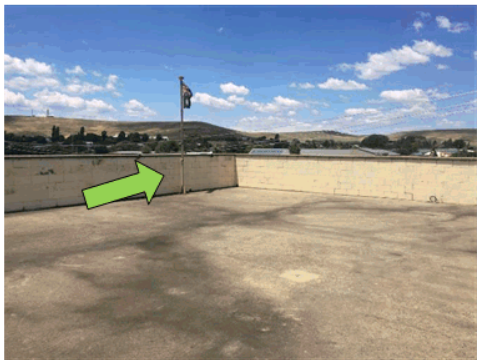
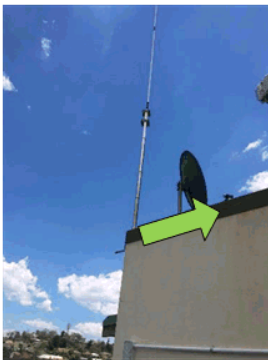
- Working at Heights / fall hazards have not been formally identified and assessed for the site. Occasional work at heights may be required for antenna maintenance.

Good barricade protection provided on the Roof Level	Anchor points with appropriate testing and tagging undertaken

- A risk assessment of the fall hazards on site should be conducted in accordance with Part 4.4 of the WHS Regulation 2011 (NSW) and with Managing the Risk of Falls at Workplaces: Code of Practice (WorkCover NSW, 2011). Ensure the Working at Heights/Fall Hazard Register is retained on site.
- Liaise with the contractors to ensure they are competent for working at heights and a roof access permit for maintenance activities involving working at height tasks performed on site such as antenna maintenance or window cleaning.

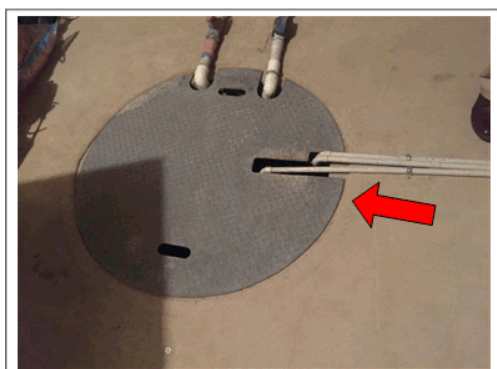
- Confined Spaces Register and associated Risk Assessments have not been developed for the site.
- The confined space (sump pit) is not appropriately labelled.
- The confined space was not secured.

Sump Pit on Basement Level

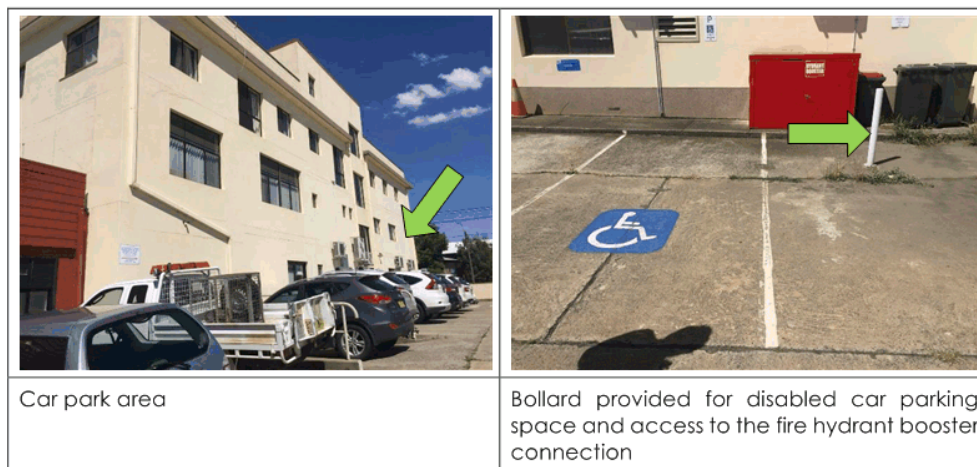
- No speed limit signage was present at the entrance to the site at the time of inspection.
- No speed humps were installed at the entrance and throughout the car park.
- No liability disclaimer was installed at the car park entry points.

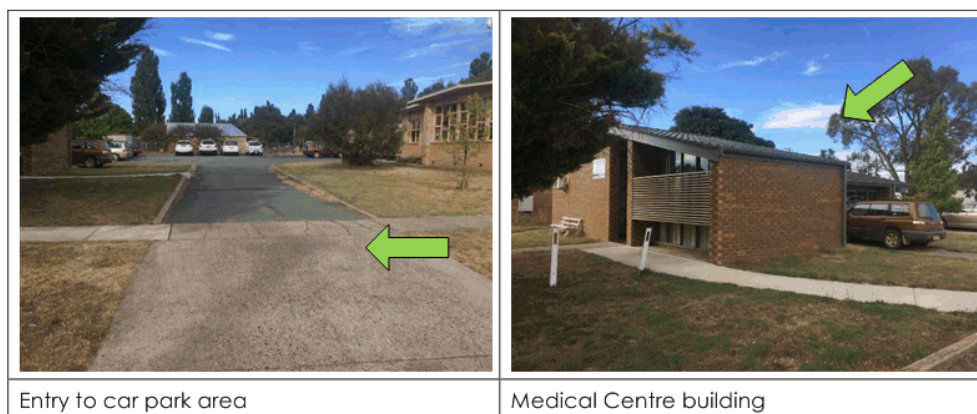
- No speed limit signage was present at the entrance to the site.
- No speed humps were installed at the entrance of the car park.
- No liability disclaimer was installed at the car park entry.

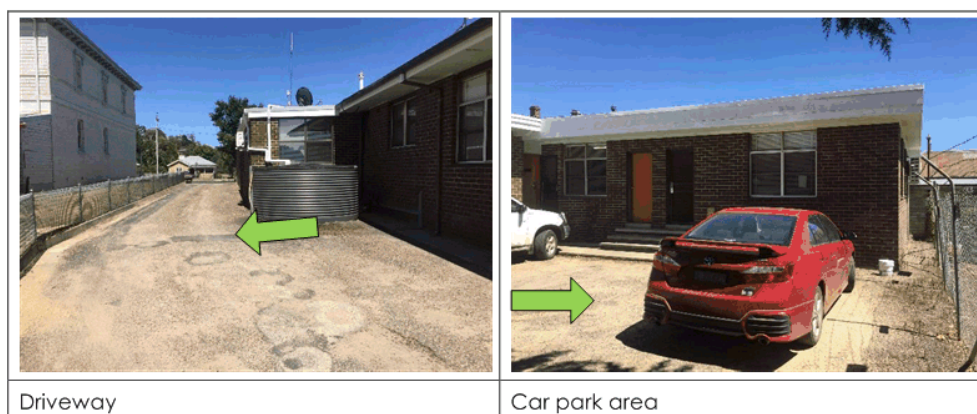
- No speed limit signage was present at the entrance to the site at the time of inspection.
- No speed humps were installed at the entrance and throughout the car park.
- No liability disclaimer was installed at the car park entry points.

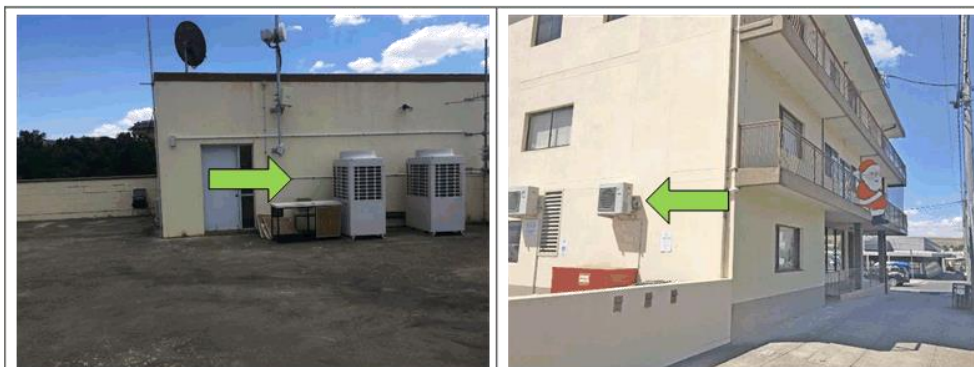
Cooma – Main air-conditioning units for floor 2 on the roof and typical split systems for the offices.

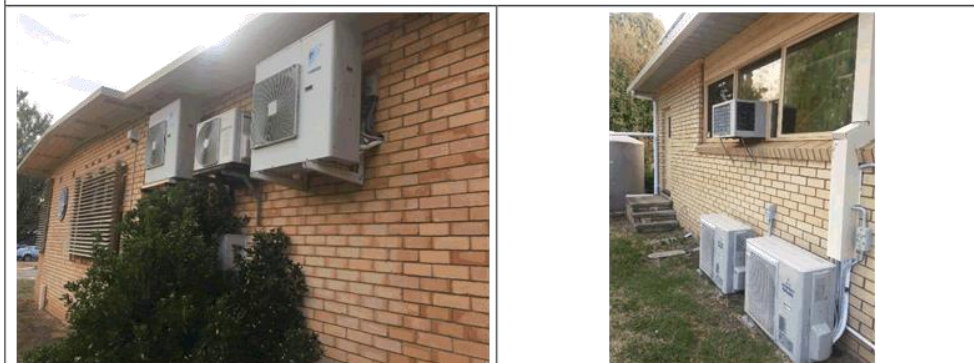
Berridale – Typical split system air conditioning units

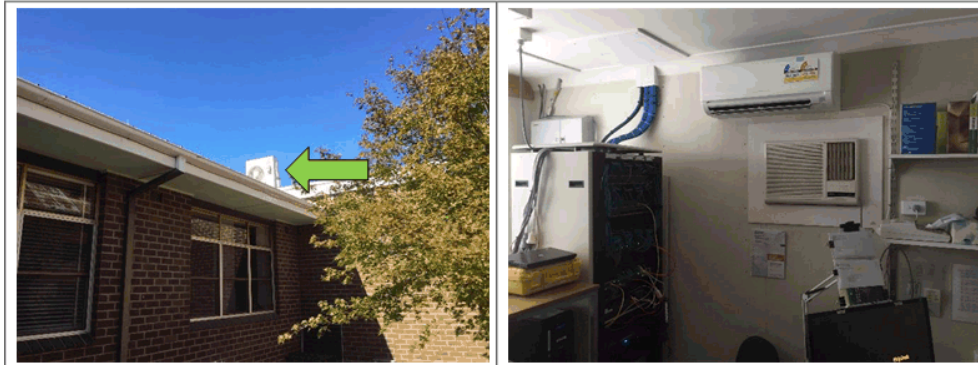
Bombala – Roof mounted split system air conditioning unit and dual units for server room.

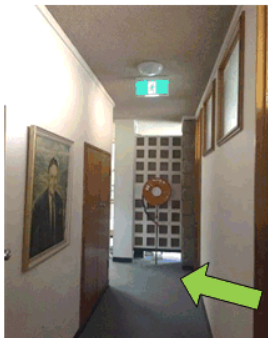
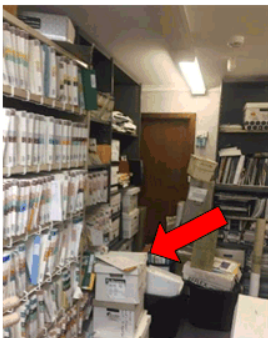
- The storage of ad hoc combustible materials noted within the electrical services and telecommunications room and poses a fire risk.

Egress routes kept clear	Untidy storage

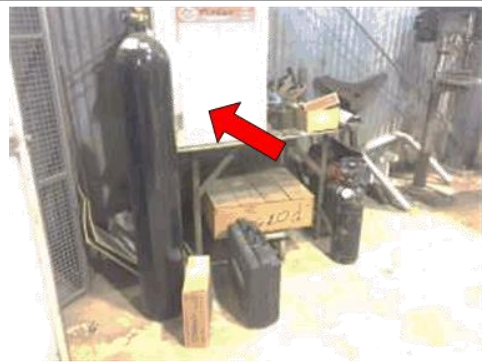
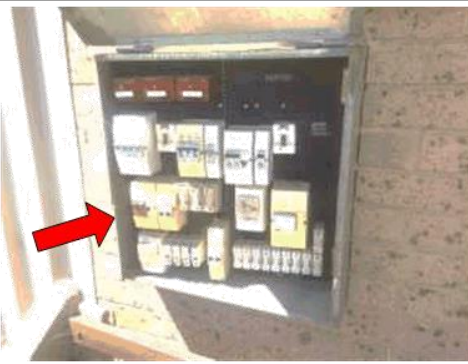
<p>Compressed gas cylinders not secured.</p>	<p>RCDs (safety switches) not provided</p>

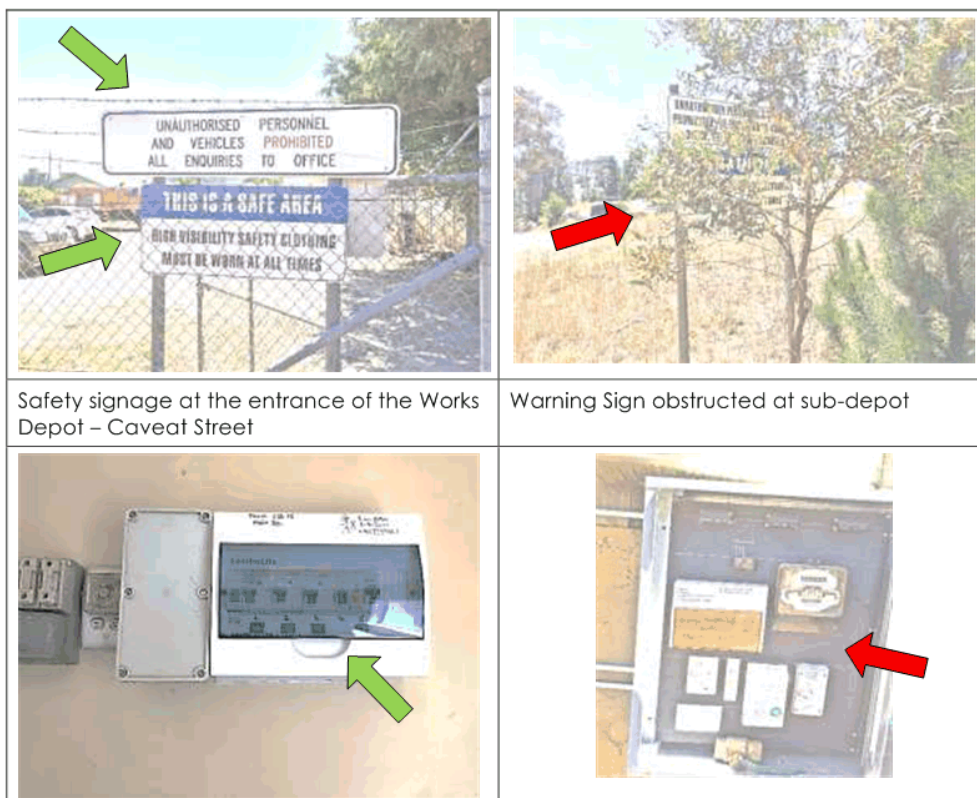
- Unsafe open wood fired heating is provided.
- Residual current devices, RCDs (safety switches) could not be confirmed at the sub-depot.
- The workshop building cannot be secured and the security fence is unsatisfactory.
- Used oil and solvent rags are not safely disposed of.
- Unsecured cylinders were noted which can become a dangerous missile if knocked over and the valve assembly is damaged.

Safety signage at the entrance of the Works Depot – Caveat Street

Warning Sign obstructed at sub-depot

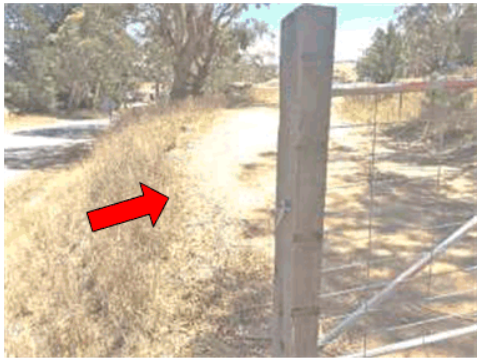
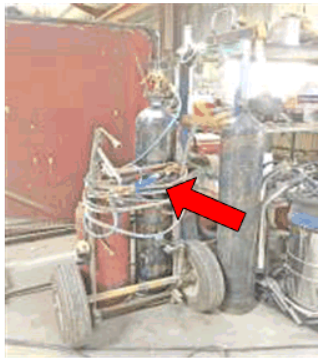
RCD Safety switches Caveat St	RCD Safety switches at sub-depot need to be confirmed

No fencing or barricade provided at sub-depot entrance driveway	Cylinders not secured

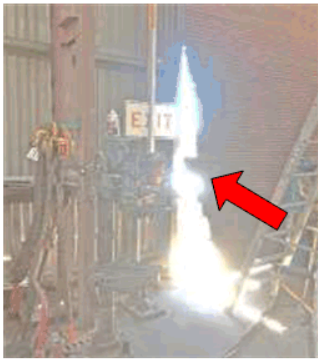
Broken roller door – Workshop Building	Old rags not safely disposed of

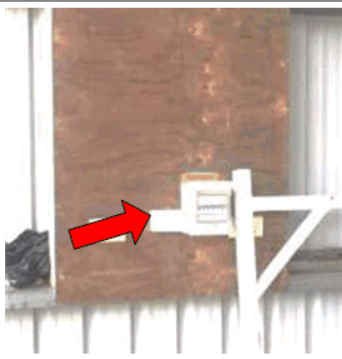
- Residual current devices, RCDs (safety switches) should be confirmed and storage against the switchboard should be prohibited.
- Overgrowth providing a fire hazard to external storage was noted.

Overgrowth provides a fire hazard to external storage	Small switchboard with unsafe storage. RCDs should be confirmed.

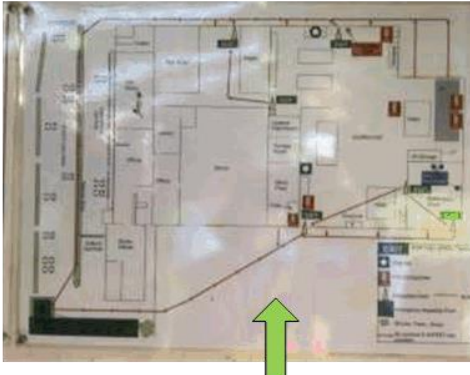
<p>Fire extinguishers are provided</p>	<p>Emergency evacuation plans are provided</p>

<p>Main Building Complex – no mandatory hydrant system provided</p>	<p>Additional fire extinguishers and hose reels are needed to protect all storage areas and buildings.</p>

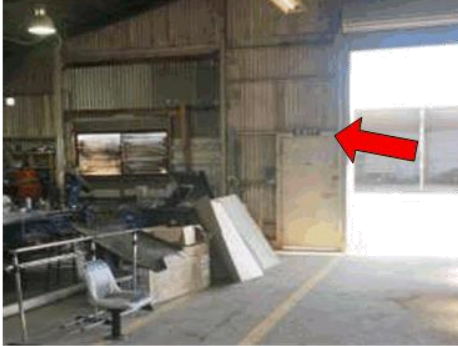
<p>Fire extinguisher maintenance tag out of date</p>	<p>No illuminated fire exit sign is provided for the vehicle workshop and the fire exit door is non-compliant.</p>

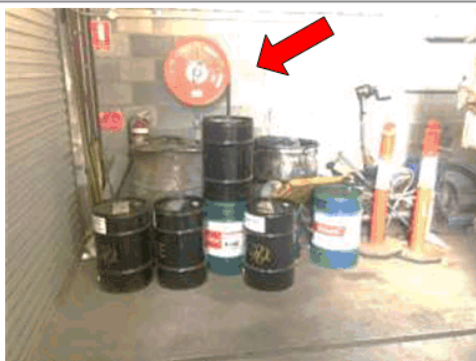
<p>Workshop – Fire hose reel and extinguisher obstructed.</p>	<p>Fire Hose reel obstructed</p>

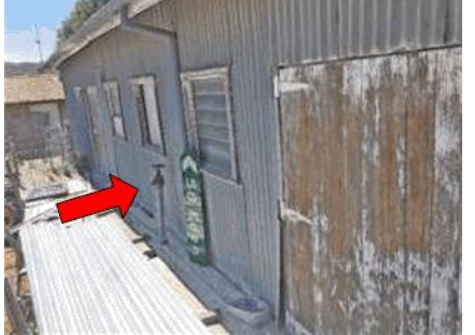
<p>Fire hydrant system upgrade and improved maintenance needed</p>	<p>Required fire exit needs to be upgraded and an illuminated fire exit sign provided for the stores building .</p>

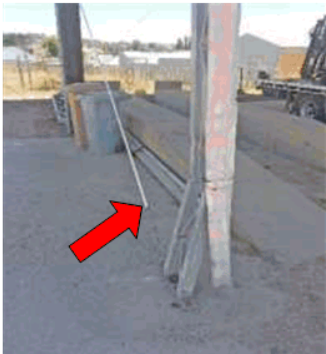
<p>Damage to Wash Bay Column.</p>	<p>Car park area is not sealed and car park spaces are not marked out.</p>

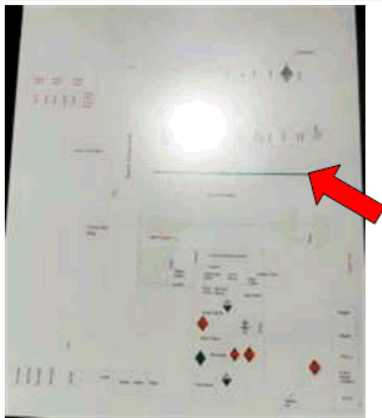
<p>Approved flammable liquid cabinets should be provided for small quantities of dangerous goods.</p>	<p>The emergency information diagram located at the main entrance has faded and needs replacement.</p>

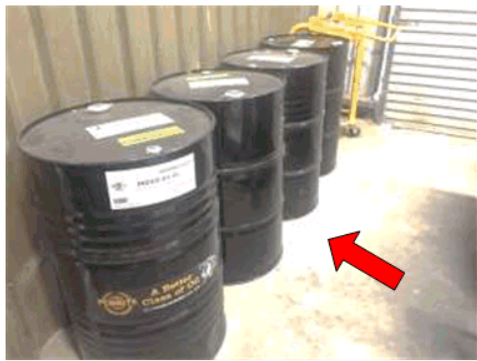
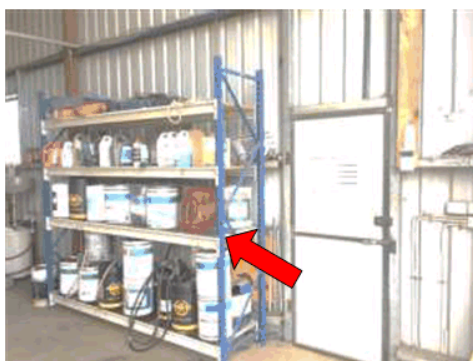
Additional secondary containment such as bund pallets are needed.	Additional secondary containment such as approved flammable liquid cabinets or bund pallets are needed for the workshop

- Secondary containment should be provided for all hazardous chemicals or dangerous goods.
- Small quantities of dangerous goods should be stored within approved flammable liquid cabinets.

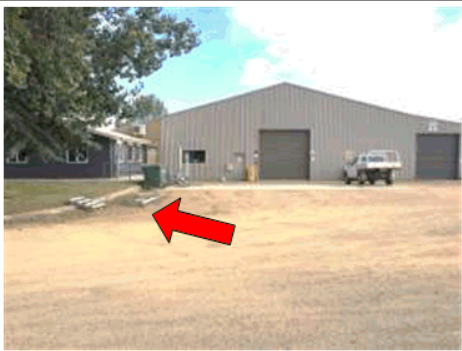
- Trip hazards were noted in front of the Stores and Office Buildings.
- Redundant equipment storage and storage close to the fence line was noted.

Neat Yard Storage	Trip hazards

- Trip hazards such as old pallets and pipes should be promptly removed or stored correctly.
- Redundant equipment storage should be removed and storage should not be located against the fence.

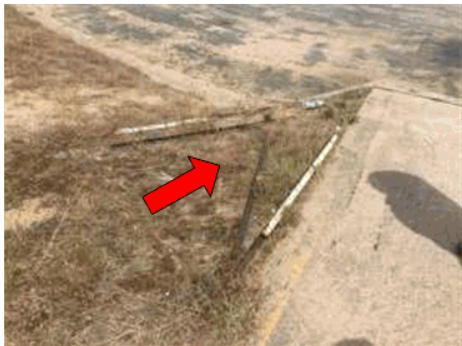
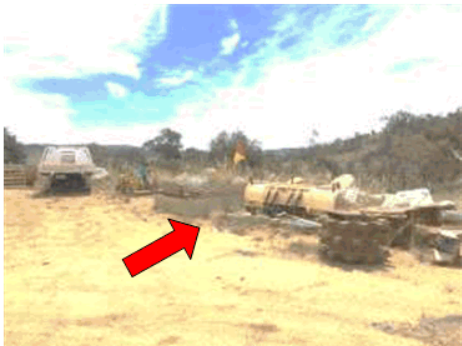
- Trip hazards were noted in front in the yard area.
- Redundant equipment storage was noted.

Trip Hazards with Star pickets left on the ground	Redundant waste storage

- Trip hazards such as star pickets should be promptly removed or stored correctly.
- Redundant equipment storage should be removed.

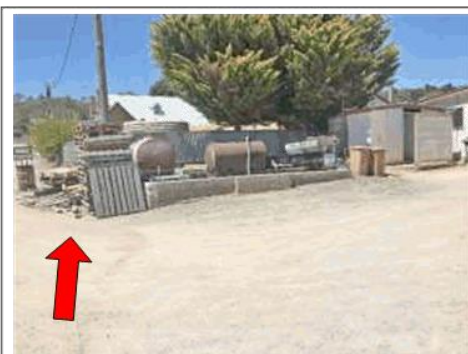
- Trip hazards with old broken pallets used as fuel for an open wood fire adjacent to the waste oil storage area represent trip hazards, and a fire risk to the waste oil storage area.
- Idle pallets should not be stored close to a hazardous area or buildings.
- Old drum storage was noted at the main depot and sub-depot.
- The disused 1,000L bulk emulsion containers should be disposed of.

Old pallets used for open fire should represent a trip hazard and fire exposure to the waste oil storage area.

- Trip hazards such as old pallets should be promptly removed.
- Old disused drums should be safely disposed of for the main and sub-depot.
- Storage should be kept clear around hazardous materials.

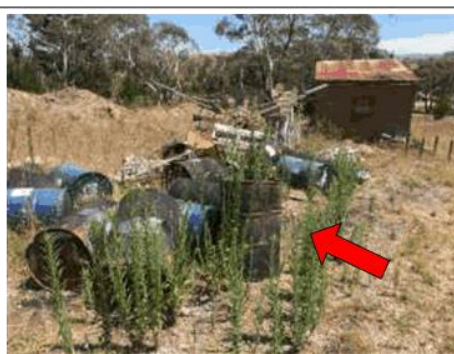
Old drums at sub-depot

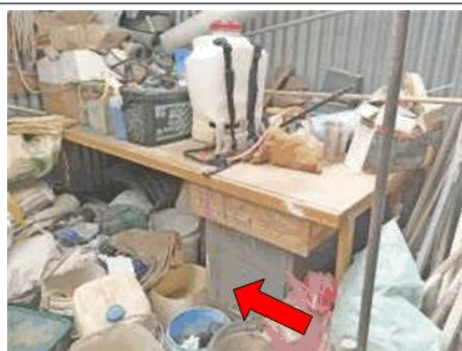
Poor housekeeping surrounding hazardous chemicals

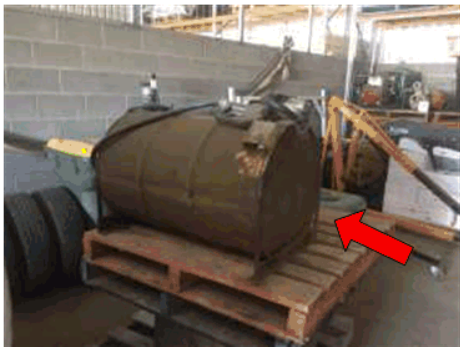
- Refuelling of mobile equipment using a small tank of about 1,000 L capacity is considered unsafe.

Bulk diesel and unleaded petrol bowsers	Bulk fuel tank used for refuelling on site equipment

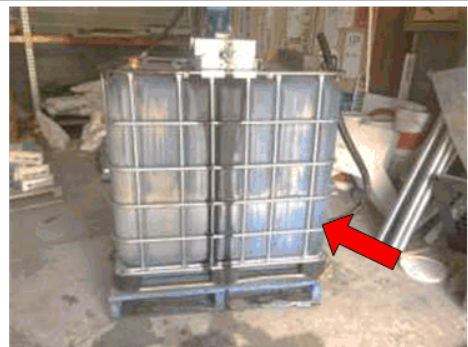
- Secondary containment is not provided for the roadworks bulk container.

Road works - bulk emulsion tank with no secondary containment

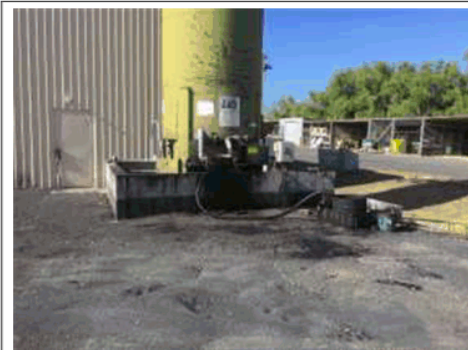
- Roll bunds to contain possible emulsion spillage are not provided.
- Spill kits could be better distributed for this large site.

Secondary containment is recommended for emulsion loading

Rec. No.	Section/Element	Recommendation/Action	Estimated Cost	Photograph
2017-22	3.16 – Environmental Management	Roll bunds to help avoid possible soil contamination are not provided for the emulsion filling area	\$5,000	
2017-23	3.1 – Safety and Public Liability	Used oil and solvent rags should be safely disposed of in metal containers with tight fitting lids.	\$2,000

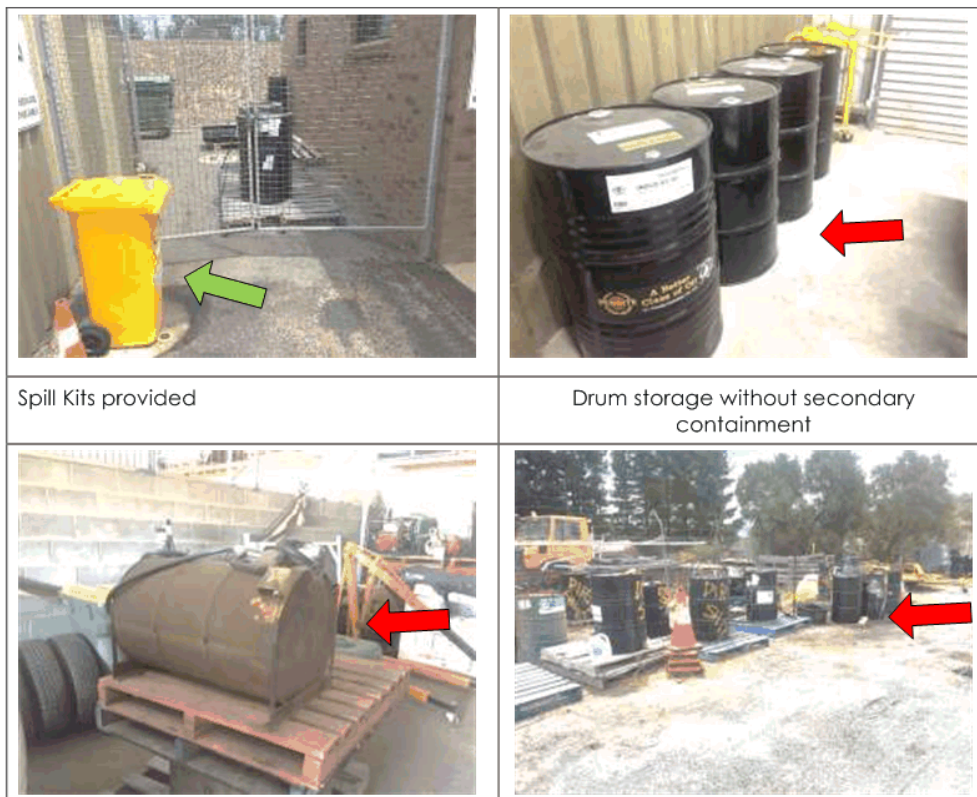
- Secondary containment for drum storage of oil fuel is inadequate.
- Refuelling of mobile plant represents a major environmental pollution risk.
- The yard storage of drums is not provided with secondary containment and evidence of soil pollution was noted.
- Empty oil drums are stored behind the workshop.

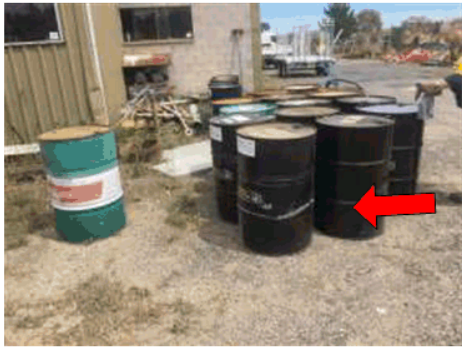
Refuelling equipment using the portable tank could result in severe pollution. Here are all	External drums without secondary containment and evidence of soil contamination.

Empty oil drums stored behind the workshop	Oil storage in the workshop without secondary containment

Rec. No.	Section/Element	Recommendation/Action	Estimated Cost	Photograph
2017-22	3.16 – Environmental Management	All empty oil/fuel drums should be promptly removed from the site.

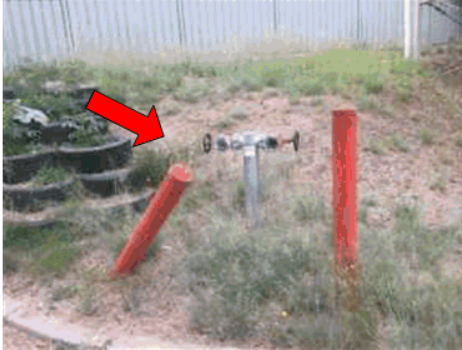
<p>Fire blanket in kitchen</p>	<p>Fire hydrant flow testing need and bollard should be repaired.</p>

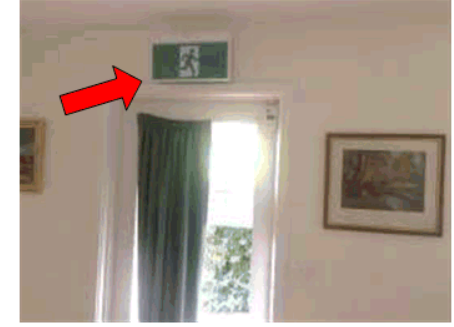
<p>Fire Exit Light not operational – House 2</p>	<p>Obstruction to Administration Building fire exit door.</p>

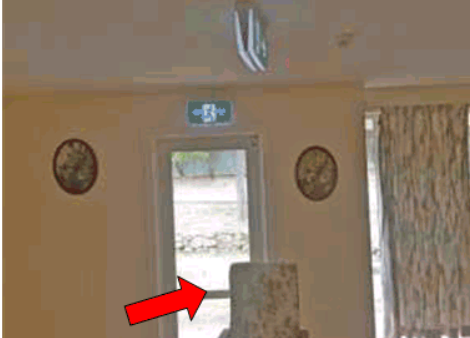
<p>Obstruction to House 3 Building fire exit door.</p>	<p>Fire hydrant booster connection – no non return check valve.</p>

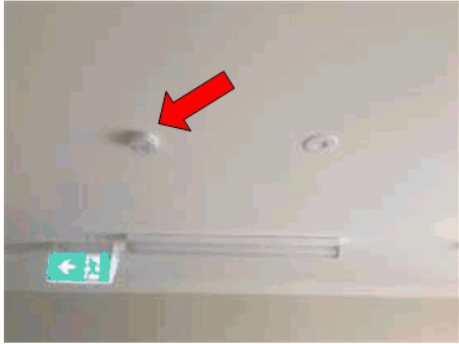
Fire hose reel	Domestic type smoke detector. Full coverage is not provided.

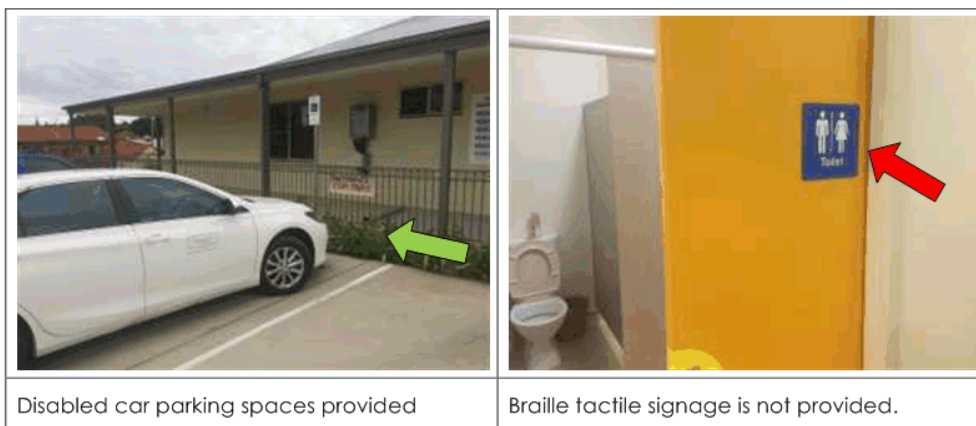
Braille tactile signage is not provided.

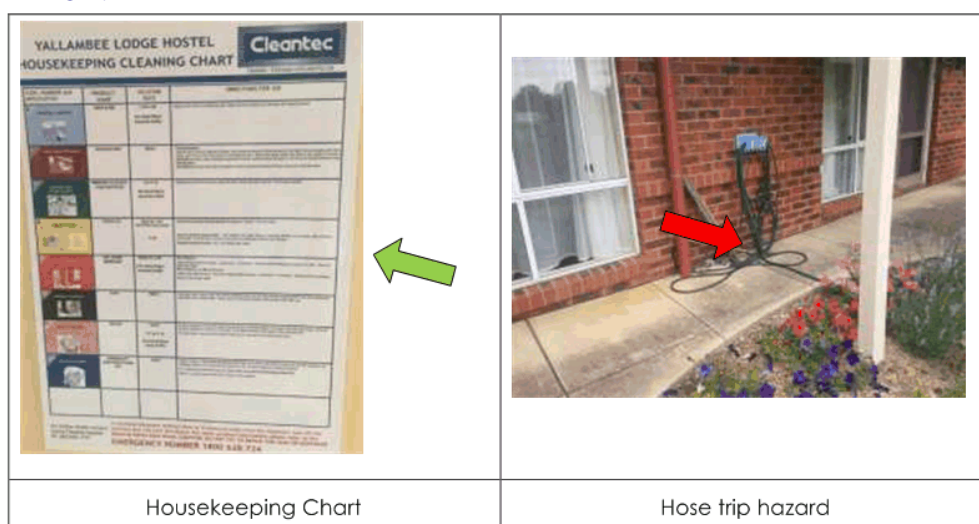
- A minor trip hazard was noted with a garden hose not safely stored away.

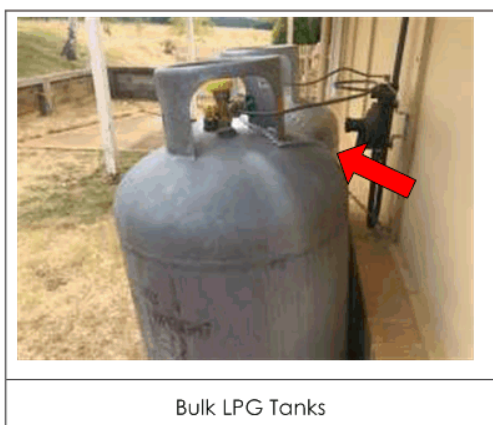
Bulk LPG Tanks

- The bulk 215kg LPG cylinders do not appear to be adequately secured or very stable.

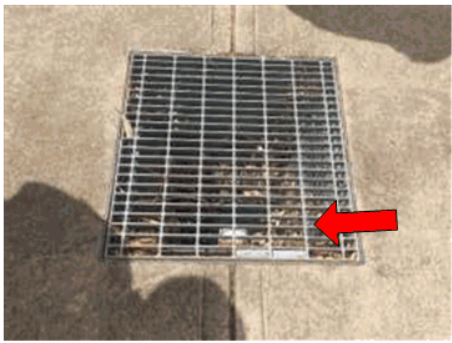
- Stormwater drains were noted to be blocked with leaves.

Water collection tanks	Stormwater blocked with leaves

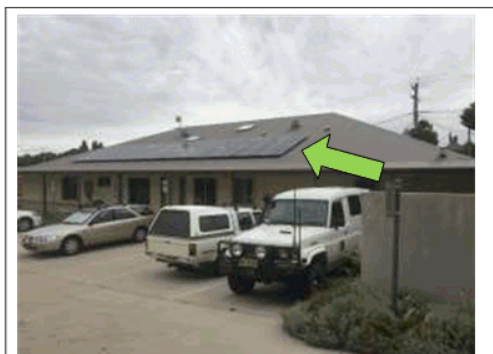
Solar panels provided
