SNOWY MONARO
REGIONAL COUNCIL

**ATTACHMENTS TO REPORTS
FOR
ORDINARY COUNCIL MEETING
THURSDAY 14 DECEMBER 2017**

Bombala Main Street Overview

Prepared by Pip Giovanelli for Snowy-Monaro Regional Council
December 2016

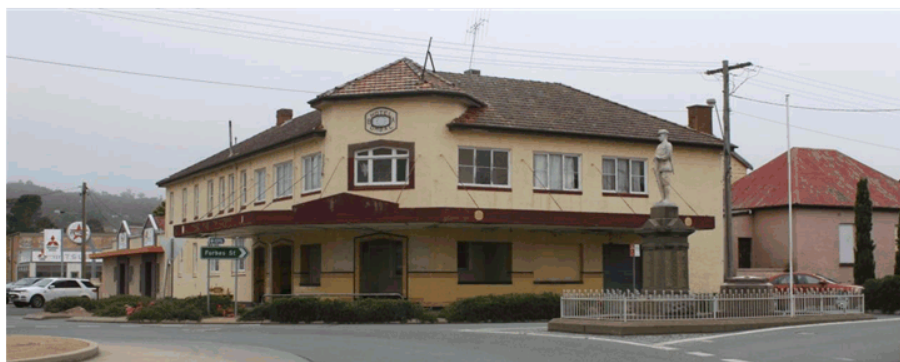
The corner building occupies a commanding position and has great potential to make a major contribution to the streetscape and would respond well to cleaning and painting. The rear building should be conserved and possibly adapted with input from council's heritage advisor.

The Bombala Hotel addresses the intersection

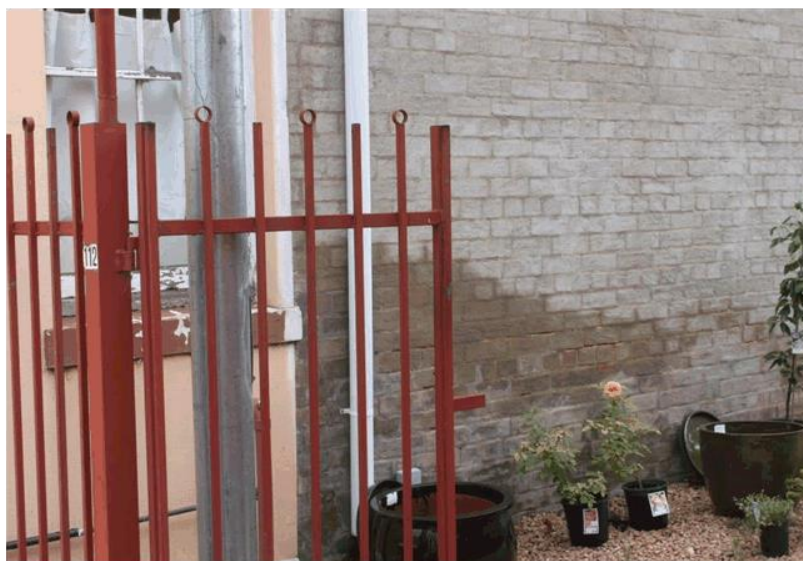
The building is in fair condition but in need of paint. A damp patch on the side wall is damaging the brickwork.

Damp problem on side wall. Note also the period winhdow

Refresh with paint,
Improve windows and make doors more attractive,
Correct damp problem on side wall.

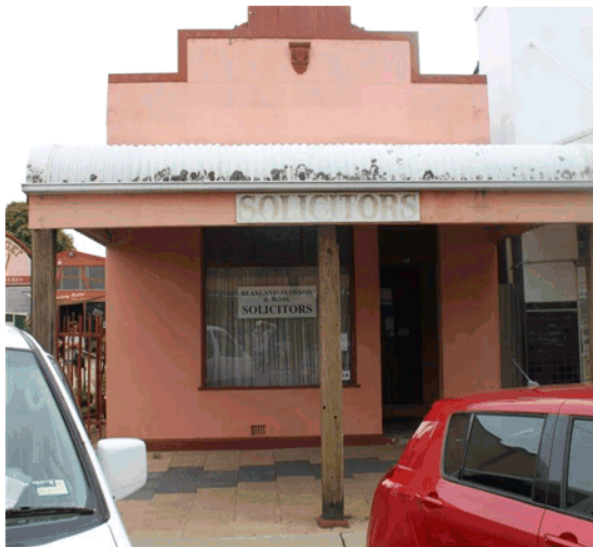
Front elevation

Condition is generally good although painting needs to be cleaned or refreshed. The verandah awning is relatively new and may have replaced a previous structure – need to check historic photos. There is some rising damp on the wall facing the garden centre. The exposed brick wall is very attractive and should not be bagged, rendered or painted.

Repaint loose and flaking paint on front elevation,

Refresh the 'solicitor' sign,

Timber posts could be painted

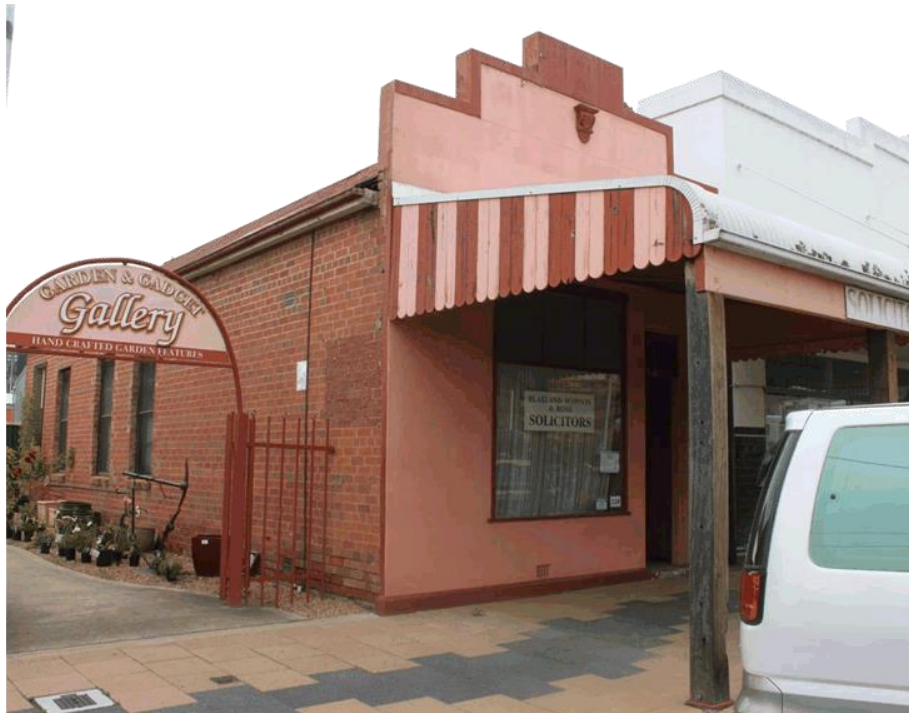
Note damp at lower portion of wall

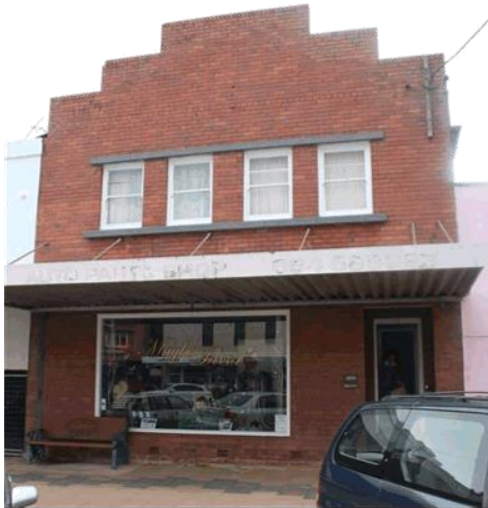
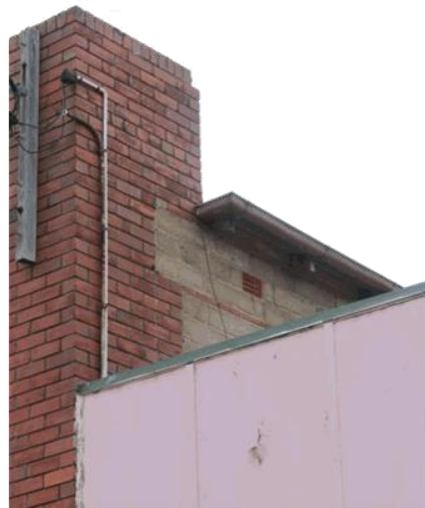
Condition seems to be good and integrity high

Note cement bricks on side wall

Repaint awning and parapet windows. Gently clean efflorescence from bricks below the damp proof course. Consider adding lights to the underside of awning to project light back onto the brick wall and door.

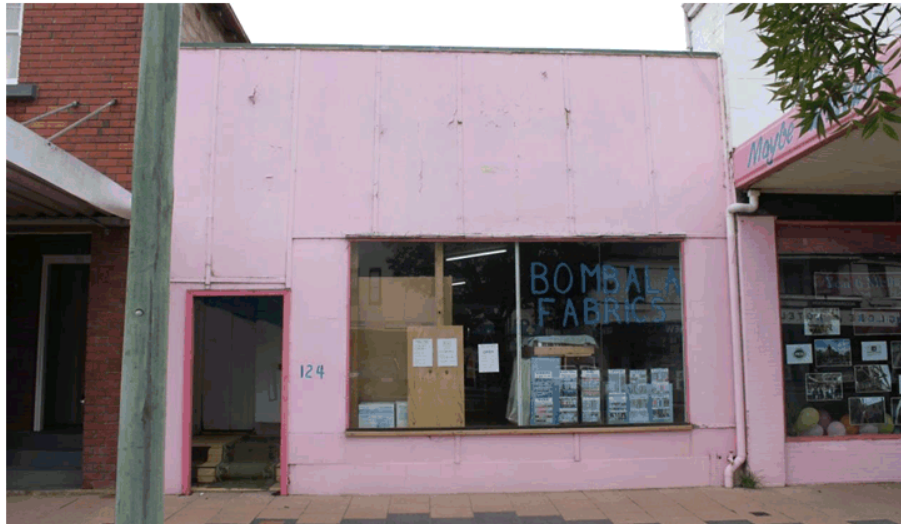
The façade is in poor condition with poor flashing above the windows and peeling paint over the whole surface. It would be interesting to look at historic photos to see if there was a previous building on this site, or even if it still exists behind the current wall.

At a minimum the façade should be painted and architraves added to the window and door. A small awning could also improve appearance.

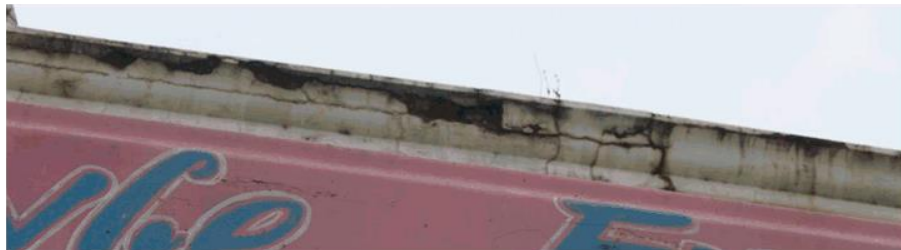
This potentially attractive front elevation needs work. The renderings are in poor condition and need cement patch repair, the underside of the awning is sagging and the window surrounds need restorations

Repair rendering

Repair renderings on parapet, repair upper and lower sides of the awning, strip paint off decorative tiles and window mullions and repaint walls to a more sympathetic colour scheme.

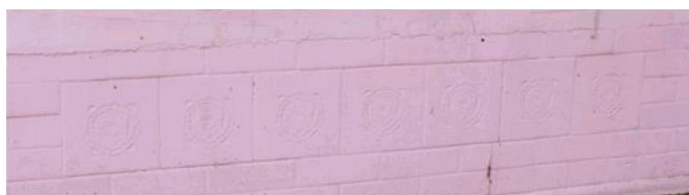
Strip paint off decorative tiles and repaint elsewhere

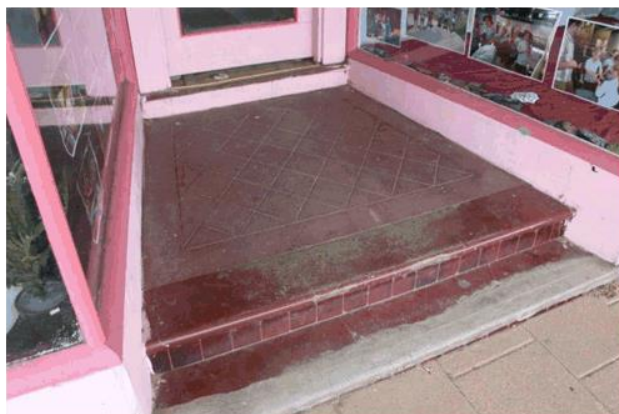
Strip or repaint window mullions and make good to entry

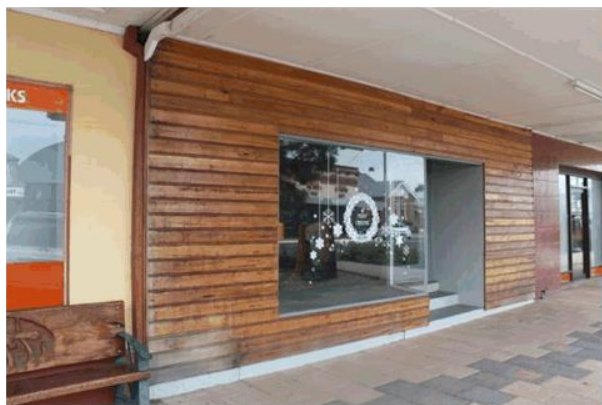
Note staining adjacent to downpipe

Awning signage to fit within the edges of the awning,
Check awning roof and downpipes for leaks,
Make good to stains on the timber panelling,
Check to see if the original shopfront lies buried beneath the timber,
Upgrade the under-awning lighting.

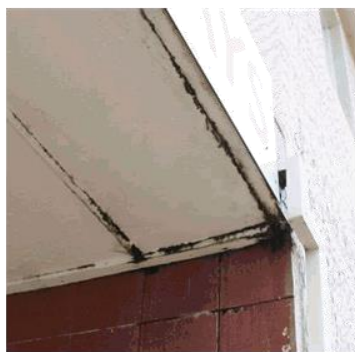
The awning and downpipes are leaking badly and need attention, and the eaves lining is decaying and coming away from the building.

Leaking awning

Repair leaking awning and downpipes,
repair decaying eaves and
refresh the paintwork as appropriate.

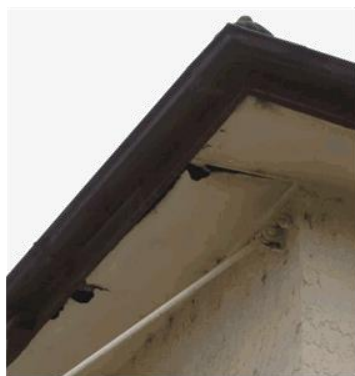
Deteriorating eaves

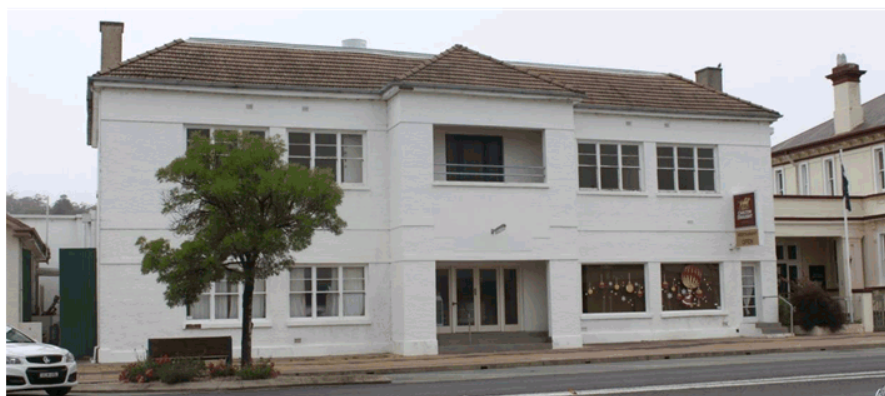
Condition is generally good although on close inspection repairs are required to rendering and soffits, and repainting needed to windows.

Lost rendering

Undertake minor repairs and painting
Upgrade entry light over central door
Research its history

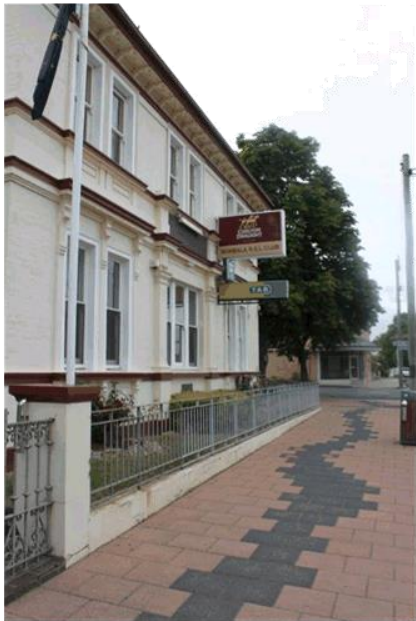
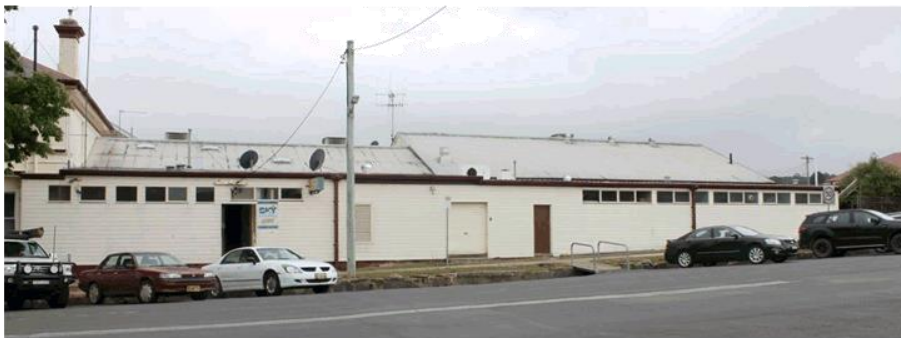
Condition is generally good although some hairline cracks can be seen in the wall, as can some structural plates. It would be interesting to see photos of the original corner details

Review the original corner details and investigate possibility of restoration.

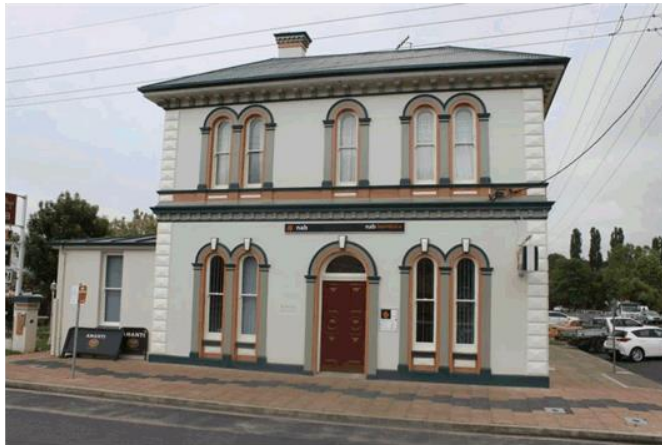
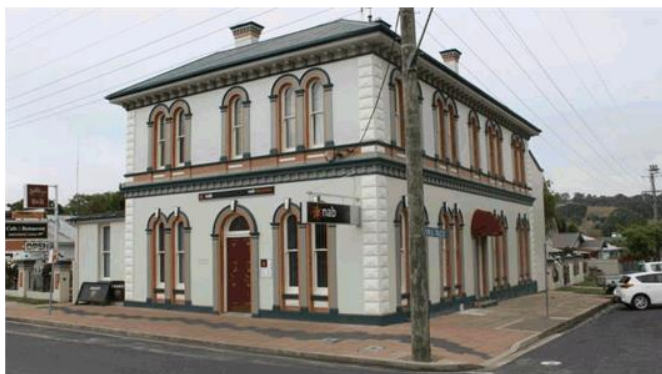
NAB bank – east elevation

The building appears to be in excellent condition, the exterior fully restored and sympathetically painted. Integrity appears to be very high.

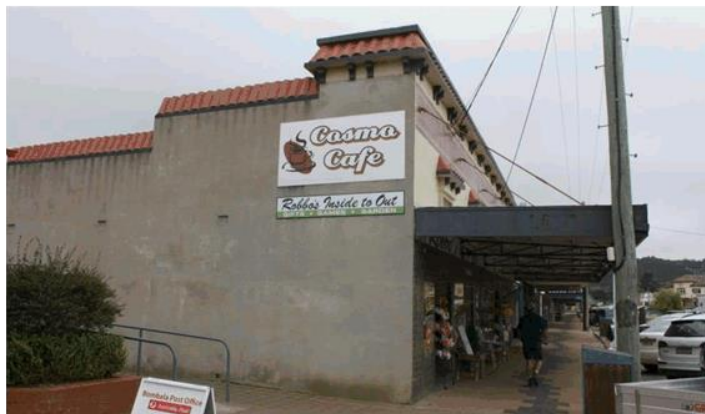
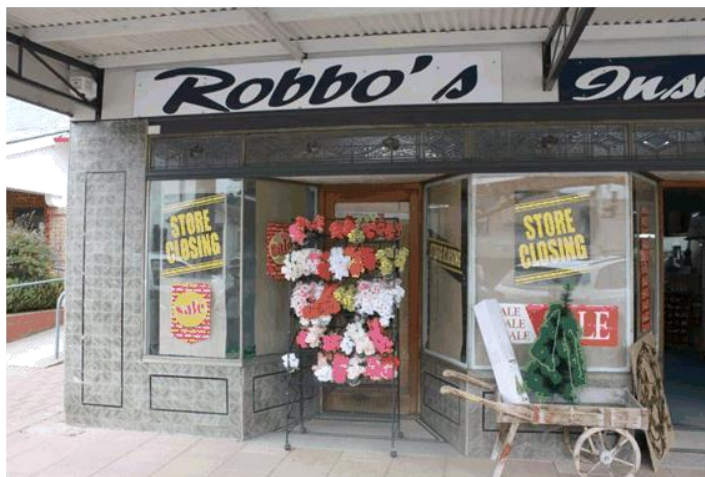
Condition is generally good and most of the Robbo's shopfront has exceptional integrity. The right-hand entry adjacent to Cosmo Café has been modified and repaired in brick and new materials and unfortunately has lost integrity in part. Over all the excellent condition of wall tiles, shopfront glazing, rebated entry, original doors and decorative glazing combine to give a very good example of Inter War shopfront design.

The main opportunity is to restore the modified doorway to original condition.

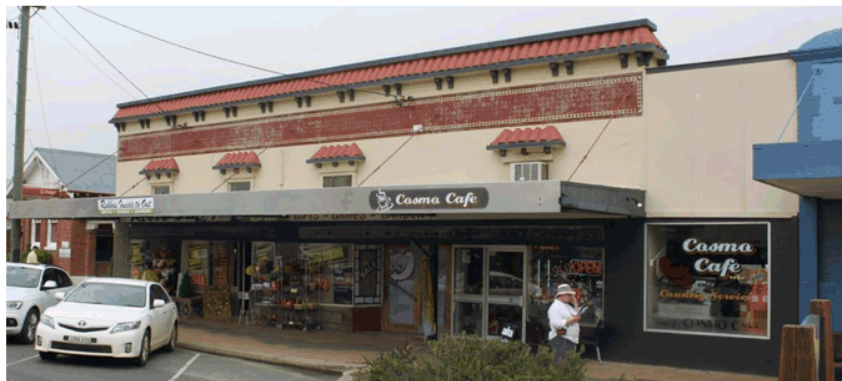
Condition is good however as noted above there has been modification to the shopfront. Note that there is what appears to be efflorescence to the wall tiles below the parapet

Note efflorescence on tiles on upper parapet

The modifications to the historic shopfront provide an opportunity to reinstate the larger building's historic character.

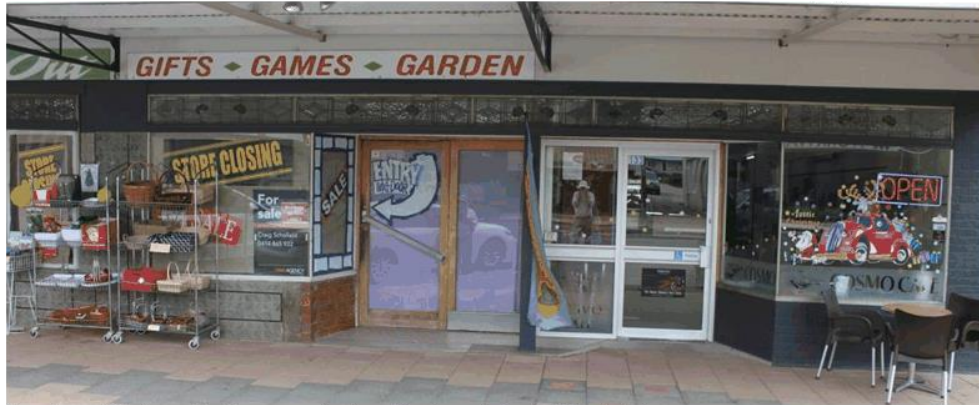
Note the modification to the doorways and painted tiles beneath the right hand window.

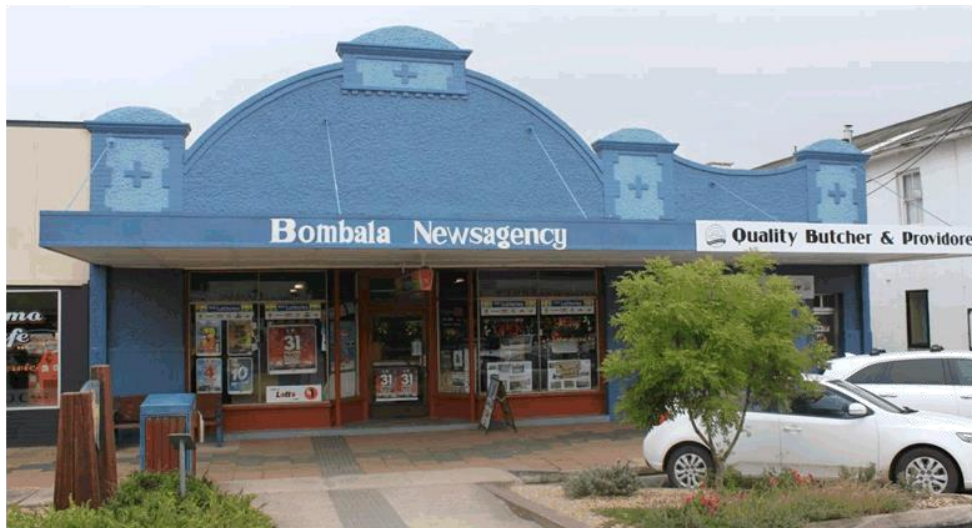
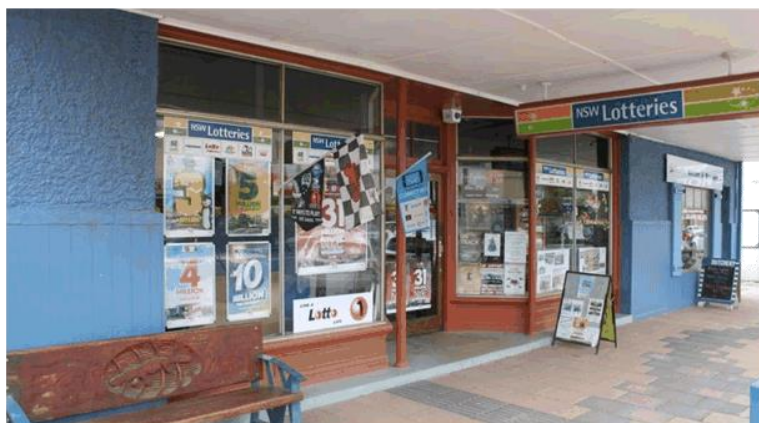
The condition is excellent and the integrity is good, although the building is unlikely to have been painted blue to its present extent. The shopfront is a successful reconstruction.

The vertical timber panelling is probably not original and could be reversed if desired.

The colour scheme could be more traditional.

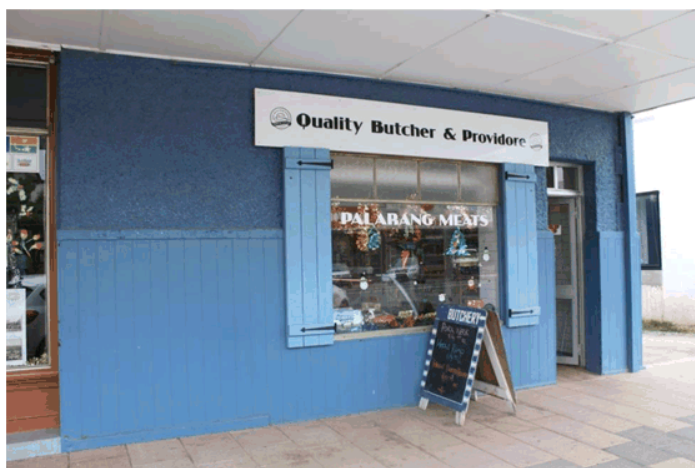
Original details and colour scheme could be reinstated.

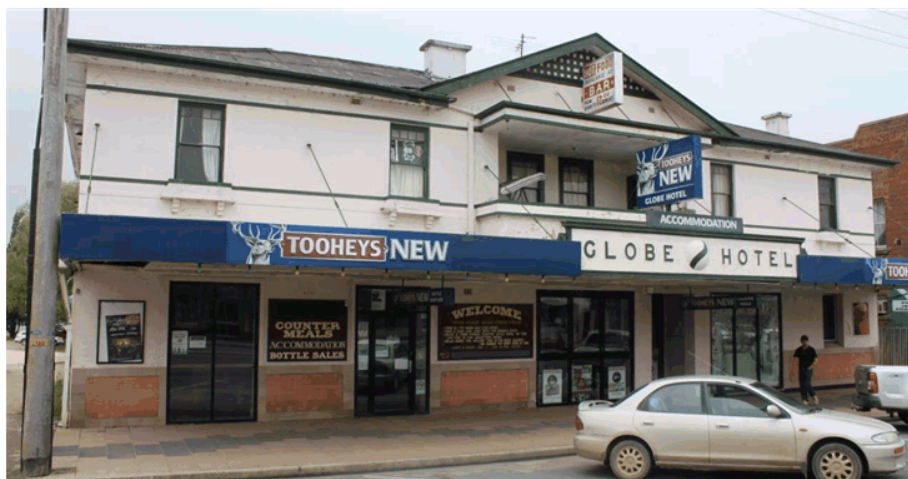
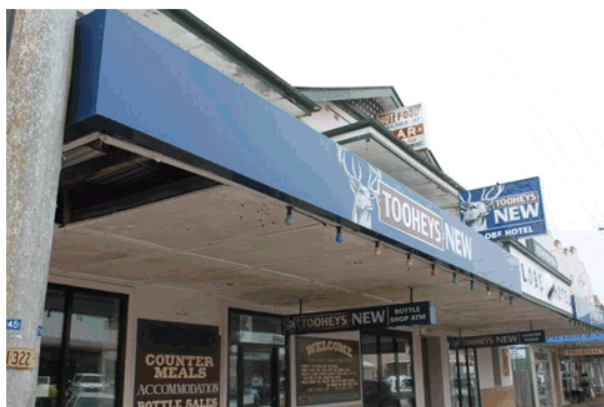
Building needs minor repairs and repainting, including repairs to underside of suspended awning. There has been change to the building over the years although most obvious change to the current building appears to be the introduction of the black aluminium windows and doors to the street frontage.

Repaint to existing colour scheme.

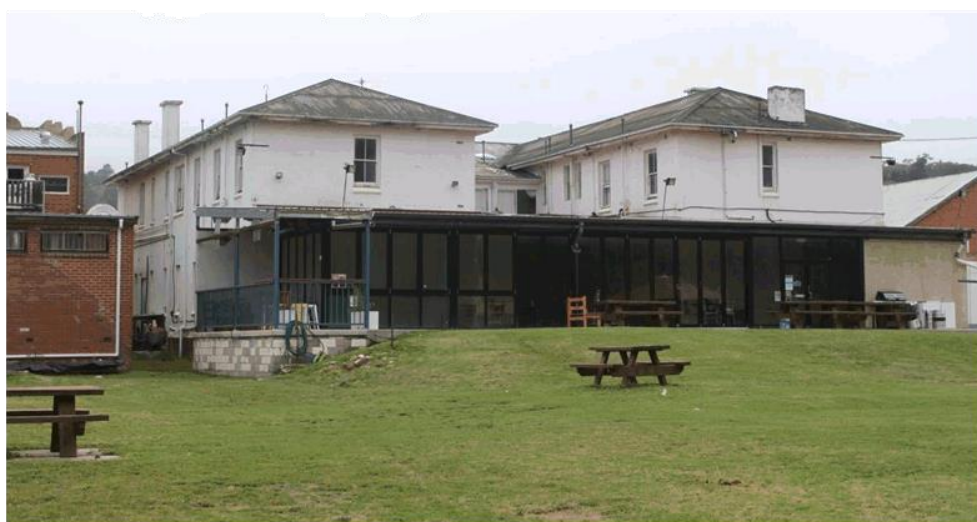
Rear of Globe Hotel provides opportunity for enhanced landscaping

Upgrade landscaping at rear of hotel

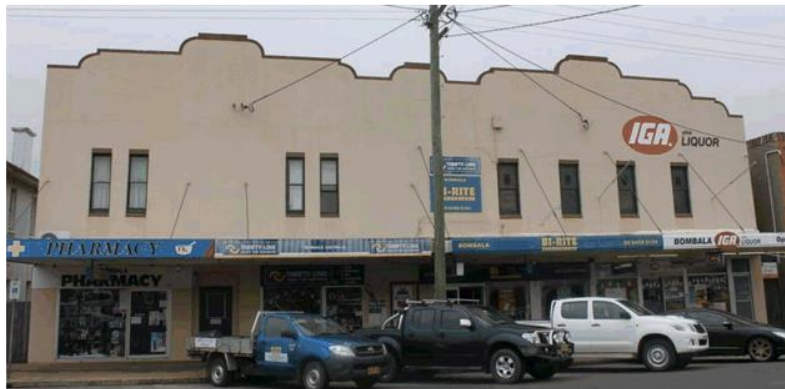
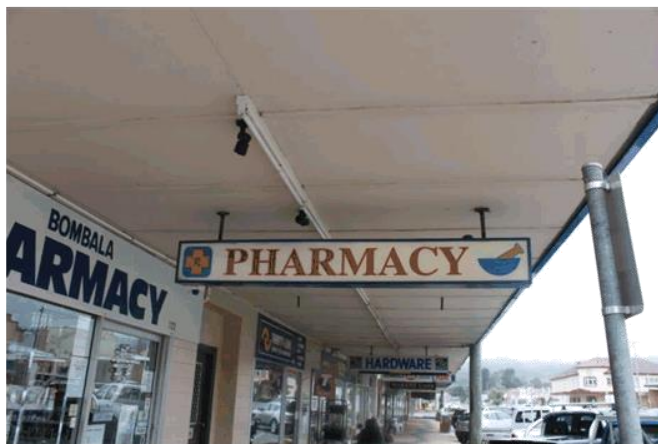
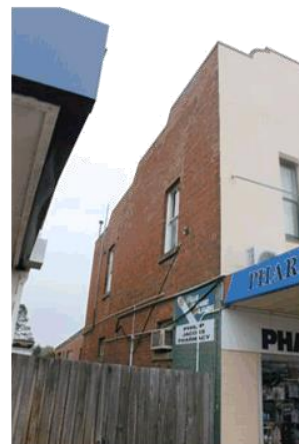
Condition appears good. Integrity unclear as that may have been considerable change over time

Avoid painting original brickwork on side walls, control signage, upgrade lighting on underside of awning, review historic photos to understand previous front of building.

Provide disabled access to shops.

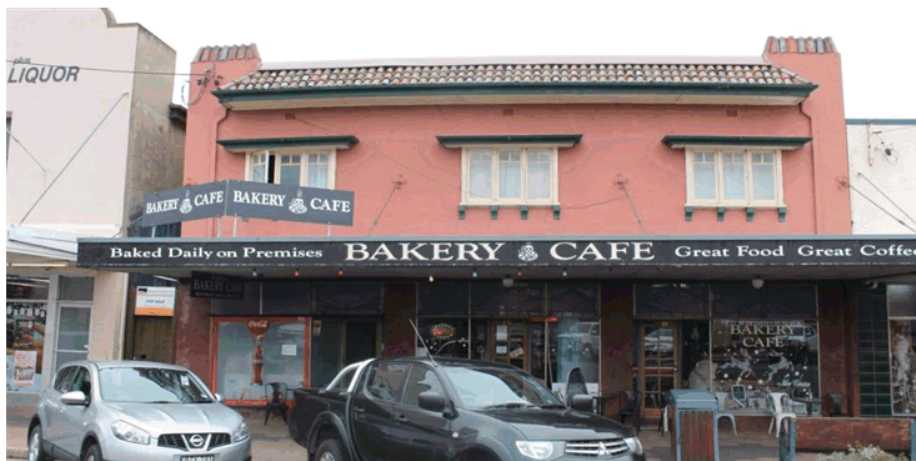
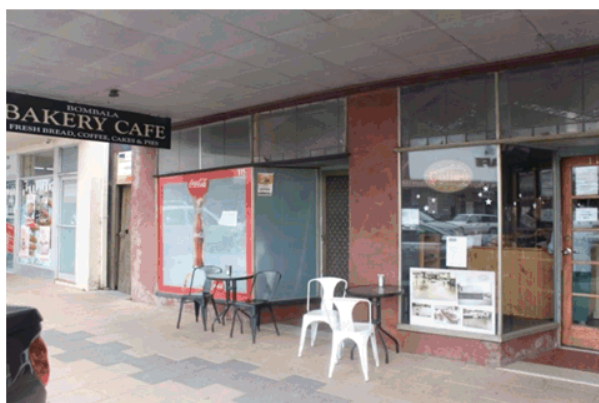
Good condition and high integrity. The building retains all three shop fronts in relatively original condition. The wall surface between shopfronts may have been modified.

Remove coca cola sign from left hand window to reinstate consistency across the three shopfronts, reinstate missing awning light. Review the limewash treatment to ground floor walls and consider reinstating the original finish.

Don't paint the Spanish parapet tiles

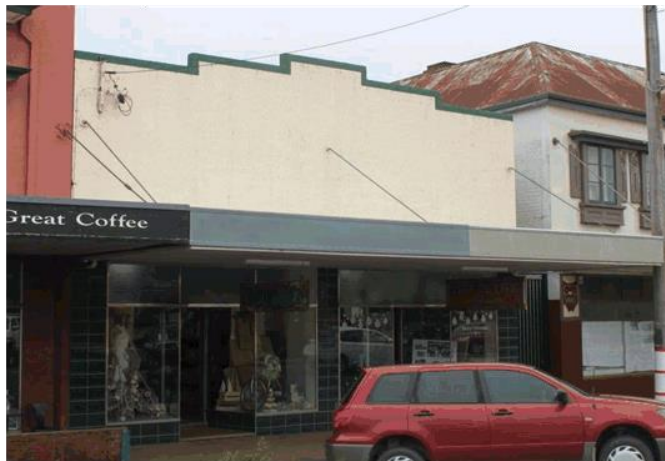
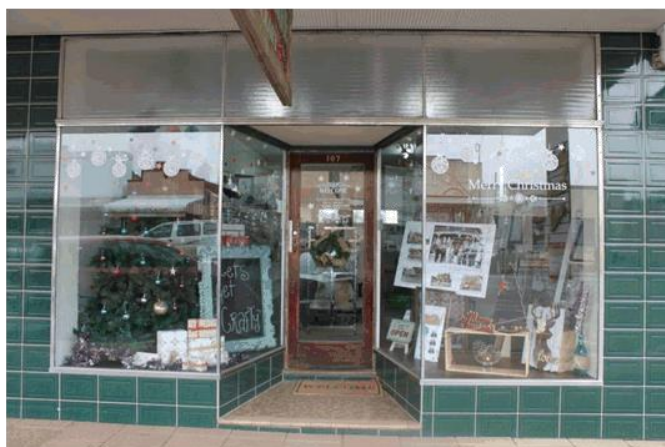
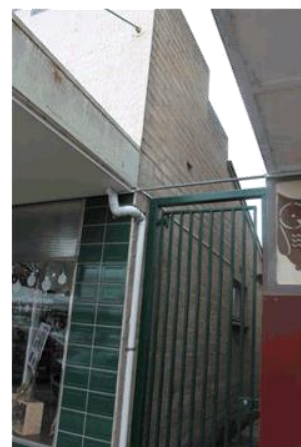
Rusting at edge of awning

Check for rusting at edge of awning, apply new varnish to doors, polish chrome glazing bars, refresh or clean parapet wall.

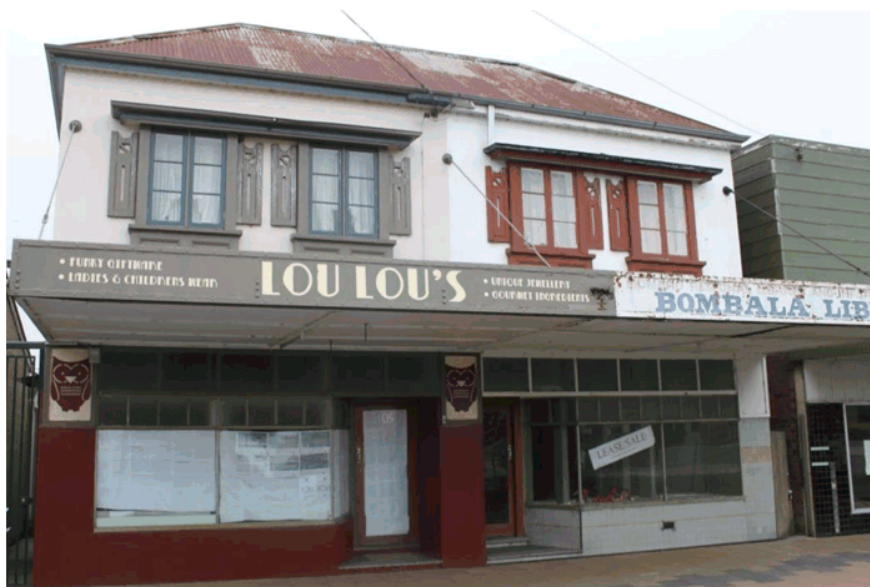
The building is in fair condition but needs refreshing including new paint to previously painted surfaces. Integrity is mixed as the building appears to have undergone several make-overs. The shopfronts generally have high integrity other than for the new mini-orb cladding.

Ideally both sides of this building would be unified – ie made to look the same, and if the tiles beneath the mini-orb are still in place, then the mini-orb could be removed and the tiles re-exposed. Glazing bars, specialty glass, tiles etc should all be restored and cleaned. The upper windows could retain their decorative additions but should be painted the same colour. Alternatively the false shutters could be removed.

Reinstate traditional under-awning lighting

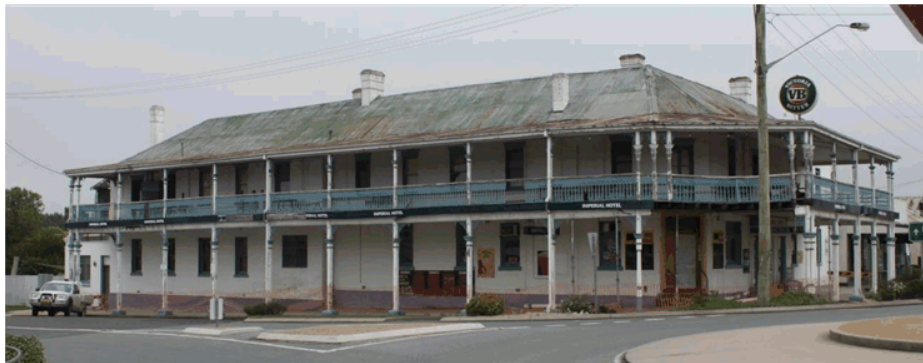
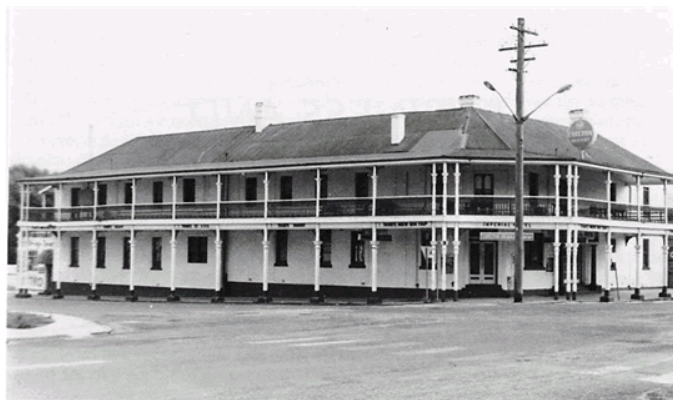
As the 1890 photo shows, the building has undergone a fair degree of change since its initial construction. It is now in poor condition that has been made worse by the recent car damage to the verandah in which several posts were knocked out. The exterior needs extensive repainting in addition to repairs to the verandah posts.

This iconic building is strategically located at the entry to the main street and needs to be restored. Given the building's size, the amount of work required and the current condition of the local economy, it may be appropriate to consider adaptive reuse of some or all of the building.

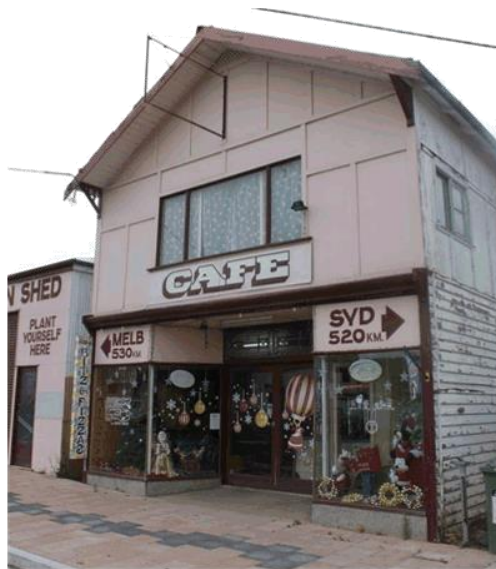
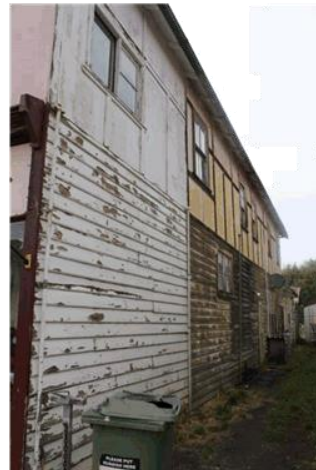
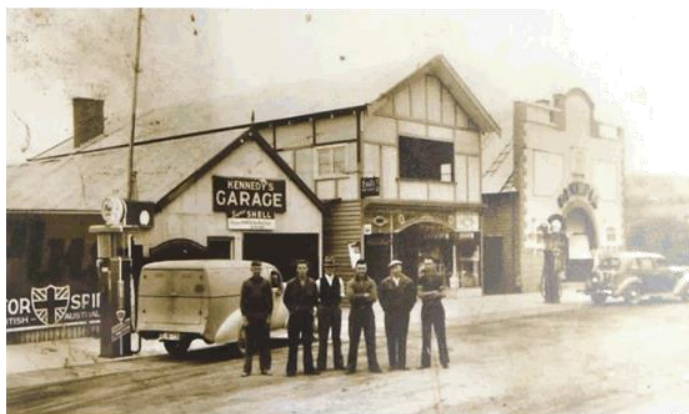
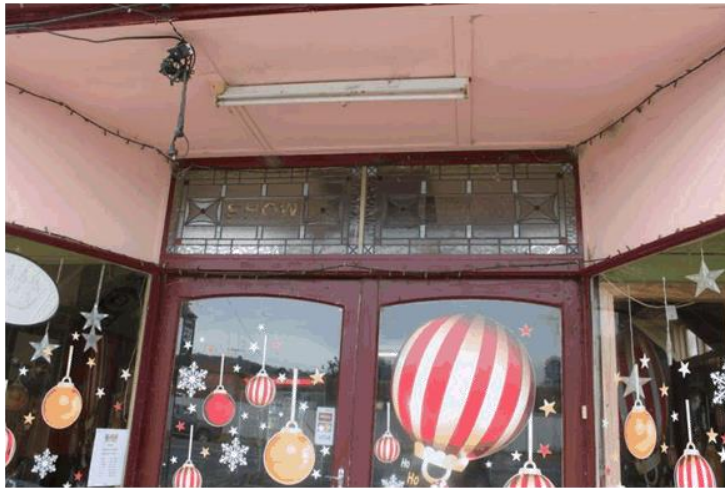
Arch has been removed from the entry

Reinstate the arch over the entry and repaint the building.

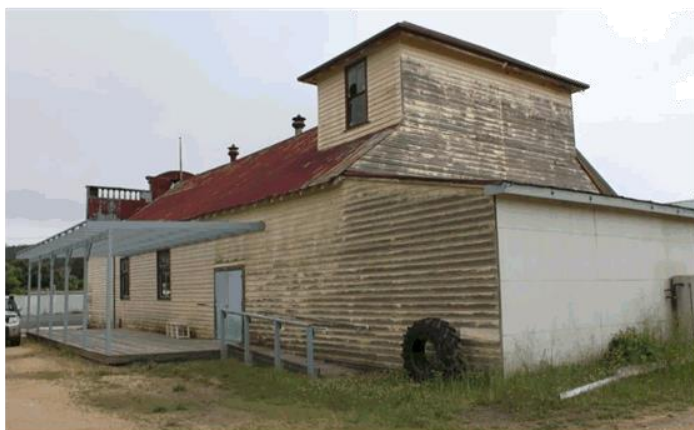
Detail of façade remains intact, but condition of side and rear is deteriorating. Generally however the integrity is good even though there have been various colour schemes.

Rear view 2016. The whole form of the building needs to be recognised as part of its significance, not just the front façade.

Ensure that all pressed metal is securely fixed and trim is in good condition. Also restore ticket entry. Repaint to match the original colour scheme reflecting tones from the 1948 image. Restore the entire building as resources permit.

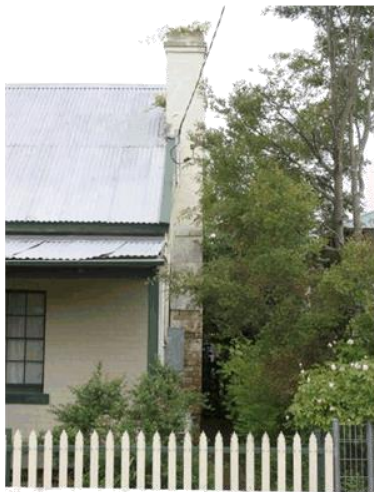
Chimney in need of attention

Remove plant from chimney and repair render at its base,
Resecure loose iron on verandah roof,
Continue to maintain in good condition.

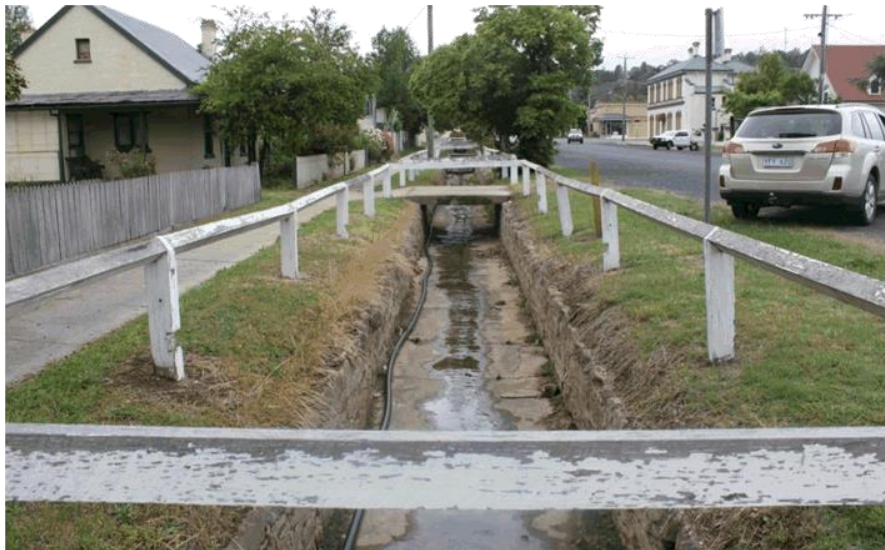
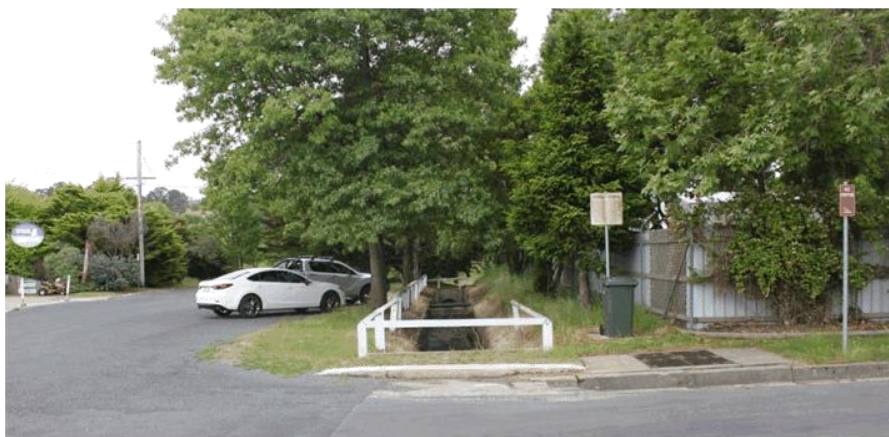
Condition seems good, age has not been established. Timber needs repainting. Note that bottom rail has been removed

Continue to maintain as a fenced open drain and paint the timber to maintain its life.

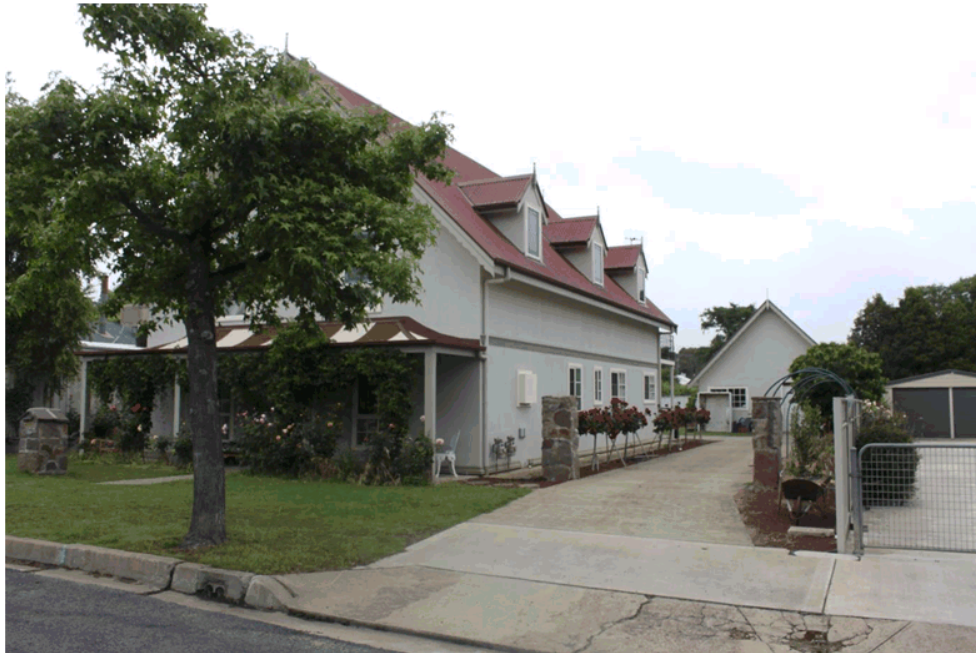
Condition is very good.

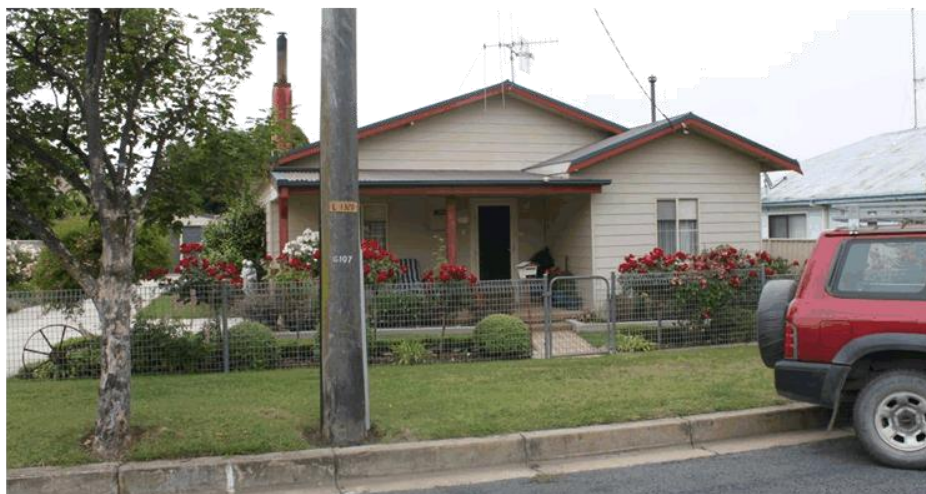
Excellent condition

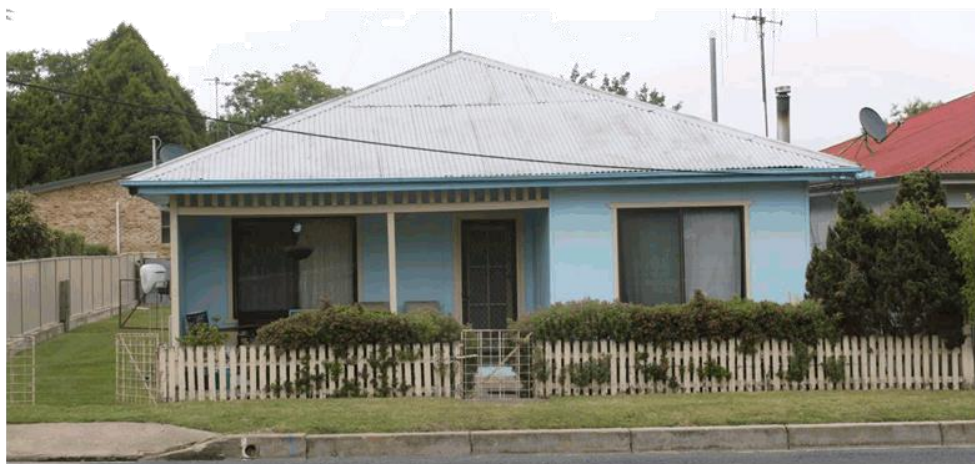
Good condition, large aluminium windows, hedge behind front fence

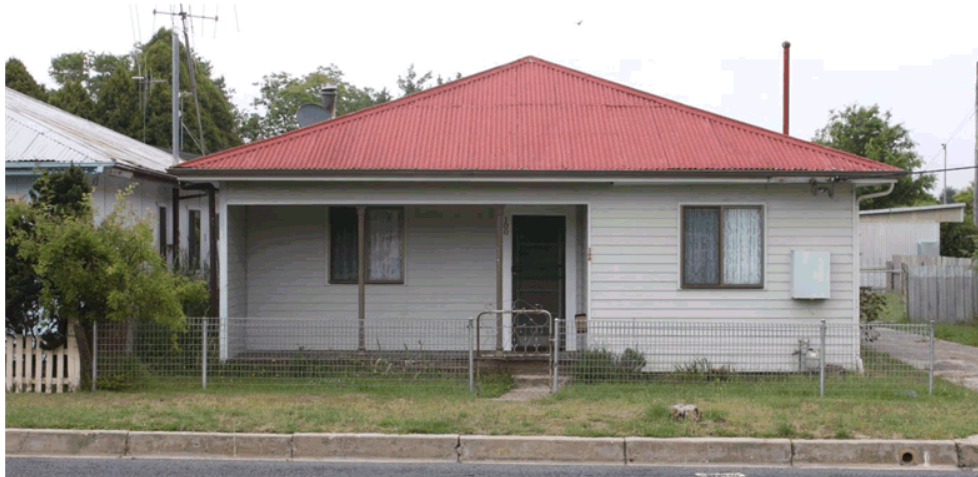
Good condition. Fibro has been clad with weatherboards, and windows are not as large as those at No 98. Front garden is minimal.

Demonstrates mid-20th century development in the town. There is an opportunity to enhance the front and side garden.

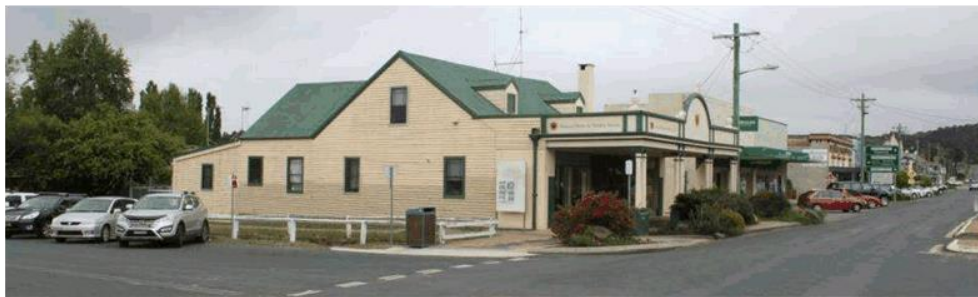
2016

The building is in very good condition. The weatherboard section is probably from the late 19th century and the shopfront from about the 1920's. The shopfront retains some excellent detailing including bronze window frames, marble stall boards and black and white door entry tiles. It is rare that such quality finishes have survived. Brick bases of verandah pillars may date from mid 20thC.

The present colour scheme is in good condition and not inconsistent with that evident in the tinted historic photo. No change recommended at present.

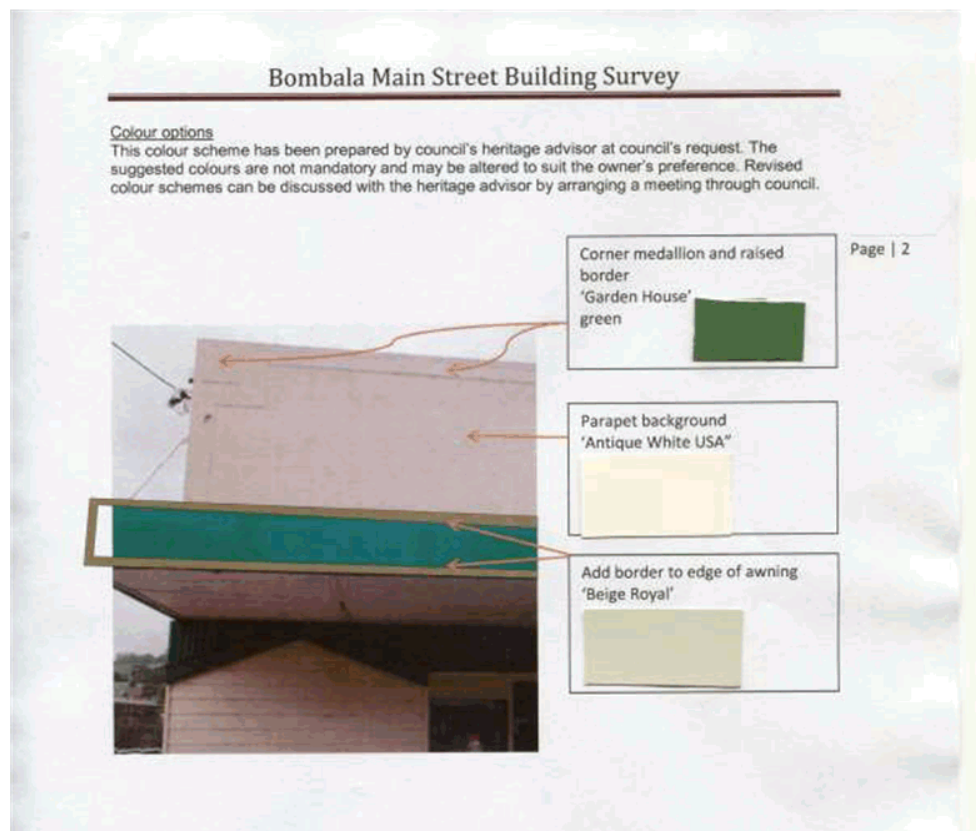
The condition appears to be good and it is difficult to know from the outside if it is a substantial modification or a full replacement of the previous building that was on the site.

Continue to maintain in good condition.

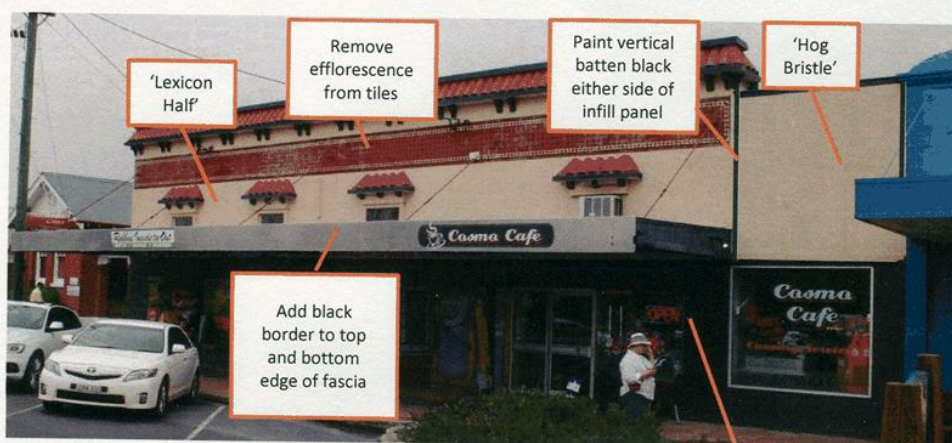
Condition is good however as noted above there has been modification to the shopfront. Note that there is what appears to be efflorescence to the wall tiles above the window hoods.

Note efflorescence on tiles on upper parapet

The infill panel between Robbo's and the newsagency should be painted a different colour or distinguished from Robbo's façade by painting the vertical batten between the two structures

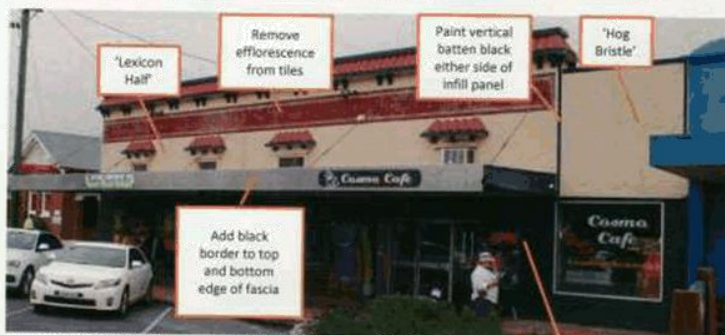
Condition is good however as noted above there has been modification to the shopfront. Note that there is what appears to be efflorescence to the wall tiles above the window hoods.

Note efflorescence on tiles on upper parapet

The infill panel between Robbo's and the newsagency should be painted a different colour or distinguished from Robbo's façade by painting the vertical batten between the two structures

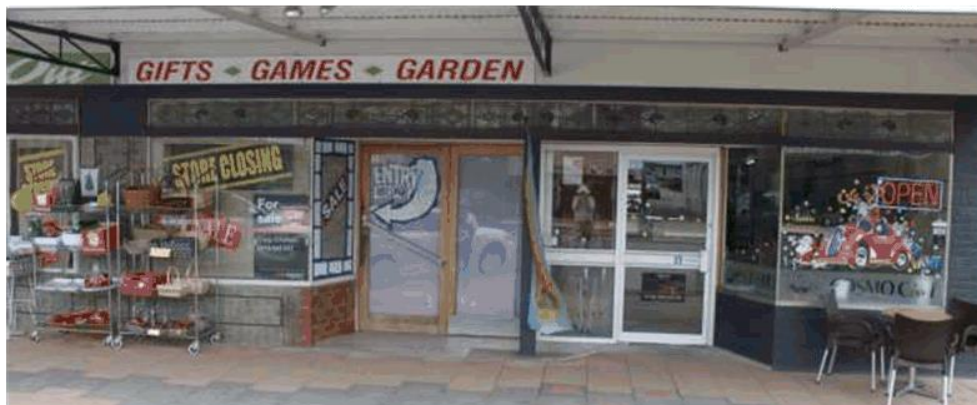
Note the modification to the doorways and painted tiles beneath the right hand window.

The painted tiles in front of the Cosmo part of this building should be stripped back to the original so that this whole building below the awning appears as it was when built.

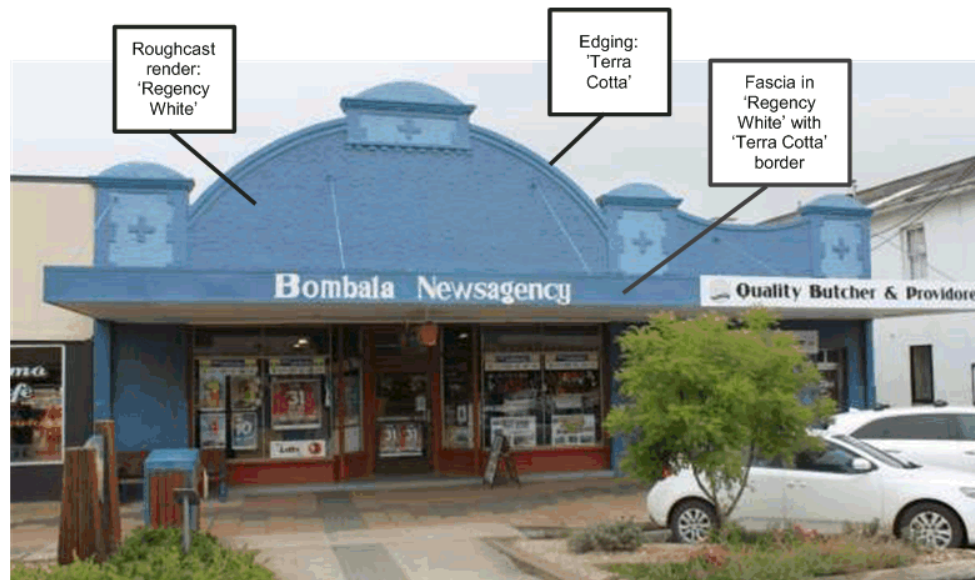
The condition is excellent and the integrity is good, although historic photos suggest a different colour scheme.

When repainting is warranted the building could be returned to replicate its original colour scheme or similar as suggested below:

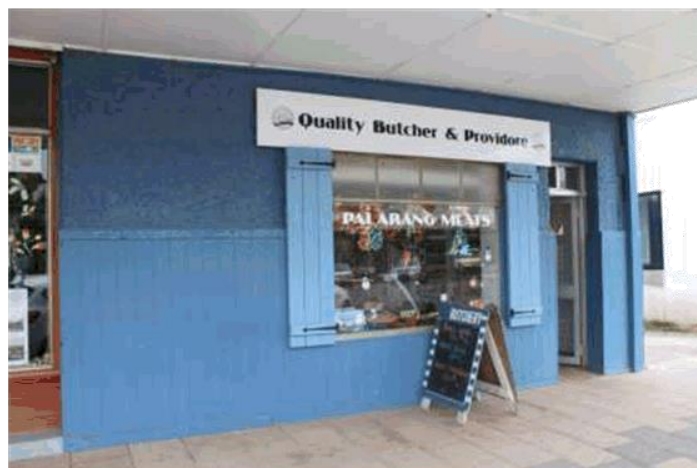
Original details and colour scheme could be reinstated.

The building is fine as it is, but alternatively could be restored to more original condition by removing the shutters and painting to a more traditional colour scheme.
