SNOWY MONARO
REGIONAL COUNCIL

**ATTACHMENTS TO REPORTS
FOR
ORDINARY COUNCIL MEETING
THURSDAY 14 DECEMBER 2017**

Bombala Main Street Overview

Prepared by Pip Giovanelli for Snowy-Monaro Regional Council
December 2016

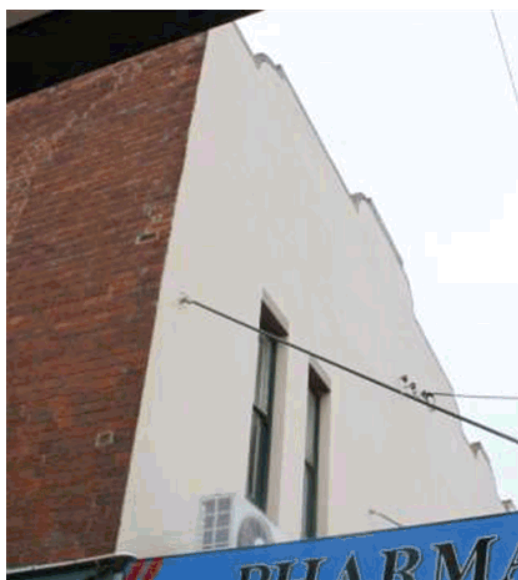
Evidence of the former verandah and removed brick coursing is visible on the front elevation above the windows.

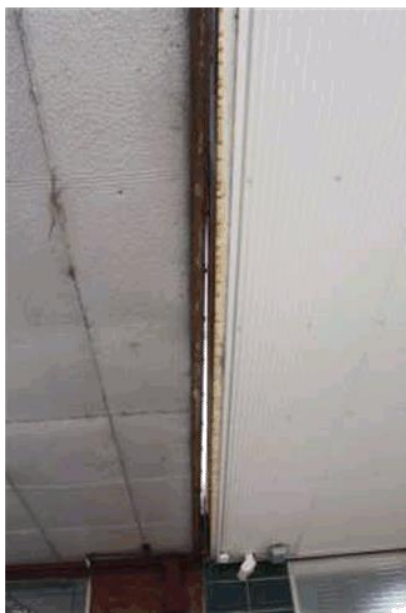
Rusting at edge of awning to be repaired

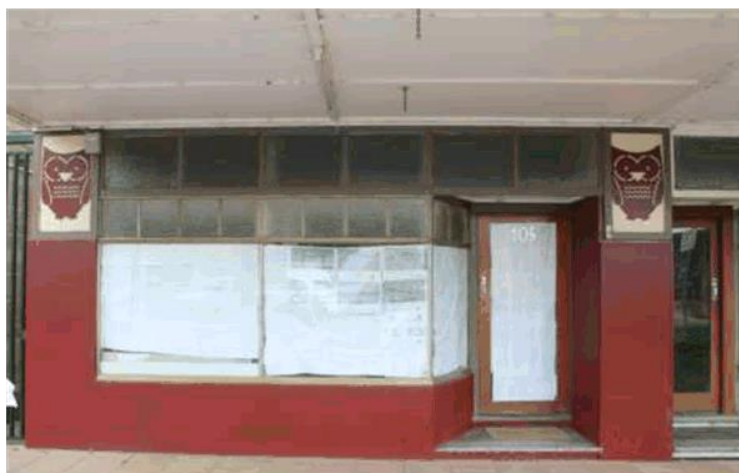
Mini-orb has been fixed over the former shopfront surface. This could be removed and the former tiled shopfront reinstated.

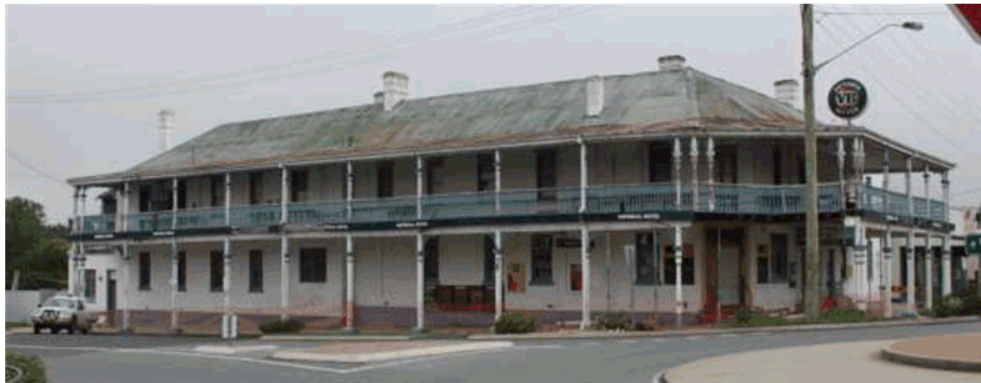
December 2016

As the 1890 photo shows, the building has undergone a fair degree of change since its initial construction. It is now in poor condition that has been made worse by the recent (2016) car damage to the verandah in which several posts were knocked out. The exterior needs extensive repainting in addition to repairs to the verandah posts.

Strategically located at the entry to the main street, the Imperial is an iconic building that requires major restoration. Given the building's size, the amount of work involved it may be appropriate to consider adaptive reuse of some or all of the structure.

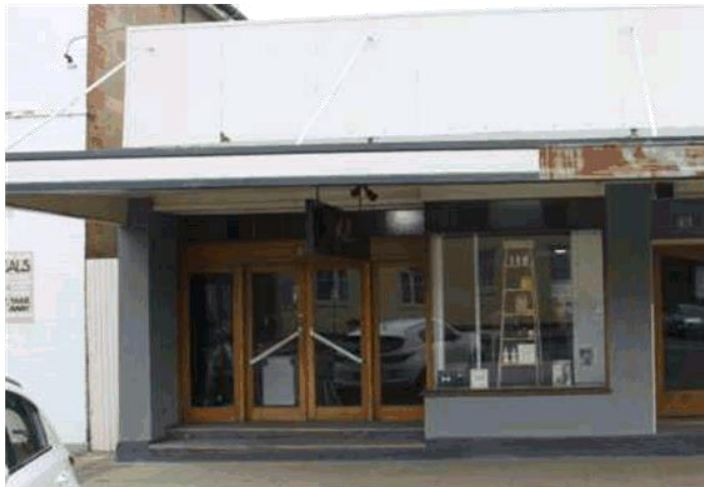
2016 – Left hand end of building. An alternative colour scheme could use similar colours to the right hand end tiles up to dado level, with matching white above so there is unity across the width of the building.

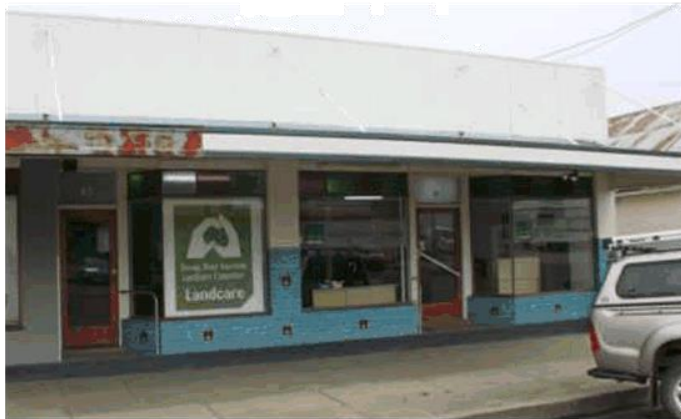
Right hand end of building with blue tiles up to dado height

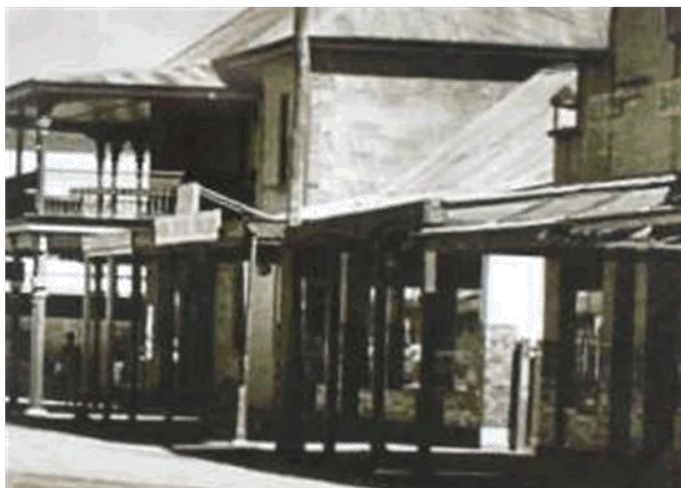
The current awning was once supported on posts

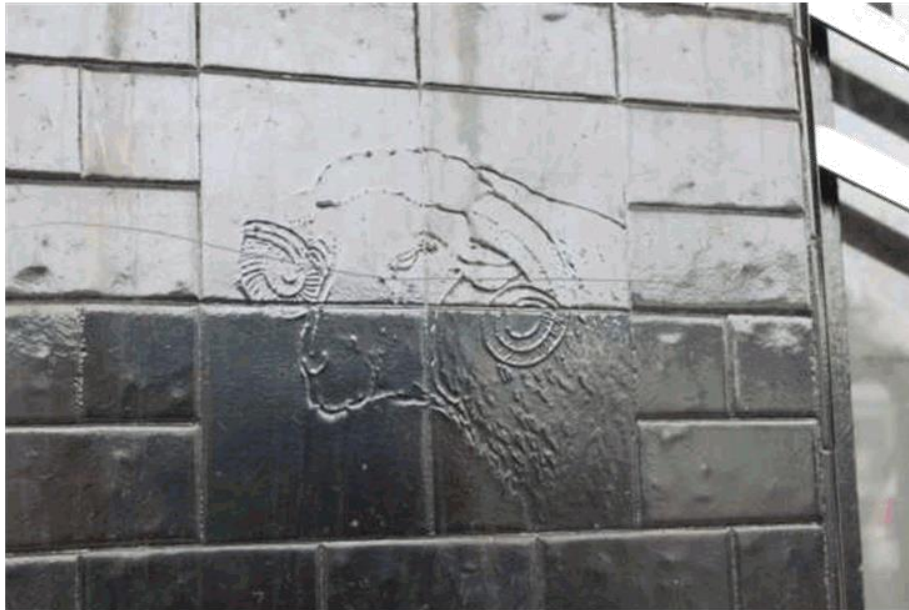
Apart from painting the tiles, and minor infill beneath one window, the form of the building appears original and in good condition.

Carefully remove paint from animal tiles

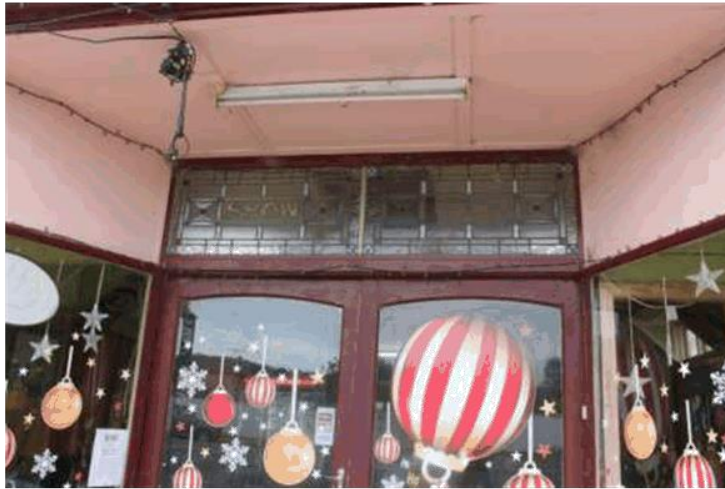
2016 Arch has been removed from the entry

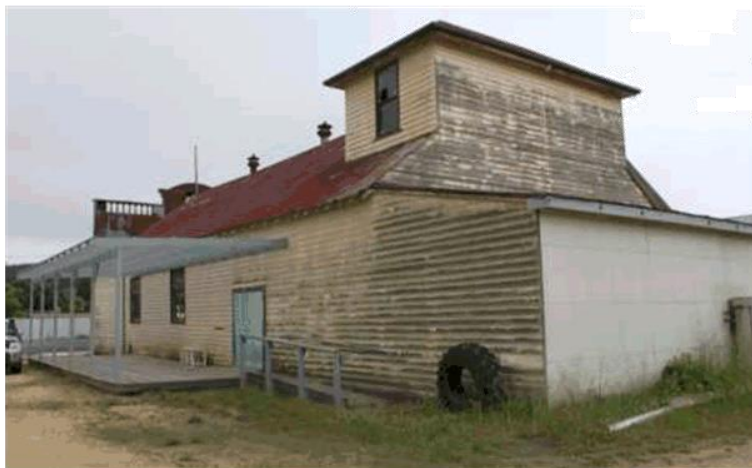
Detail of façade remains intact, but condition of side and rear is deteriorating. Generally however the integrity is good even though there have been various colour schemes.

Rear view 2016. The whole form of the building needs to be recognised as part of its significance, not just the front façade

Ensure that all pressed metal is securely fixed and trim is in good condition. Also restore ticket entry. Repaint to match the original colour scheme reflecting tones from the 1914 image. Restore the entire building as resources permit as the sides and raised rear section are all part of the building's significance.

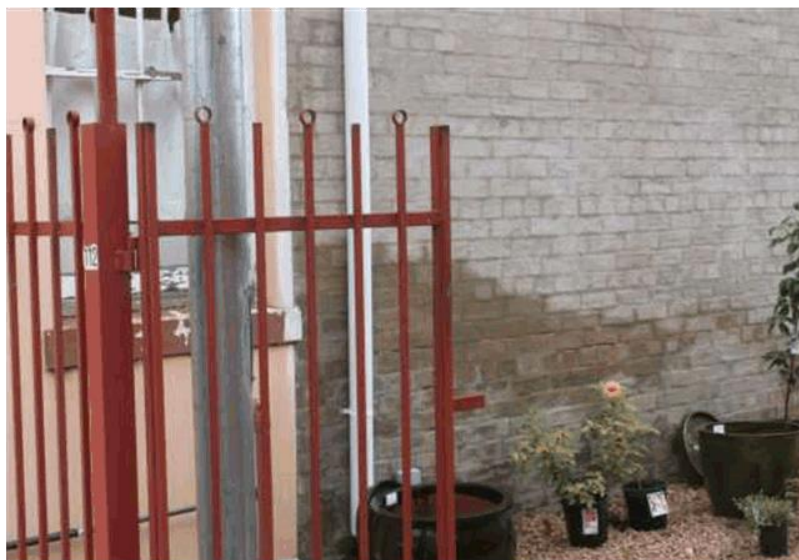
The building is in fair condition but in need of paint. A damp patch on the side wall is damaging the brickwork.

Damp problem on side wall. Note also the surviving period window

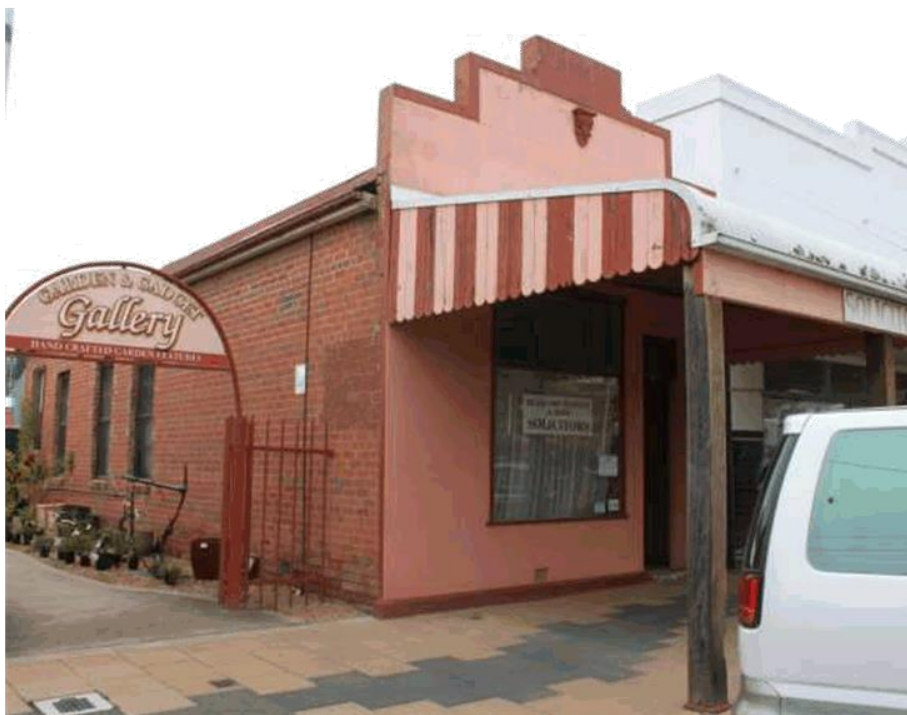
Condition is generally good although painting needs to be cleaned or refreshed. The verandah awning is relatively new and has replaced a previous structure – see historic photos. There is some rising damp on the wall facing the garden centre. The exposed brick wall is very attractive and should not be bagged, rendered or painted.

Note damp at lower portion of wall

Repaint loose and flaking paint on front elevation,

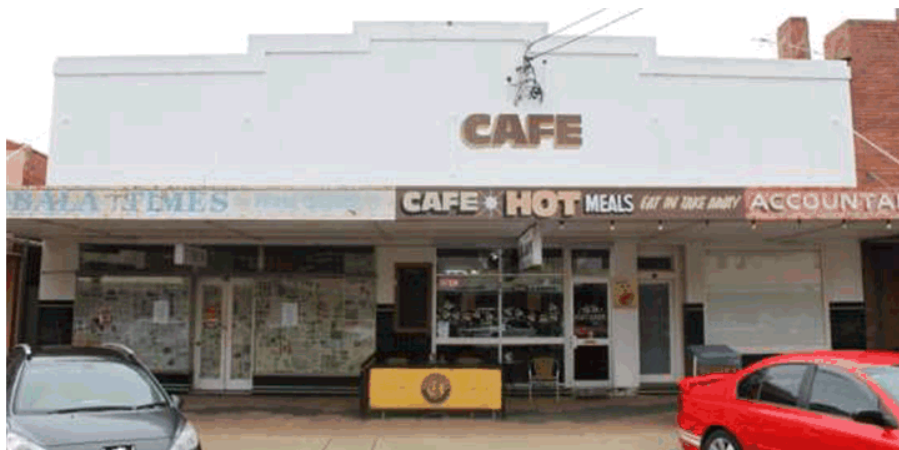
Condition appears to be OK. Integrity of the Bombala Times section is very high and should be retained and conserved. Installation of the shopfront in the café section resulted in loss of original detailing. The window to the former accountant's office is not consistent with Art Deco detailing and may indicate the building façade was modified long ago. The Art Deco crest at the centre of the parapet ridge has been removed or painted over.

Retain all historic detailing and glass associated with Bombala Times shopfront

Unify consistency of detailing across front eg café blackboard to go above or below top edge of tiles (but not across), column between cafe and accountants to be tiled to match elsewhere, tiles below café shopfront to be repaired.

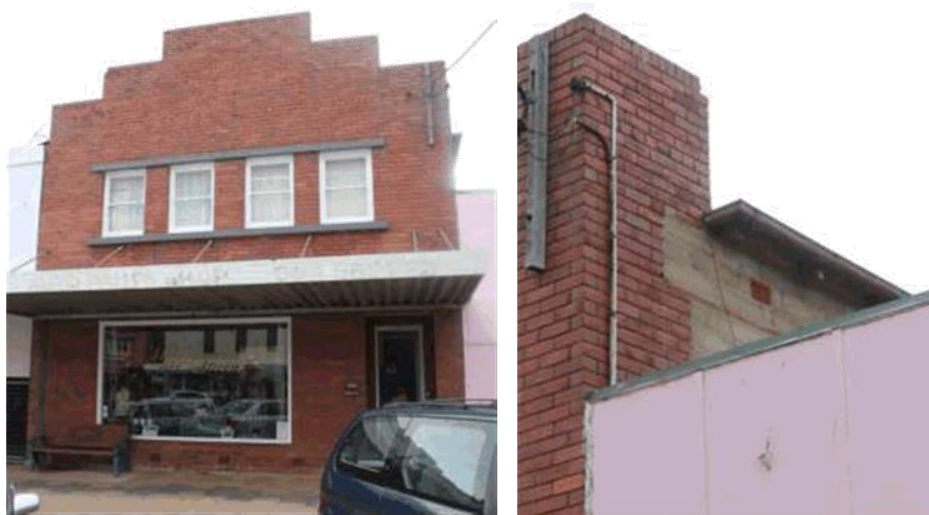
Condition seems to be good and integrity high. Windows in parapet may have always been white and if so should remain that colour. They could be a softer white if desired, such as 'Hog Bristle quarter' or 'Sandy Day Half'.

Note cement bricks on side wall

Gently clean efflorescence from bricks below the damp proof course.

Consider adding lights to the underside of awning to project light back onto the brick wall and door.

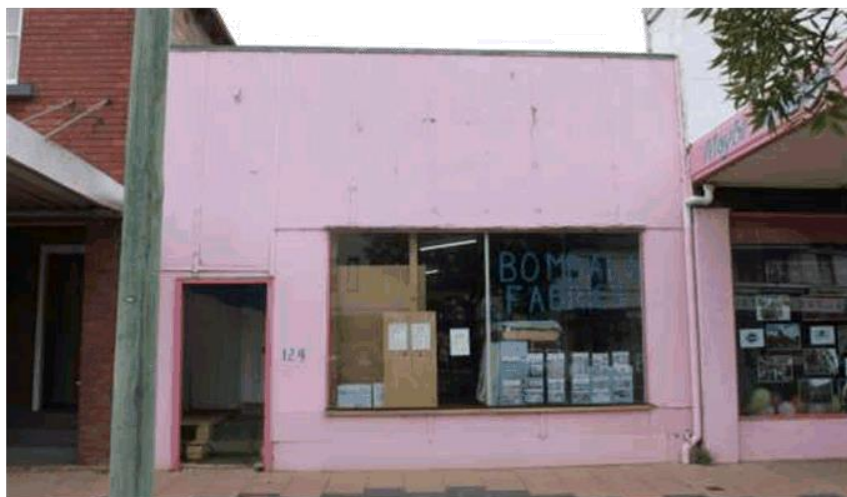
The façade is in poor condition with poor flashing above the windows and peeling paint over the whole surface. Historic photos indicate it was constructed in the 1940s

At a minimum the façade should be painted and architraves added to the window and door. A small awning could also improve appearance.

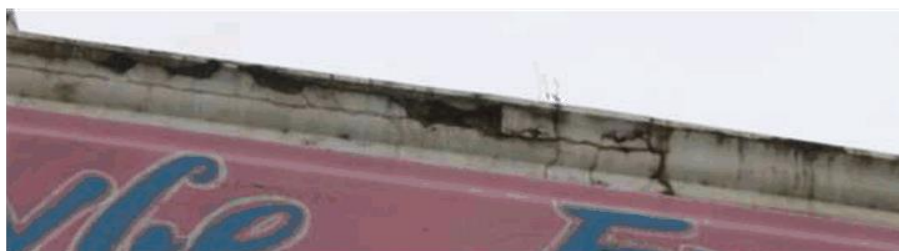
This potentially attractive front elevation needs work. The renderings are in poor condition and need cement-patch repairs, the underside of the awning is sagging and the window surrounds need restoration.

Repair rendering before painting

- Repair renderings on parapet,
- repair upper and lower sides of the awning,
- strip paint off decorative tiles and window mullions and
- repaint walls to a more sympathetic colour scheme.

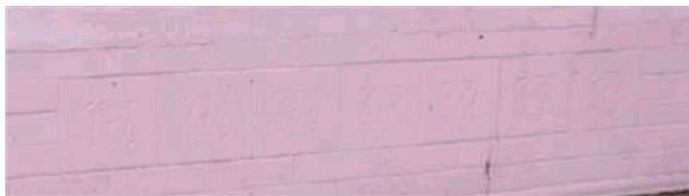
Strip paint off decorative tiles and repaint elsewhere

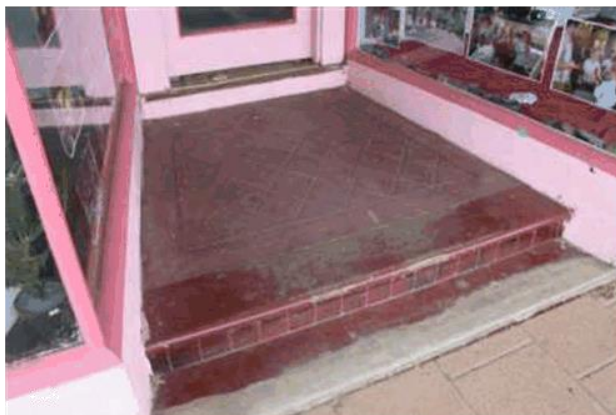
Strip or repaint window mullions and make good to entry

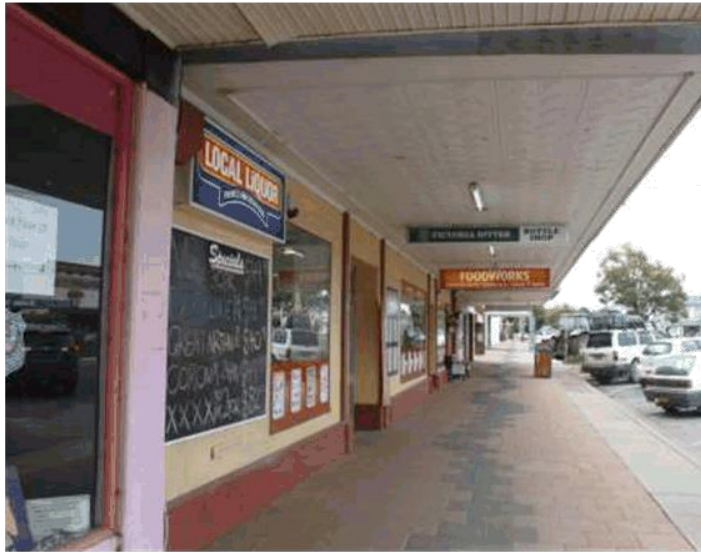
Note Art Deco ceiling awning

Repair leaking awning and downpipe

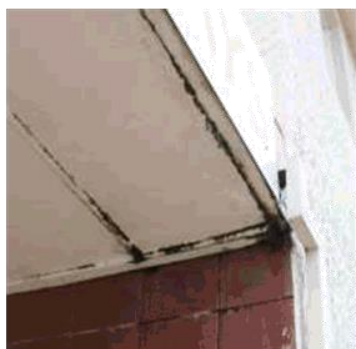
The awning and downpipes are leaking badly and need attention, and the eaves lining is decaying and coming away from the building.

Leaking awning needs repair

- Repair leaking awning and downpipes.
- Repair decaying eaves and
- Refresh the paintwork as appropriate. Existing colours are satisfactory.
- The signage should be reduced to fit within the frame of the suspended awning.

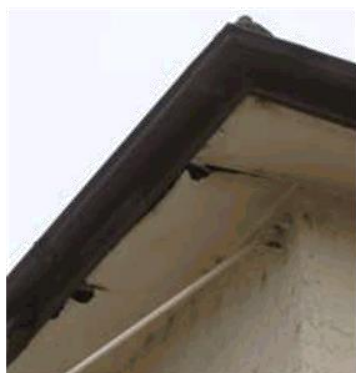
Deteriorating eaves also in need of repair

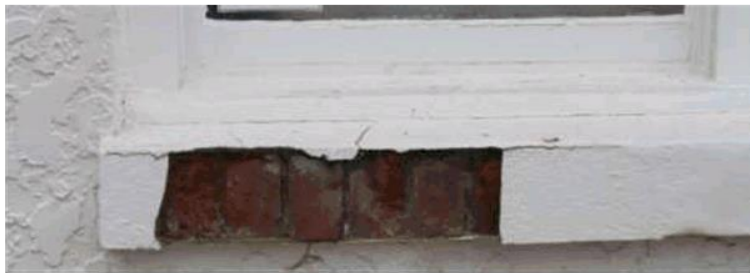
Condition is generally good although on close inspection repairs are required to rendering and soffits, and repainting needed to windows.

Lost rendering to be repaired – 2016

- Undertake minor repairs and painting
- Upgrade entry light over central door

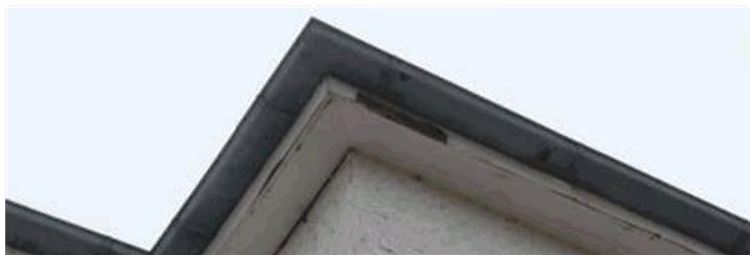
Fascia and soffits to be repaired and painted - 2016

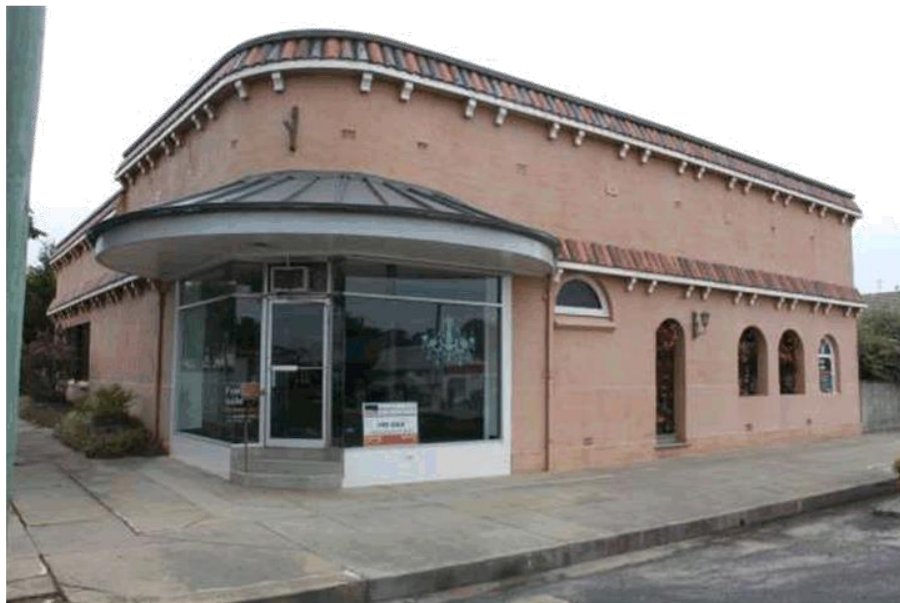
2016

Condition is generally good although some hairline cracks can be seen in the wall. It would be interesting to see photos of the original corner details

Review the original corner details and investigate possibility of restoration.

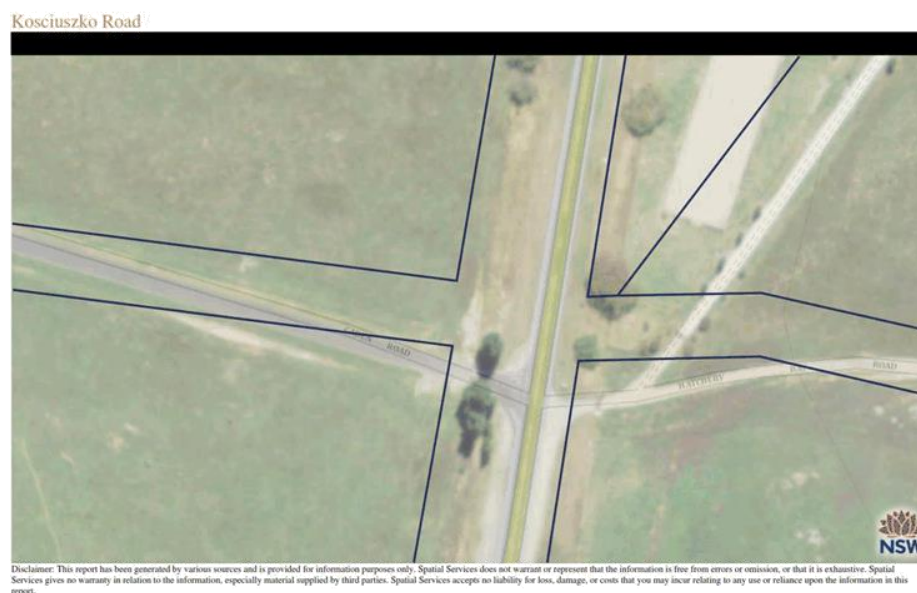
The extract below from maps.six.nsw.gov.au shows that the road formations for Gaden Road and Hatchery Bay Road are located to the south of the road reserve, leaving potential for dedicated bicycle facilities to be located on the northern side of the existing intersection, within the road reserve. The boundary alignments shown in the image below should be confirmed by site survey before committing to specific design arrangements.

Figure 1 Road reserve boundaries

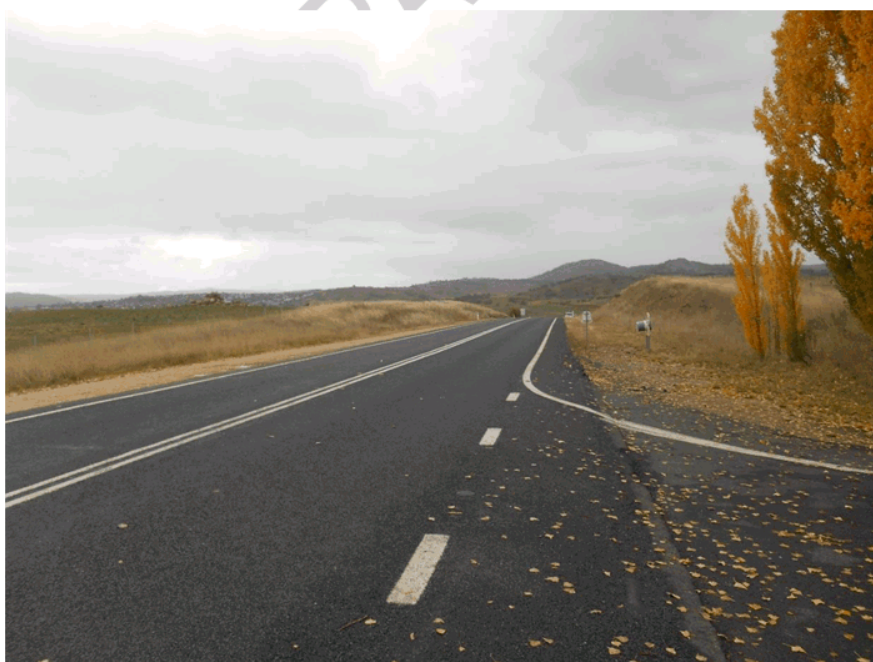
A bridge could be located approximately 100 metres south of the intersection where the road cutting is at its deepest. Refer to photo below. This would minimise the length of elevated approach ramps, but not eliminate these, especially on the eastern side of Kosciuszko Road.

Figure 2 Kosciuszko Road, looking south from Gaden Road

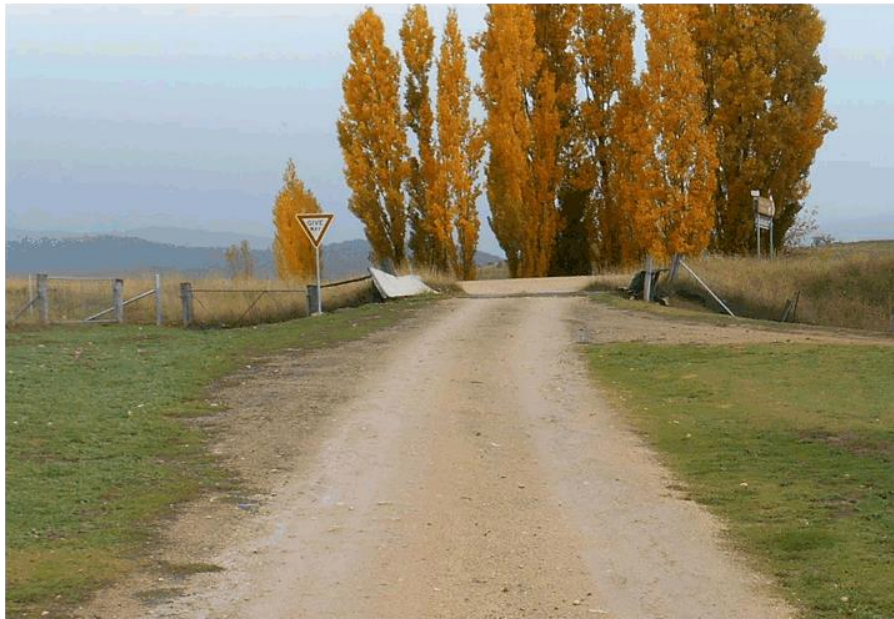
The cattle grids in both Gaden Road and Hatchery Bay Road present a hazard for bicycles and pedestrian users. The bypass gate adjoining the grid in Hatchery Bay Road is not suitable for use by cyclists and pedestrians. There does not appear to be a bypass gate at the grid in Gaden Road. Refer photos in figures 7 and 8.

Figure 7 Cattle grid in Hatchery Bay Road

Existing cattle grids in Gaden Road and Hatchery Bay Road control livestock to prevent them from straying across Kosciuszko Road. These grids are effective in catering for vehicular traffic but present hazards to cyclists and pedestrians. Bicycle wheels may slip on the steel grate, and tubes may be pinched and punctured while crossing.

In promoting this crossing as part of the cycle track linking the Thredbo Valley Track to Jindabyne the hazards posed by these cattle grids should be addressed by provision of suitable bypass gates and possibly by suitable grid for bicycle use. See discussion below about suitable arrangements for controlling livestock.

Options for controlling stock, while permitting bicycles and pedestrians to pass, include systems of gates and stock grids with suitable bar sizing and spacing that suits bicycle wheels.

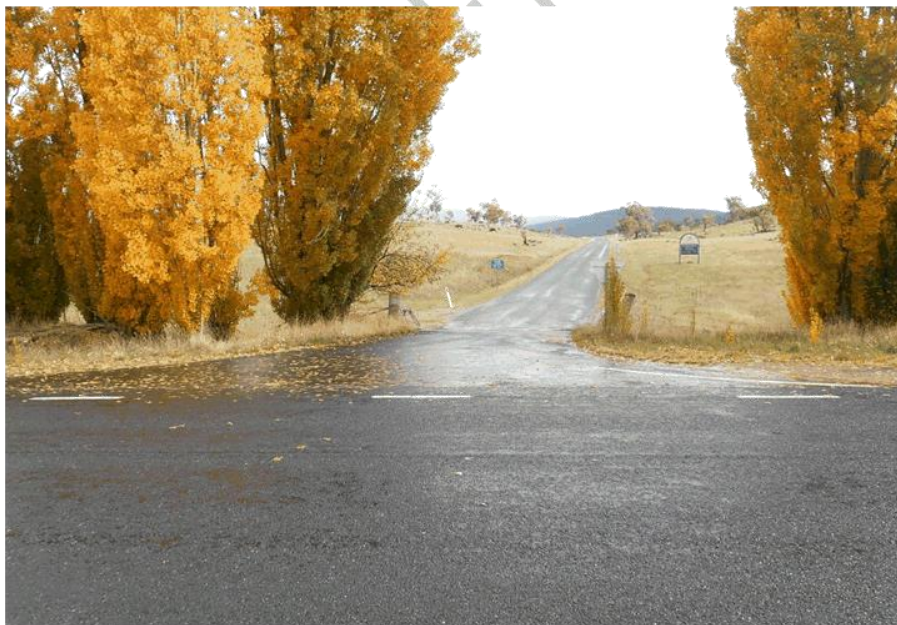
Figure 8 Cattle grid in Gaden Road
