Monaro Rail Trail

Trail Development Plans – Stage 1a

MONARO RAIL TRAIL TRAIL DEVELOPMENT PLANS

FINAL REPORT

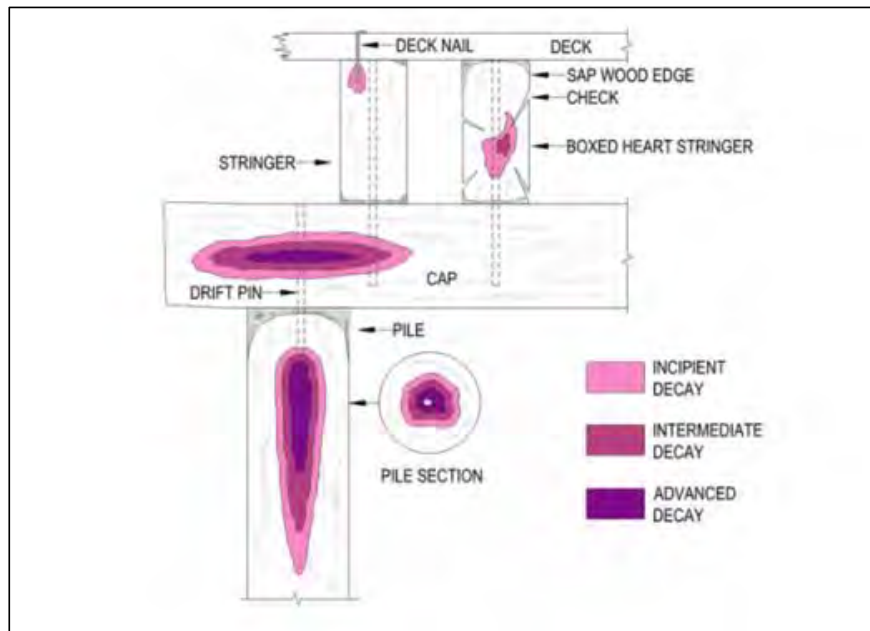
Figure 3-2 below shows the level of decay typically found due to vertical through bolts. A similar occurrence happens to the base of the pile when they are sitting directly on concrete. The timber soaks up the water from the concrete, which accelerates decay.

Figure 3-2: Shows the level of decay that occurs in timber due to the use of vertical fasteners. Vertical fasteners increase the rate of decay in timber as they allow moisture to travel down the fastener into the heartwood of the headstock (cap), girders (stringers), corbels and piles, therefore increasing the moisture content in the middle of these elements. The heartwood of a log element is less capable of breathing and expelling moisture than the sapwood that surrounds it, so vertical connectors funnel the moisture directly into the heartwood accelerating decay. Once the moisture content exceeds 22%, timber consuming fungi are activated, and the decay process begins.

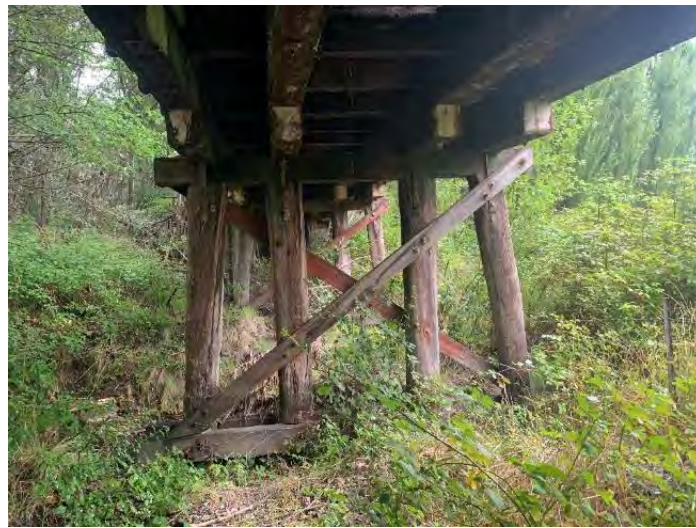
Figure 4-2: View of the typical timber pile bent configuration. The bent is comprised of 4 driven piles, single timber head stocks and corbels. The bent is also supported by a double cross bracing system with sashes at halfway and timber wales at the bottom. Overall, the timber bents were found to be in a poor to very poor condition. Note the surface brown rot fruiting bodies on the faces of some of the cross braces -orange brown colour.

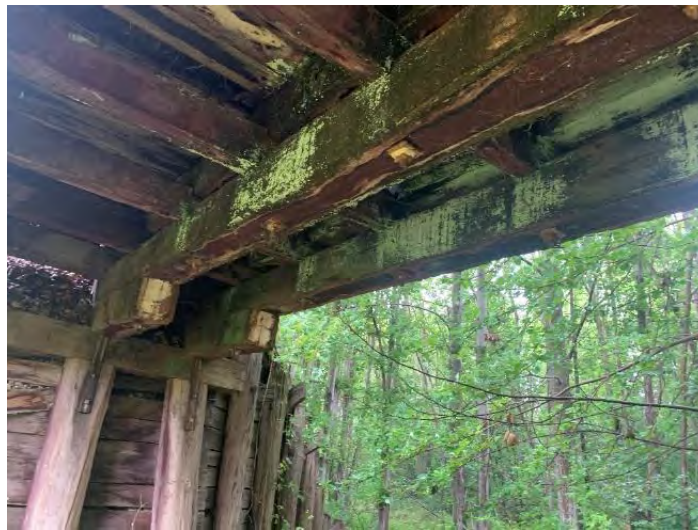
Figure 4-6: View of 2/4 girders. Consists of 4 girder lines which are double stacked with the top girder serving as a lateral bearer beam end stabilizer as well increasing the elevation of the ballast tray floor. All girders exhibited major water stains and decaying fungal growth.
Girders were found to be in poor to very poor condition.

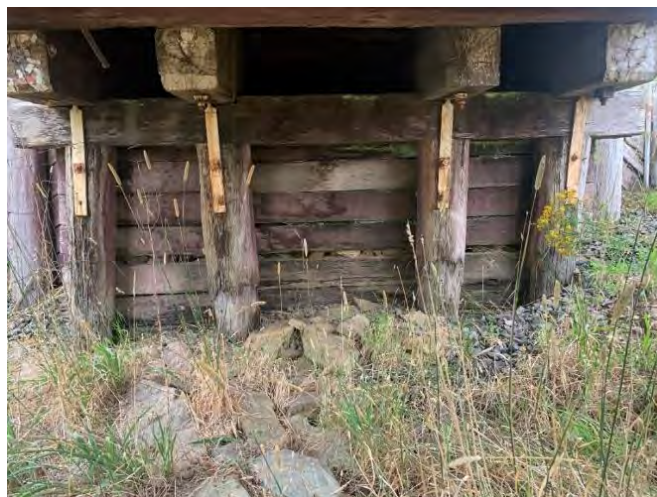
Figure 5-5: View of abutment shows the general formation. The timber sheeting was found to be in poor condition, with water stains and decaying fungi growth present. Significant sapwood deterioration was located on members near the ground. Gaps between lower planks show minor erosion of backfill material. The breast wall planks are spiked to the backside of the piles which has resulted in their shrinkage producing gaps and subsequent loss of fines. They should be stitched.

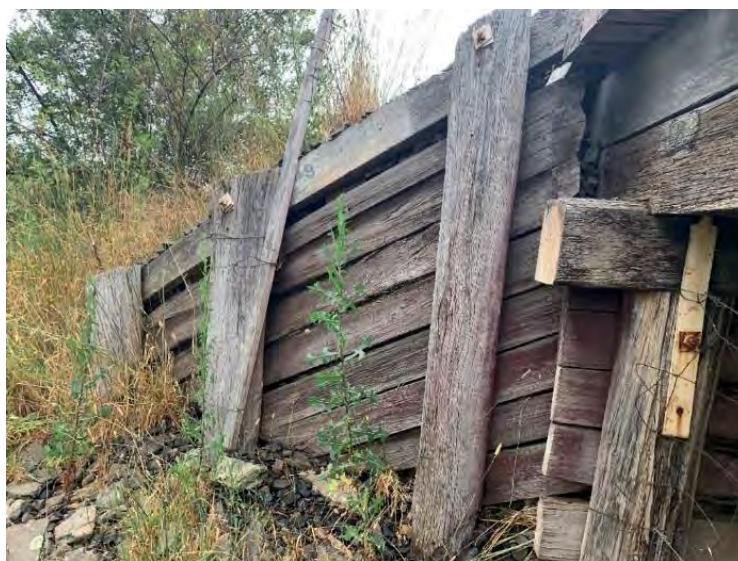
Figure 5-6: A view of abutment wingwall. The wingwall was found to be in fair to poor condition with minor deterioration present throughout all components. Minor deformation was present at top of wall due to bearing load of ballast.

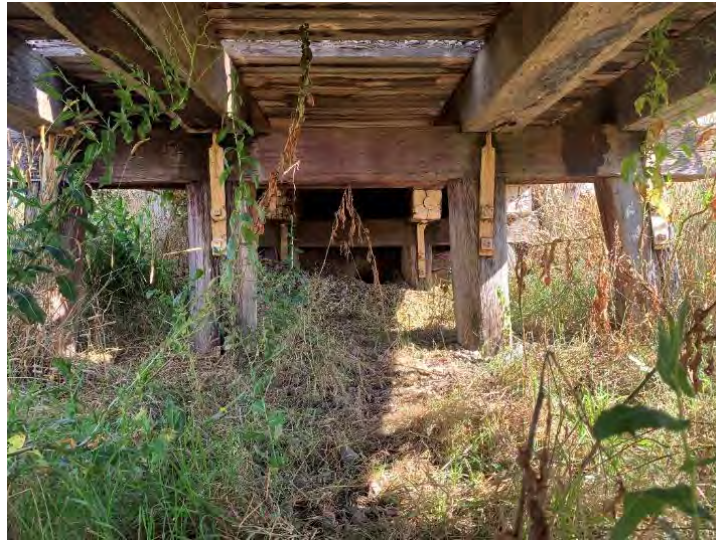
Figure 6-2: View of the typical timber pile bent configuration with each bent varying in height. The bent comprises of 4 driven piles a capsule (cap) and at bent 2 4 corbels located directly underneath girders. Overall, the timber bents were found to be in fair to poor condition. Note: large Wombat hole at abutment 2 between pile 2 and 3 and the significant amount of vegetation growth surrounding the substructure elements. Note that the use of horizontal bolts in the side plates have let to improved pile top condition. Also note the notches in the caps for the girders to drop into.

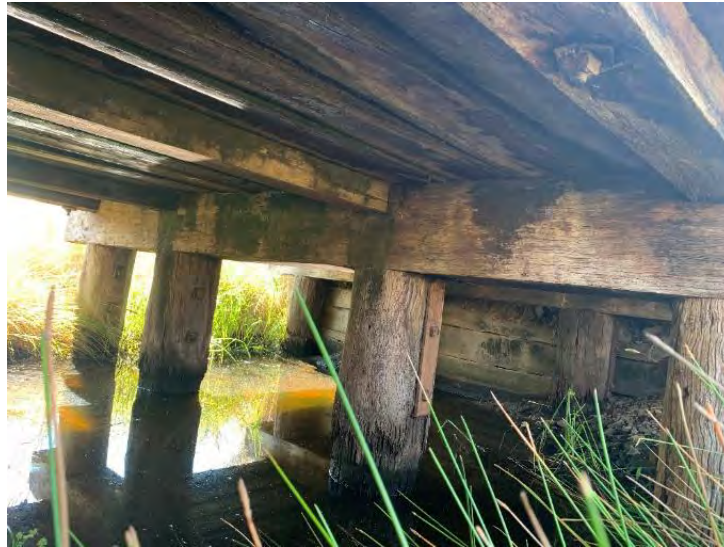
Figure 7-2: Shows the general configuration of the pile bents. Piles are approximately 1m high and in fair condition. Minor deterioration of sapwood is present at water level due to increased moisture content. Water stains and fungal growth present. Note: top plank in abutment sheeting has failed leading to erosion of backfill material.

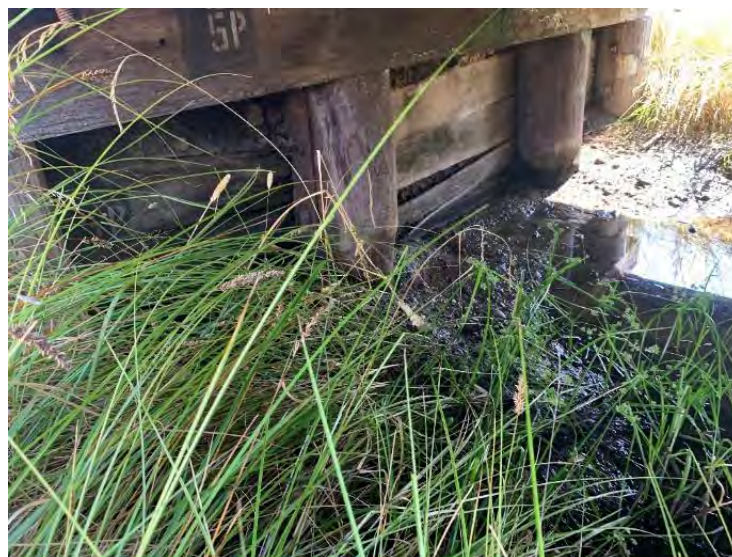
Figure 7-3: View of abutment 2, overall, in a poor condition. Sheeting planks have separated due to spiking to the pile backs in the breast wall, causing loss of fines in the approach fill material through gaps.

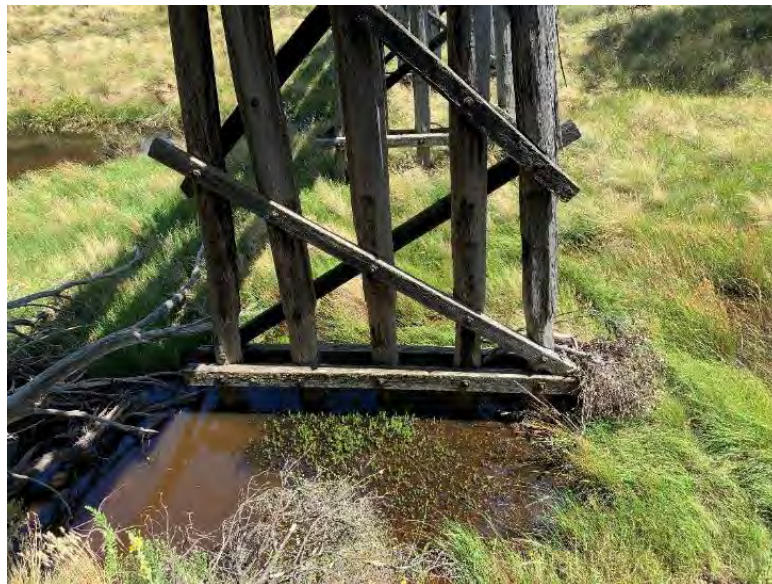
Figure 10-3: Significant decay is present on all piles in above image. Large decrease in pile cross-section on the bottom end of the piles located in the river (Body of water). Debris is caught up in the wales and surrounding areas of pile bents. It is recommended that deteriorated sapwood be removed appropriately.

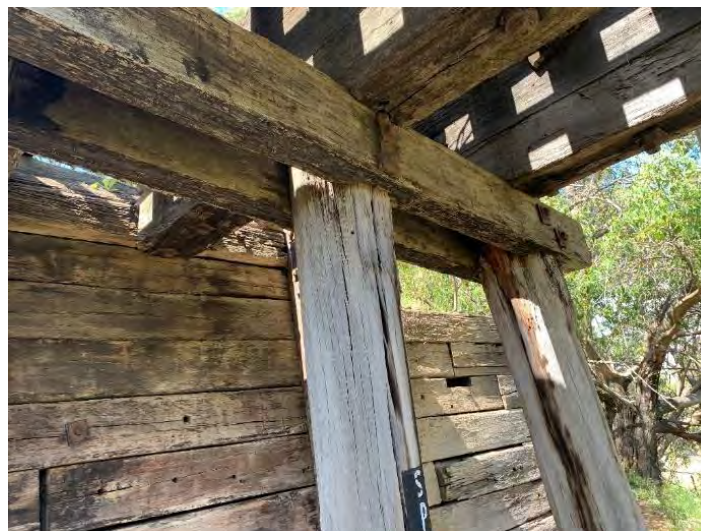
Figure 10-4: The images above show the condition of the split headstocks and the abutment breast wall. The headstocks were found to be in poor to very poor condition, exhibiting significant decay. The breast wall is in poor condition with missing members and weathered elements with splits and cracking throughout. Note: major vertical crack down middle pile exposing bright wood and accelerating decay. Typically, these decay cracks are initiated by fastener systems

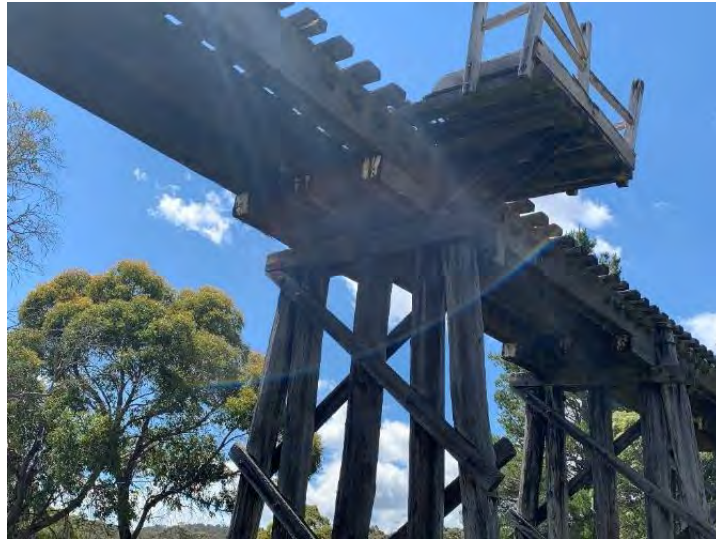
Figure 10-5: View of the walk out standing platform. Platform appears to be in poor to very poor condition with missing/failed members. This would not be safe to stand on. All timber appears to exhibit significant decay.

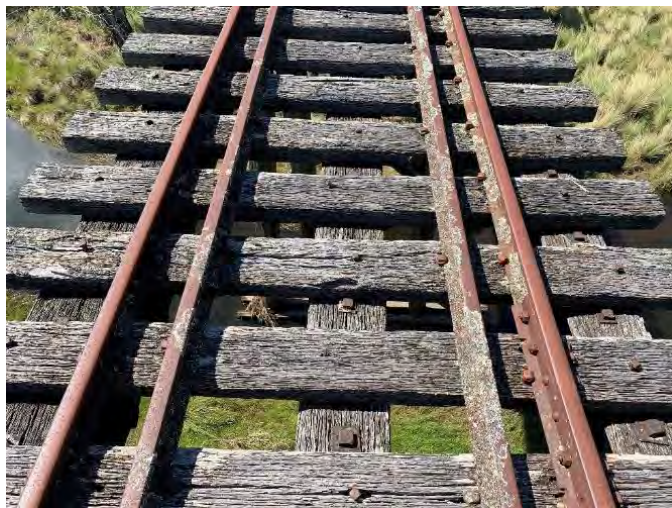
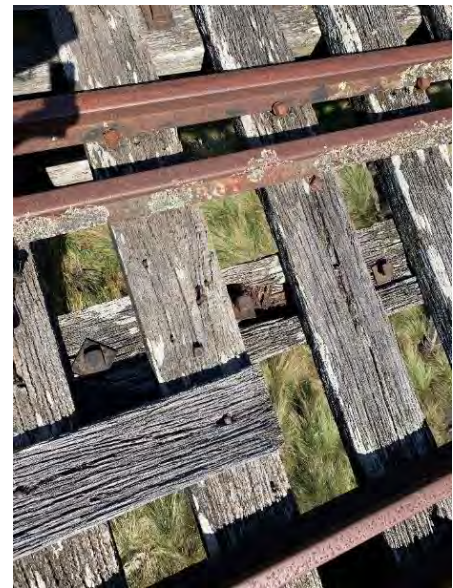
Figure 10-6: Top view of bridge open deck. Transoms and girders can be seen to be in poor to very poor condition, with significant deterioration present in all elements. This is seen to be caused by the vertical connections used in construction. If not sealed appropriately they are seen to funnel water and become moisture traps, when moisture content within timber exceeds 22%, decay causing fungi are activated and the decay process begins. Note: Large cavity around vertical connection in right side photo.

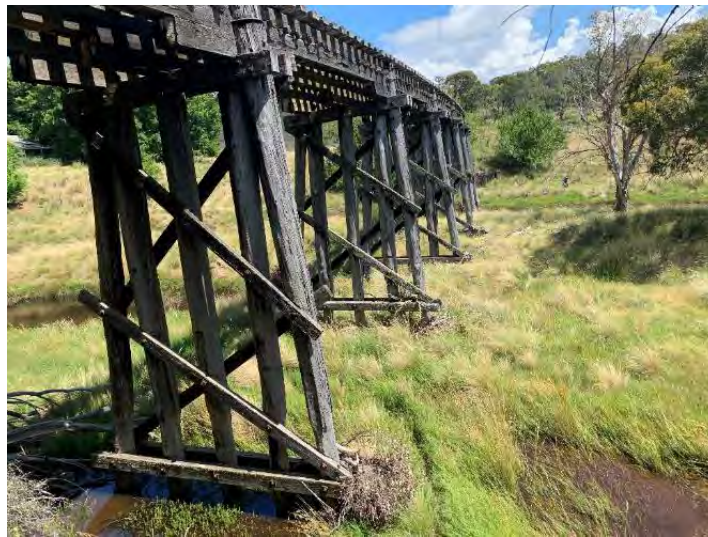
Figure 10-7: Above image shows the left curve and camber in the bridge. The bent configuration is also highlighted, it was noted that significant overgrown vegetation and debris build up was present at the base of all bents. This increases moisture retention leading to accelerated decay of the lower timber elements.

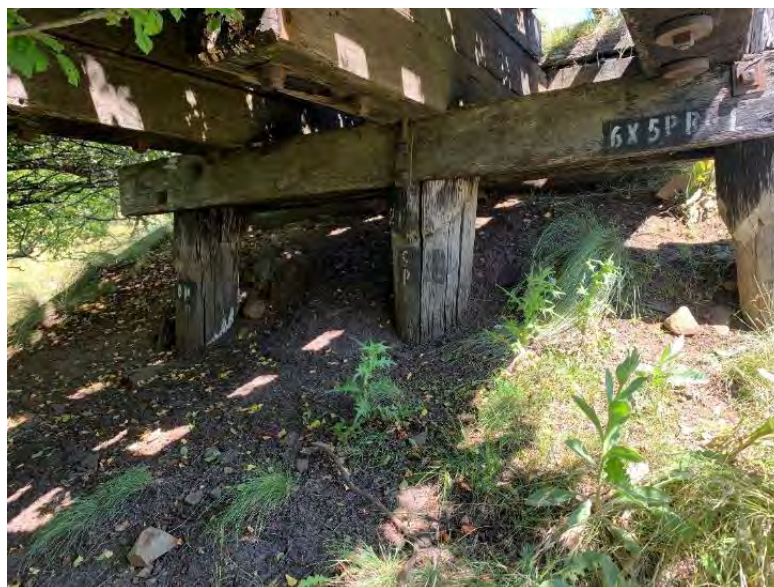
Figure 10-8: View of abutment 2 configuration, the abutment was found to be in poor condition with significant decay present. It was noted that the left two piles had large vertical splits in them, whilst the right pile had significant decay of sapwood.

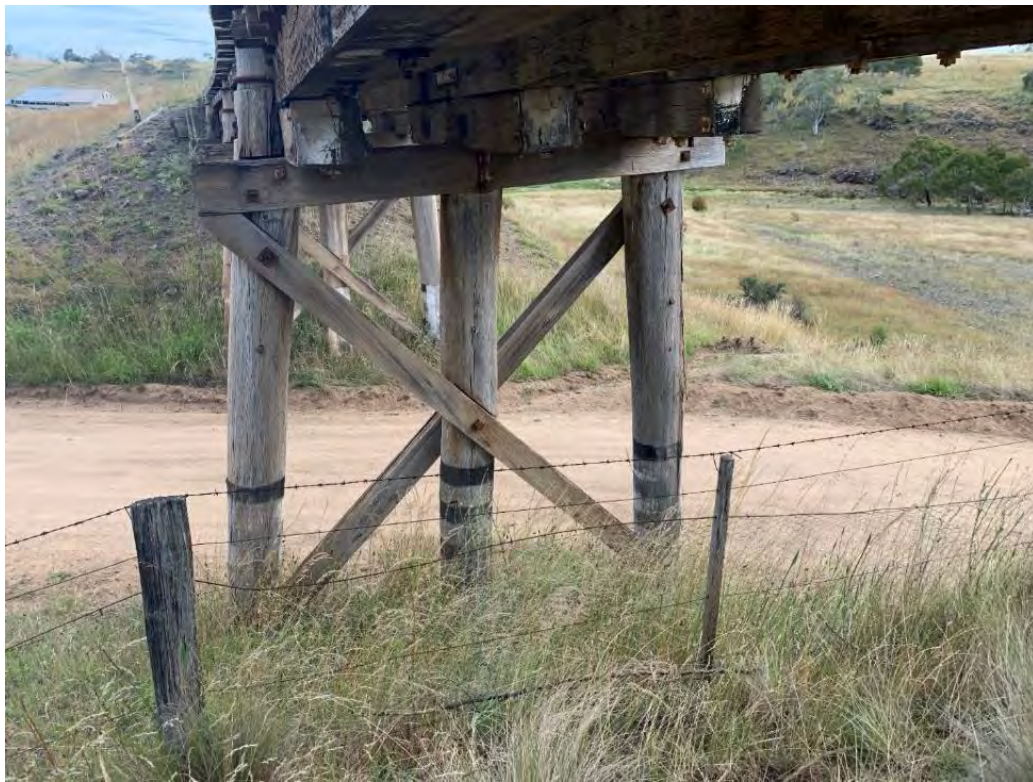
Figure 11-2: View of pile bent 1 configuration. The bents comprise of 3 driven piles. Pile bent 2 and 3 are supported by cross bracing. The two abutments do not contain the cross bracing but are supported by sheeting planks to retain backfill. It was noted that several piles and headstocks have started to undergo decay. It can be seen on pile 3 significant sapwood decay occurring.

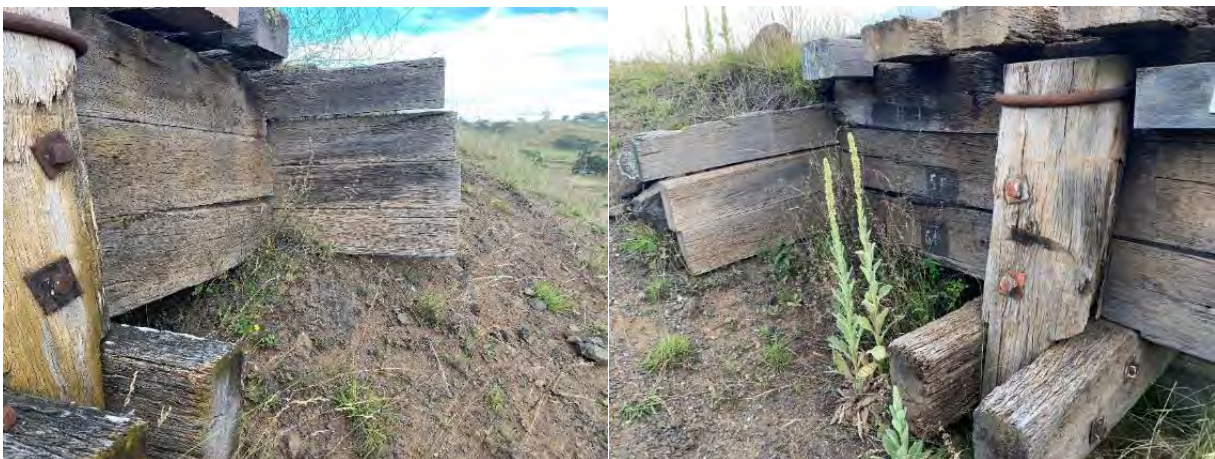
Figure 11-3: General view of pile bent 2. piles were found to be in poor condition. With significant sapwood decay present in all piles, it was noted that all piles have large vertical splits through the horizontal connections. The bottom sections of the timber piles were determined to be a 'hotspot' for decay due to increased moisture retained by the overgrown vegetation.

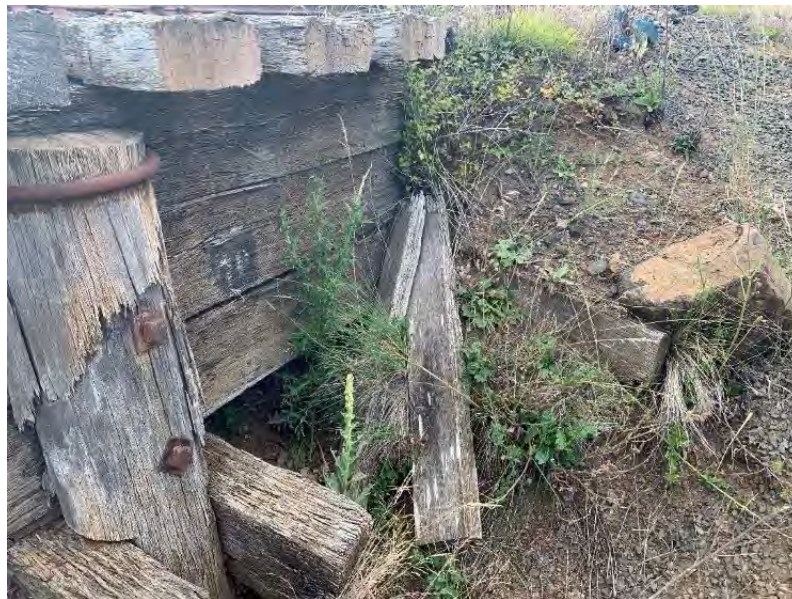
Figure 11-4: The images above show the condition of the breast wall at AB2. The abutment sheeting was found to be in fair condition with minor decay of the sapwood present. The headstock ends were in poor condition with decay and cracking present.

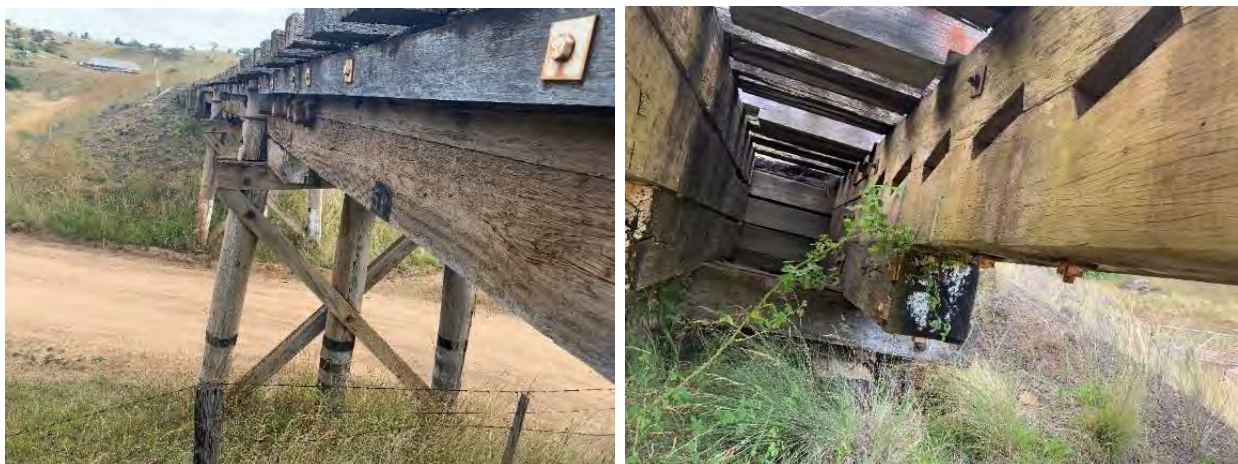
Figure 11-5: View of abutment 1, found to be in poor condition with major decay of sapwood present in piles and broken/missing elements in abutment sheeting.

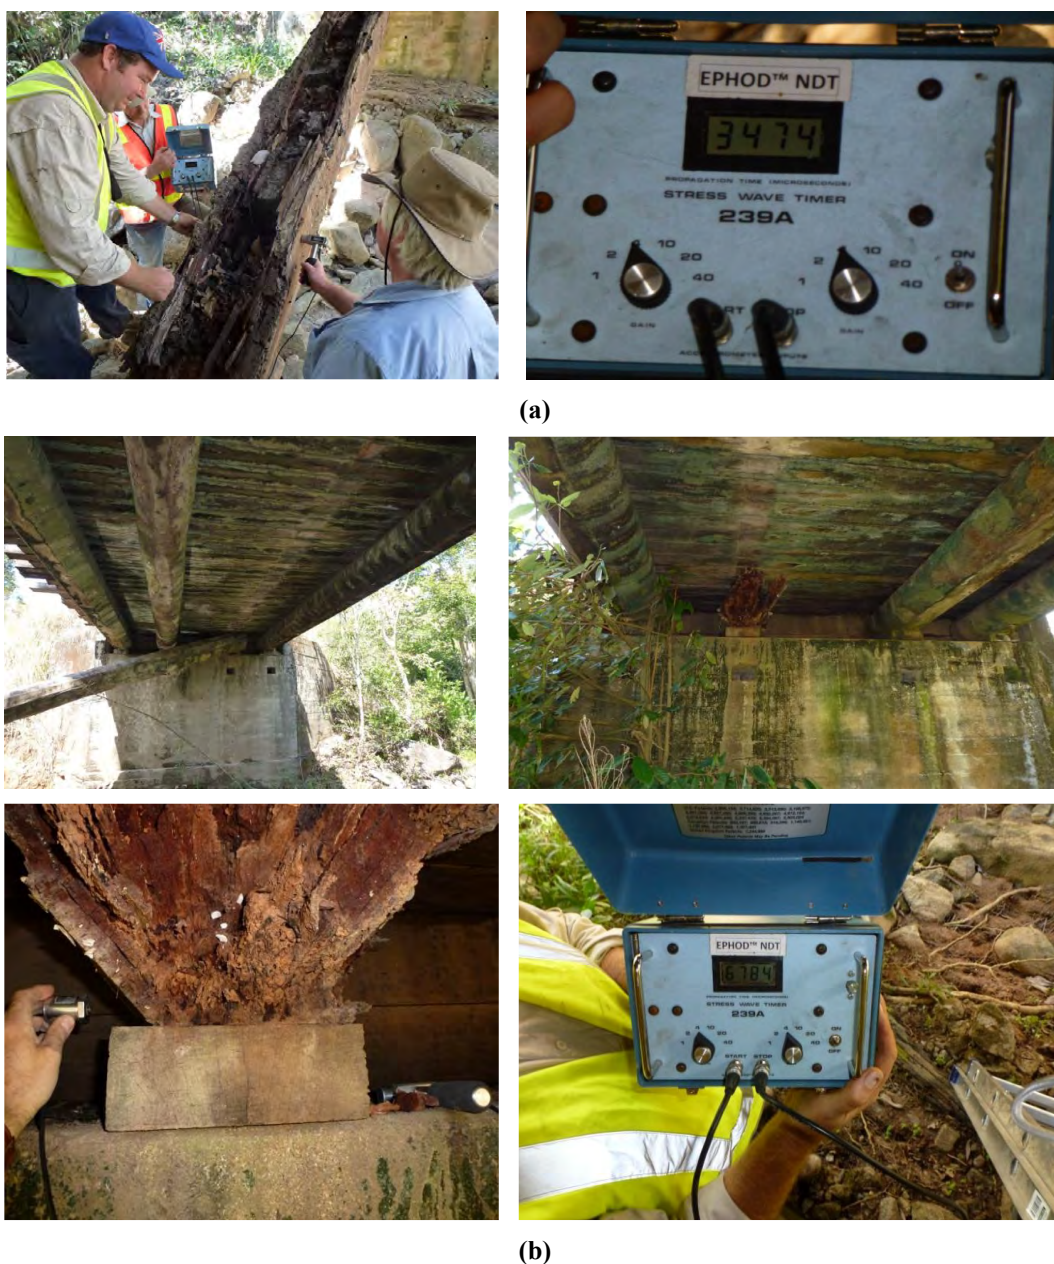
Figure 12-1: Photos showing global failure of a timber log girders. Both failures were caused by advanced decay in the ends of the girders and transverse shear failures. The primary cause of this decay was due to vertical fasteners. These failures were found in elements with SWT values in the 3k μ s (photos a. above) to 6k μ s range (photos b. below). Typically, similar bending extreme tensile fibre failures in log girders occur in zones of decay where there are over 2k μ s SWT values. Similarly, if vast portions of the log girder have SWT values over 3k μ s the failures may occur.
